Spectrum Analysis and Oscilloscope Tracings of Harmonics from Photovoltaic (PV) Grid-Tied Inverters

written by Oram Miller | 31 August 2014

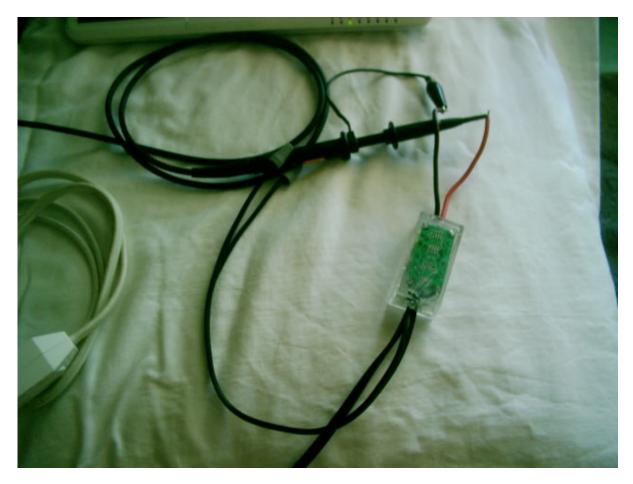
The tracings on the pages below are a spectrum analysis and oscilloscope tracings of a circuit close to the main breaker panel and inverter in each house. I used an attenuator plugged into an outlet, provided for \$50 by Stetzer Electric:

This allowed me to tap directly into an outlet without damaging the O-scope, which can only handle a maximum of 30 Volts input. The attenuator removed 60 Hz frequencies on the oscilloscope, allowing frequencies below and above 60 Hz to be shown on the tracing (however a whip antenna on a separate channel showed the typical 60 Hz sine wave configuration). The attenuator also reduced the input voltage to less than 1 Volt.

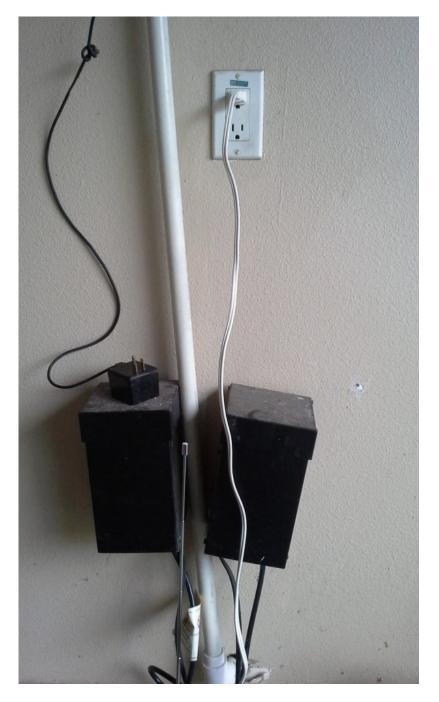
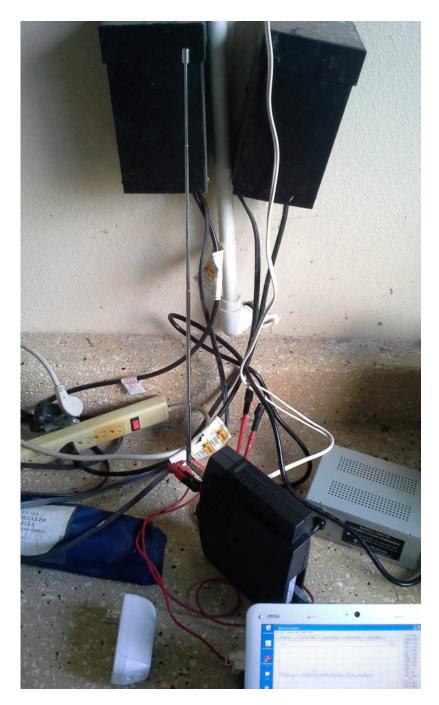
I measured dirty electricity by plugging the Stetzer attenuator into an outlet as close to the main breaker panel and PV inverter as possible. This was usually in the garage.

I first measured frequencies of dirty electricity with the spectrum analyzer, both by plugging into an outlet as well as measuring in the air with a whip antenna.

This was followed by an analysis of the 60 Hz electricity sine wave on the circuit using the Velemann's oscilloscope.

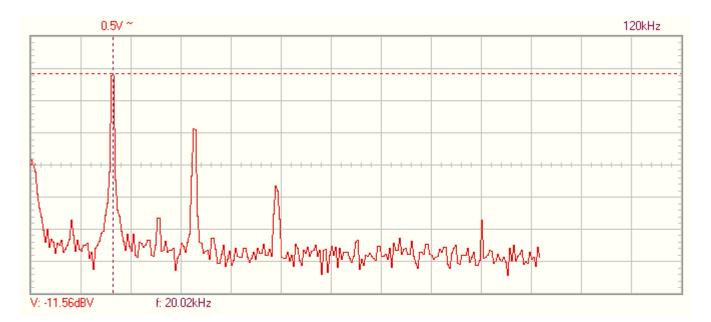
The frequency shown in the upper right corner of the image is the maximum value of the range being shown. For instance, the number 120 kHz is displayed in this case. That means the tracing shows all activity being measured on the circuit from 0 Hz on the left, to 120 kHz at the right end of the tracing on the display:

There are ten divisions along the horizontal axis from left to right, meaning each division measures 1/10th of the total range. Thus in this case, each division would display 12 kHz increments as you move from left to right.

You can thereby determine the frequency of any spike by counting the divisions from the left and multiplying that number by the frequencies per division. A spike of 20 kHz, which is the first large spike on the tracing above, would therefore be located just less than two divisions from the left margin in the case of a 0-120kHz range (1.7 divisions X 12 kHz per division), and just under four divisions in the 0-60 kHz range (as shown in a tracing below).

Using markers on the display, you can also determine the frequency by looking at the number that appears along the bottom of the tracing for the location that the dotted line is placed upon. In the tracing above, notice that the vertical marker is lined up with the first large spike on the left, corresponding with a frequency reading of 20.02 kHz displayed at the bottom of the tracing.

This first large spike is the fundamental frequency of a source of dirty electricity, which in this case, is the photovoltaic inverter. If you then count the divisions, you can see harmonics at the expected frequencies (multiples of the fundamental frequency), but with lower voltages (heights). These are at 40 kHz, 60 kHz, and so on.

The vertical axis, along the left margin of each tracing, shows the strength of each spike measured in Volts (V). The number at the top left shows the number of Volts per vertical division, which in all cases is 0.5V, or one-half of one Volt.

When I lined the vertical marker with the top of the first (fundamental frequency) spike, you see the strength or height of that spike recorded at the lower left margin in decibel Volts (dBV), which is -11.56 dbVolts in this case.

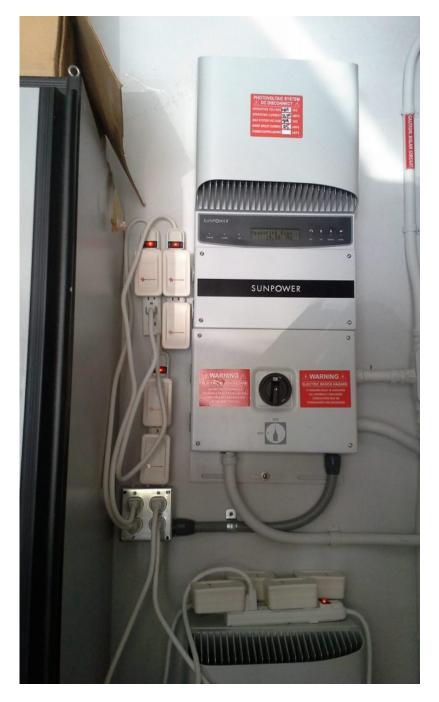
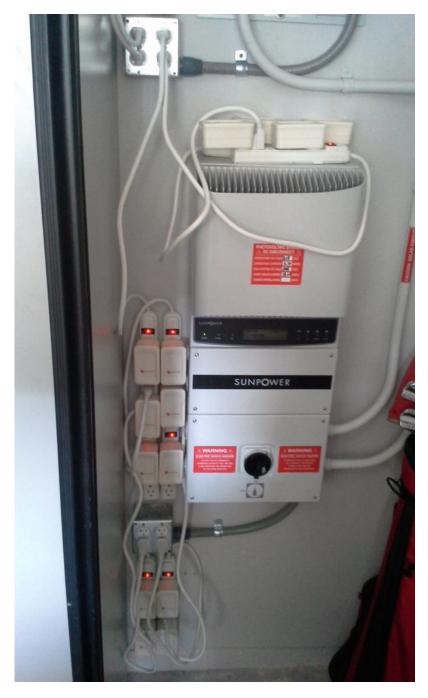
The first home was measured on 4/17/14. It has two Sunpower brand grid-tied inverters, mounted one above the other in the garage (and, yes, those are numerous Stetzer filters plugged in all around these inverters, in the homeowner's attempts to reduce the DE that bothers him to a great extent):

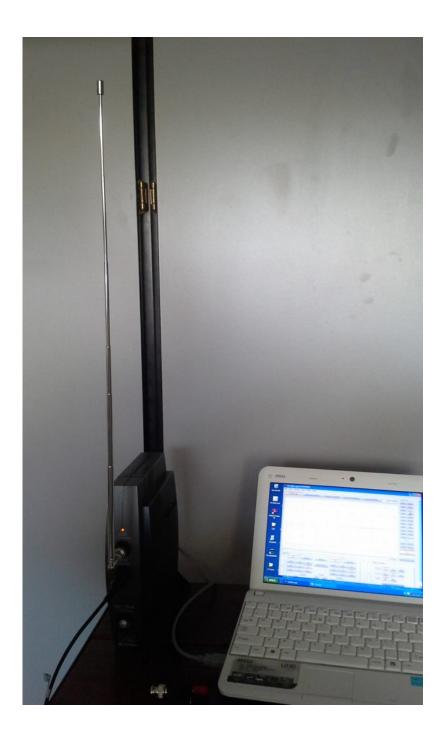
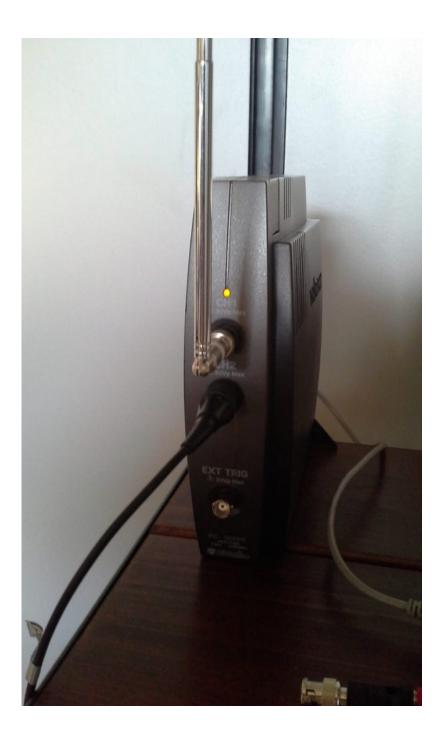
Here are photos of the oscilloscope set up. In the first photo, you see the Velleman scope with a whip antenna connected to channel A, while a wired lead from the circuit is connected to channel B. A close-up is shown in the second photo:

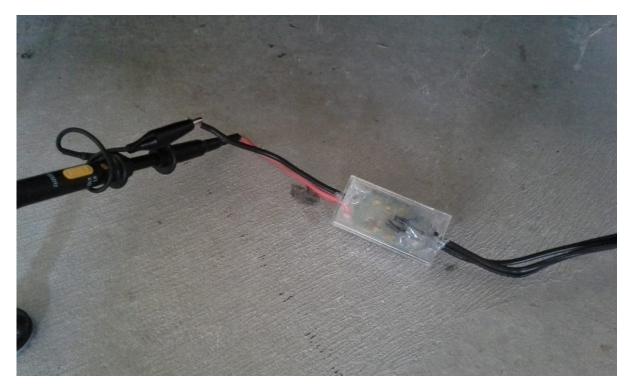
The wired lead is connected to the two wires of the Stetzer attenuator, which is plugged into an outlet:

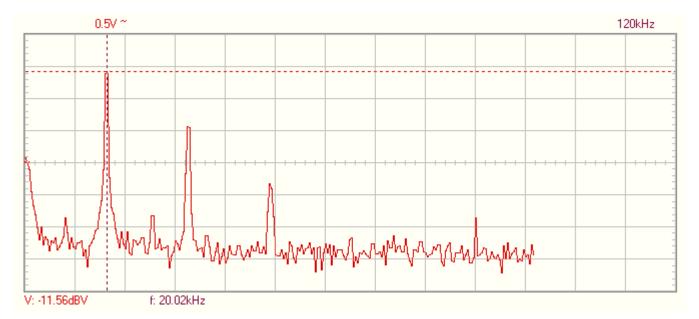
In the first tracing below, you see a fundamental frequency at 20 kHz with a height of -11.56 dB. You can count the height of the spike above the baseline by noting that each vertical division is 0.5 Volts and the peak is roughly 5.5 divisions above the baseline. Thus 0.5 Volts/division X 5.5 divisions correlates with roughly 2.75 Volts of height, equal to -11.56 dBV.

Notice also the harmonics at 40 kHz and 60 kHz to the right, each one with diminishing intensity or strength (height):

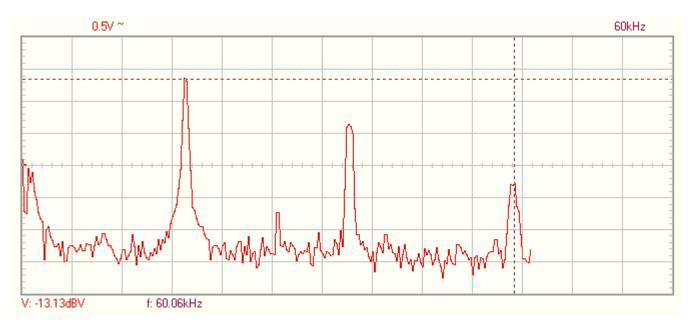
Below you will see the reading at closer range (0-60 kHz), meaning the range from left to right is from 0 to 60 kHz rather than from 0 to 120 kHz, and each division measures 6 kHz in width instead of 12 kHz.

I happen to have placed the marker over the third harmonic, which registers at the bottom as

60kHz. The height of the fundamental frequency on the left at 20 kHz is roughly the same as in the tracing above (-13.1 dBV vs. -11.6 dBV):

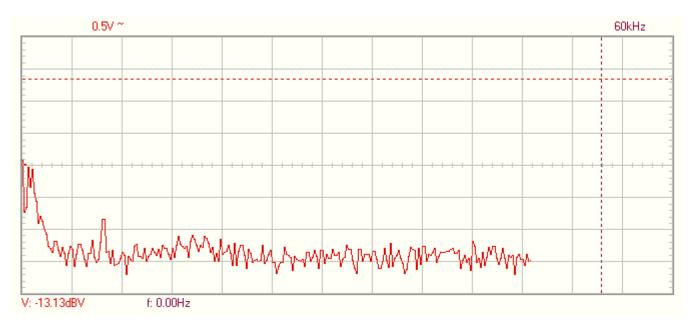
Now I show you a tracing at the same range of 0-60 kHz but with the PV system inverter turned off. Notice that the fundamental frequency and its harmonics are completely gone:

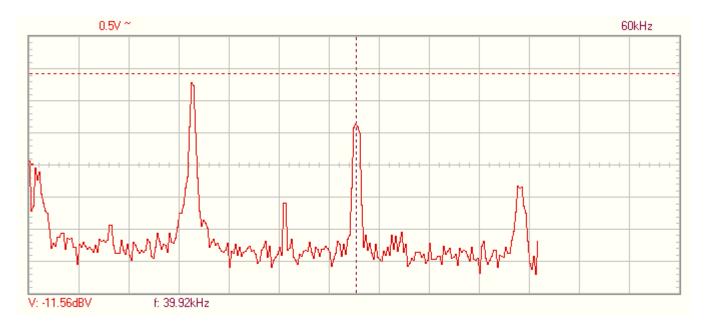
Next is a depiction of the reduction of DE with the inverter on but with all the Stetzer filters shown in the photos above in place. I first show a tracing with the surge protectors into which the Stetzer filters are plugged switched off, as a baseline. Notice, again, the height of the fundamental frequency (at 20 kHz) is -13.13 dBV, shown in the lower left margin (5.5 divisions above the baseline, corresponding to 2.75 V high):

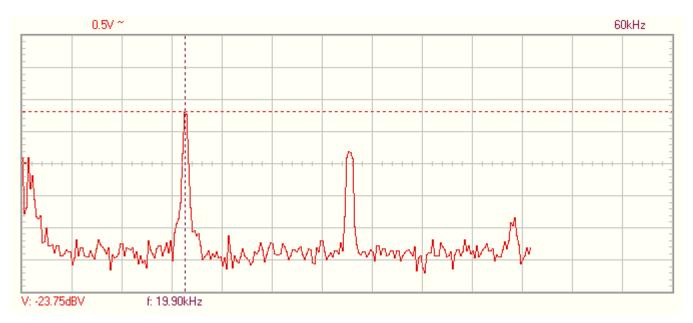
Next is a tracing with the surge protectors switched on, powering the Stetzer filters. Notice that the height of the fundamental frequency at 20 kHz has dropped from -13.1 dBV to -23.75 dBV (the more negative the dBV value, the lower the Voltage or height of the spike). This is shown in the lower left margin. With Stetzer filters on, the new height is 4.2 divisions above baseline, or 2.1 V, compared to 5.5 divisions above baseline with Stetzers off, at 2.75 V.

This represents a 25% reduction. The spikes for the first and second harmonics are also smaller than in the tracing above:

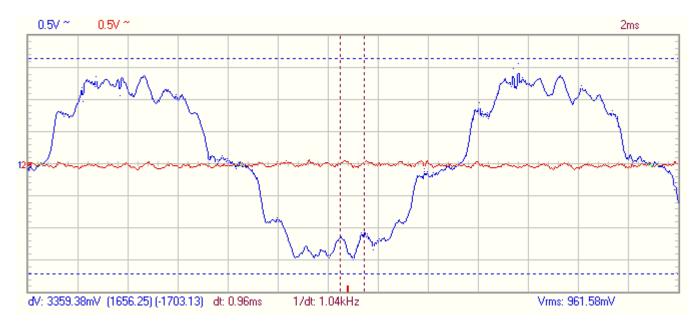
The first oscilloscope tracing below is with the inverters shut off. The red tracing (channel B) is taken directly from the circuit, as are the spectrum analyzer tracings shown above (remember, the Stetzer attenuator cuts out the 60 Hz sine wave, resulting in a flat oscilloscope tracing if no higher frequencies are present).

The blue tracing (channel A) is from a whip antenna, which measures any DE in the air (and shows a

true 60 Hz sine wave because there is no attenuator on the lead from the whip antenna, only on the lead from the electric circuit). There is some amount of harmonic frequencies (DE) in the air (at 1.06 kHz), which is not from the inverter (remember, it was turned off at this point). The blue sine wave is not completely clean, but this particular amount of DE, from some other source, is not of a significant amount:

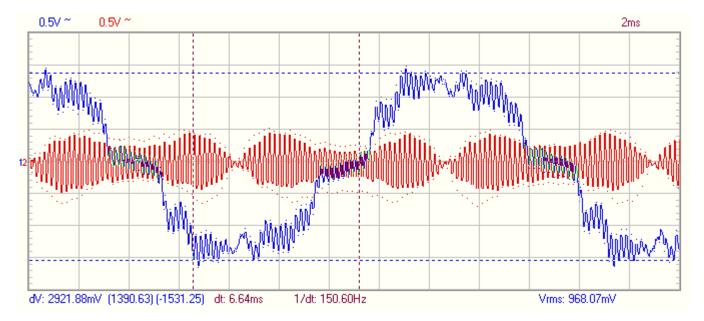
Compare this relatively clean oscilloscope tracing to the tracing below, this time with the inverters turned on. A higher frequency is superimposed upon the 60 Hz sine wave, as seen on both channel B connected to the circuit (red) and on channel A connected to the whip antenna in the air (blue):

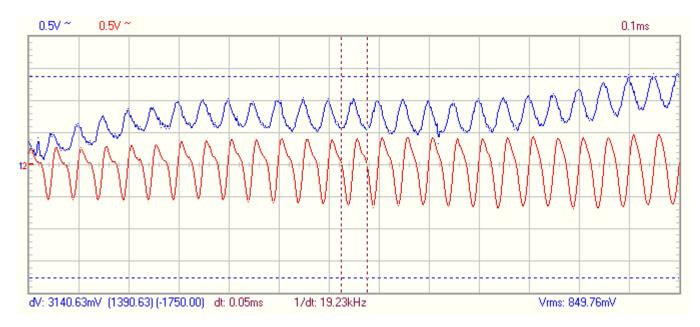
Here is a close up of the same tracing with the horizontal divisions now at 0.1 milliseconds (ms) rather than 2 ms, as in the tracings above. We know that this higher frequency superimposed upon the 60 Hz sine wave is from the inverter and that it has a frequency of 20 kHz. You can actually determine this on the oscilloscope by placing the markers at the beginning and end points of any one cycle. The markers below are placed on roughly the zero point of the red tracing (an imaginary horizontal line running through the sine waves). They can be placed anywhere on two sequential oscillations as long as they are on the same point in each cycle.

In the case below, the markers measure 0.05 milliseconds of time (listed at the bottom of the graph

as dt, or "delta time," at 0.05ms). This represents the wavelength, shown as a red number at the bottom margin. You can then calculate the frequency based upon the wavelength, because frequency is inversely related to wavelength, or 1 over delta time (1/dt). The frequency is shown in red on the bottom margin as well. It reads 19.23 kHz, matching the fundamental frequency of roughly 20 kHz seen on the spectrum analysis tracings shown above. Thus you can determine any harmonic frequency of DE using either the spectrum analyzer or the oscilloscope.

Here is the oscilloscope tracing showing the wavelength and frequency of the higher (20 kHz) frequency superimposed upon the 60 Hz sine wave of utility electricity:

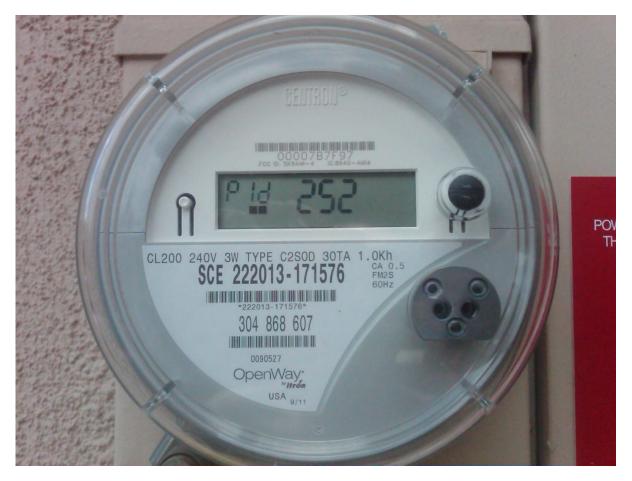
This house has a Southern California Edison Itron brand smart electric meter, as seen in this photo taken by the homeowner (at the bottom of the smart meter are the words, "OpenWay by Itron" and the letters "SCE" stand for Southern California Edison):

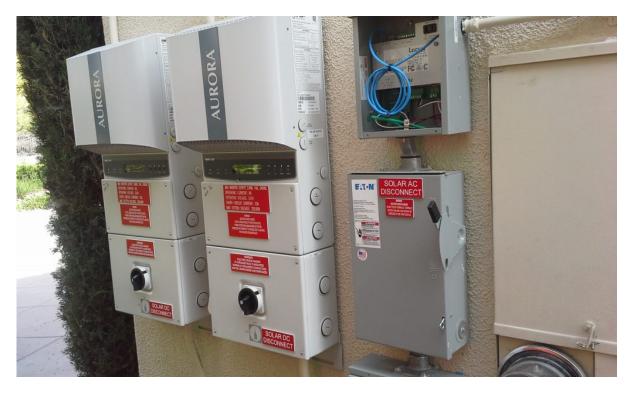
We measured DE at a home on 3/26/14 that also has PV solar panels and two Aurora Power One photovoltaic grid-tied inverters, leased from Verango:

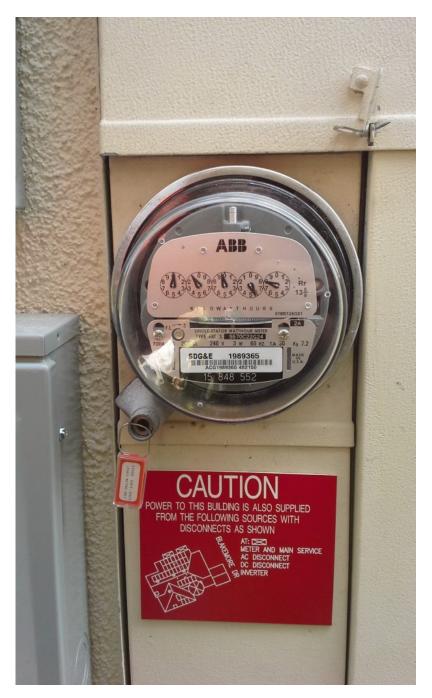
This client had opted out of San Diego Gas & Electric's smart meter program and instead had an opt-out analog meter. This resulted in a solar panel set up that was devoid of any wireless

transmissions from either Verango's meter nor from SDG&E's electric meter:

This is actually a bit unusual in that we are told by certain other electric utilities that they cannot use an analog meter, which is what smart meter opt out customers get, on a house with a grid-tied net metering system with PV panels. Yet San Diego Gas & Electric has just such a set up at this house in Ladera Ranch.

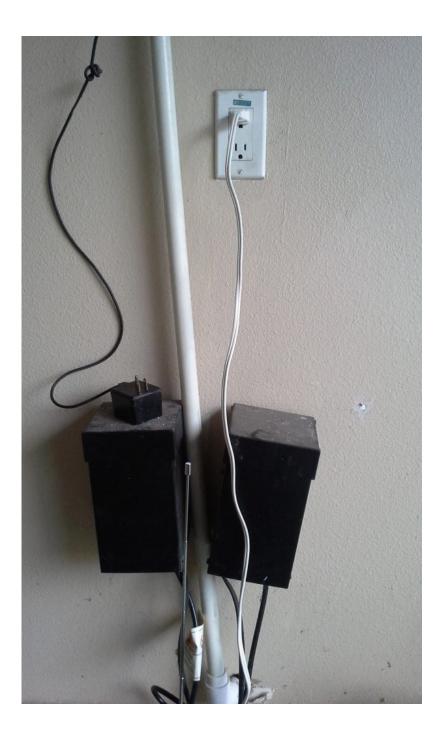
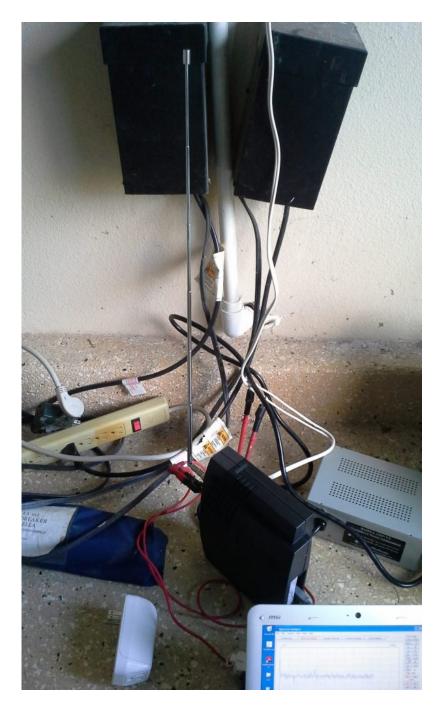
Once again, here is the oscilloscope set up at the home in Ladera Ranch. The Velleman scope was plugged into an outlet in the garage on the opposite side of the wall from the inverters, allowing DE measurements straight off the circuit into channel B. I also had a whip antenna connected to channel A. The power supplies for the two irrigation timer motors in the black boxes mounted on the wall were removed, as they produced extraneous DE, which would have been an artifact on our tracings had I left them plugged in:

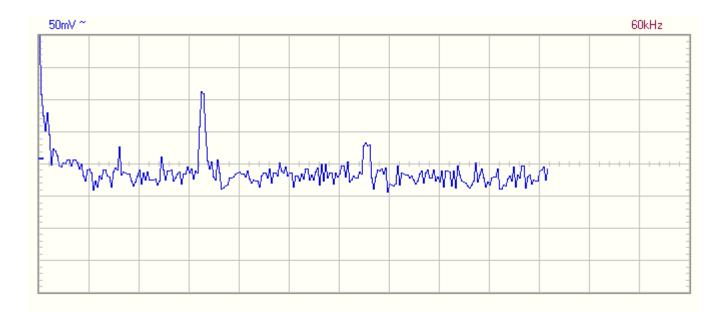
Tracings of the spectrum analysis of this circuit are shown below. The first image shows a spike 3.3 divisions from the left in the 0-60 kHz range. Since each division is 6 kHz wide, 3.3 divisions would equal roughly 20 kHz. Just as with the house in Trabuco Canyon with the Sunpower inverter, this fundamental frequency is also at 20 kHz:

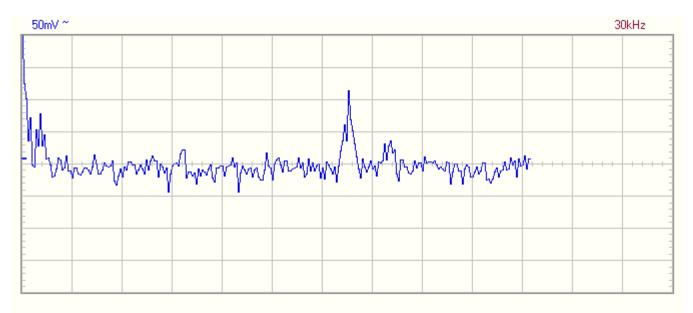
Here the 20 kHz spike is seen again, this time at 6.6 divisions from the left on a tracing with a 0-30 kHz range:

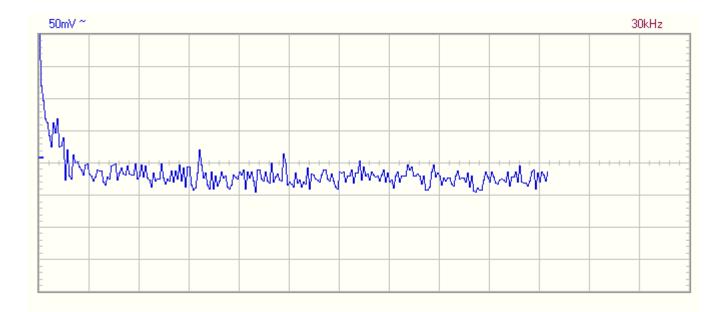
Now see the same tracing but with the inverters switched off. As at the previous house, the spikes are now completely gone:

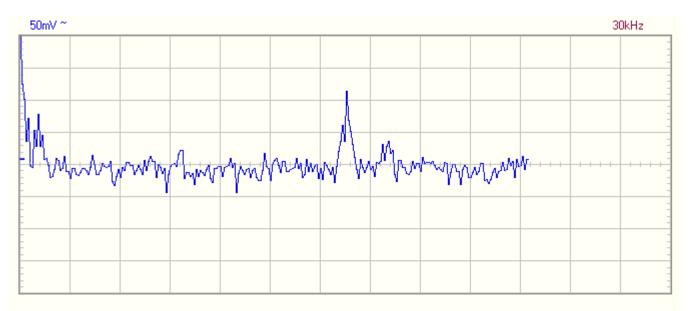
The following tracings show the reduction of DE using DE-reducing devices. First we show you a tracing without devices in place, showing the spike from the Aurora inverters. The spike measures 125mV (2.5 divisions) high:

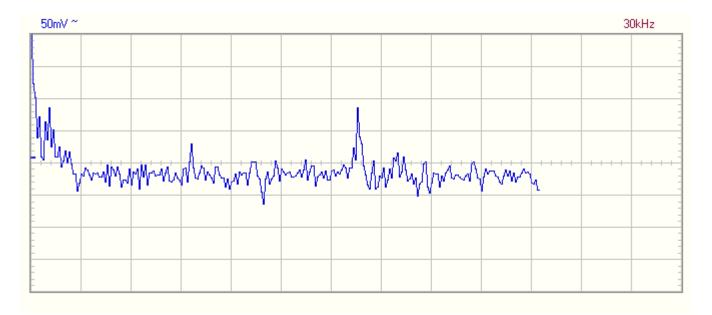
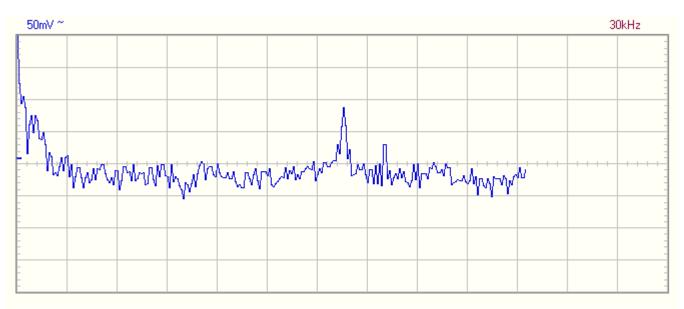
The first photo below shows a Greenwave filter in use. Below that an RxDNA device is in use. In both cases, spikes are 100 mV (2 divisions) high, not 125 mV (2.5 divisions) high, representing a 20% reduction:

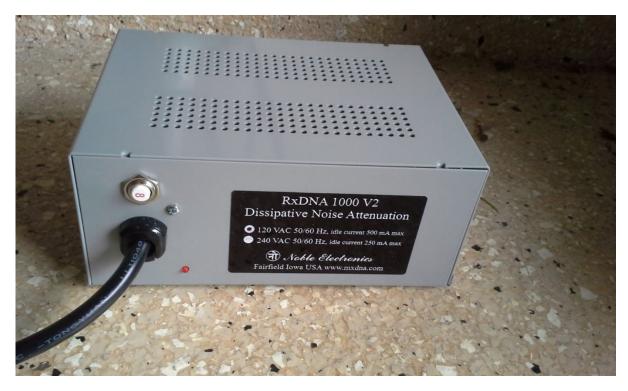
Here is a photo of the RxDNA dissipative noise attenuation device:

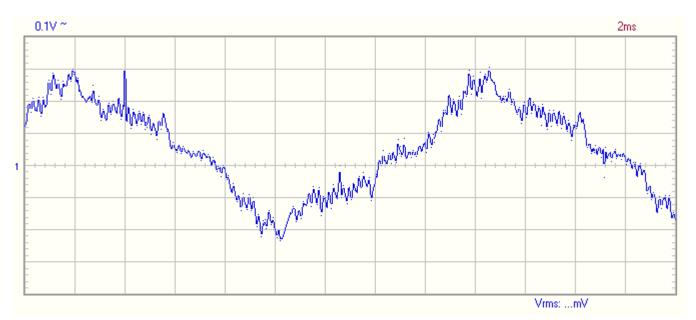
Below you see an oscilloscope tracing of the 60 Hz sine wave captured in the air with a whip antenna comparing inverters switched on versus switching them off.

The first tracing shows a sine wave with the inverters switched on. You will notice a high frequency pattern (20 kHz) superimposed upon the 60 Hz sine wave, appearing as a tiny saw-toothed oscillation overlaid onto the sine wave. Both tracings are at 2ms per horizontal division and 0.1V per vertical division.

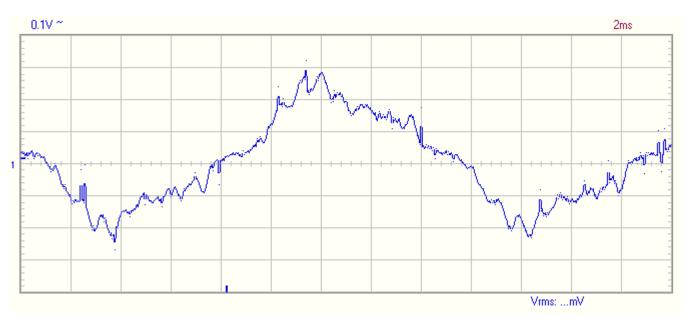
Here is the oscilloscope tracing with the inverter switched off. Notice how much smoother the tracing is, devoid of the saw-toothed higher frequency superimposed upon the 60 Hz sine wave above:
