# **Study to Determine the Presence of Dirty Electricity from Smart Electric Meters in Southern California**

written by Oram Miller | 3 June 2015

Reports exist of dirty electricity from switched mode power supplies in smart electric meters in the Pacific Gas & Electric (PG&E) service area of Northern and Central California (see below). In an effort to try to document the existence of dirty electricity from the brands of smart meters used by electric utilities in Southern California, I conducted a study of over 20 homes in May and June of 2012. The results of that study, along with oscilloscope tracings, are presented below.

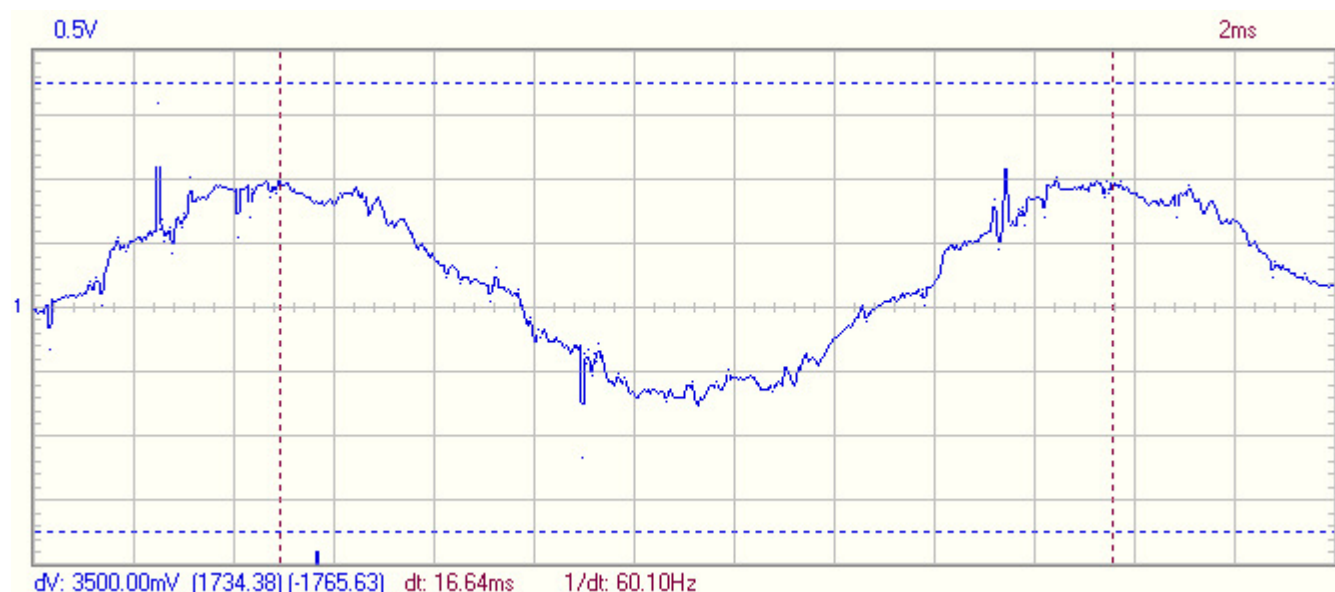
The first tracing shows the oscilloscope tracing at a home with a Landys+Gyr smart meter in Moro Bay taken on July 29th. Dimmer switches, which are a source themselves of dirty electricity, were turned off. Notice the voltage transient on the portion of the sine wave preceding each peak, which may, indeed, be due to the Landys+Gyr smart meter (although I was not able to seek out and isolate other possible sources of dirty electricity in the home):

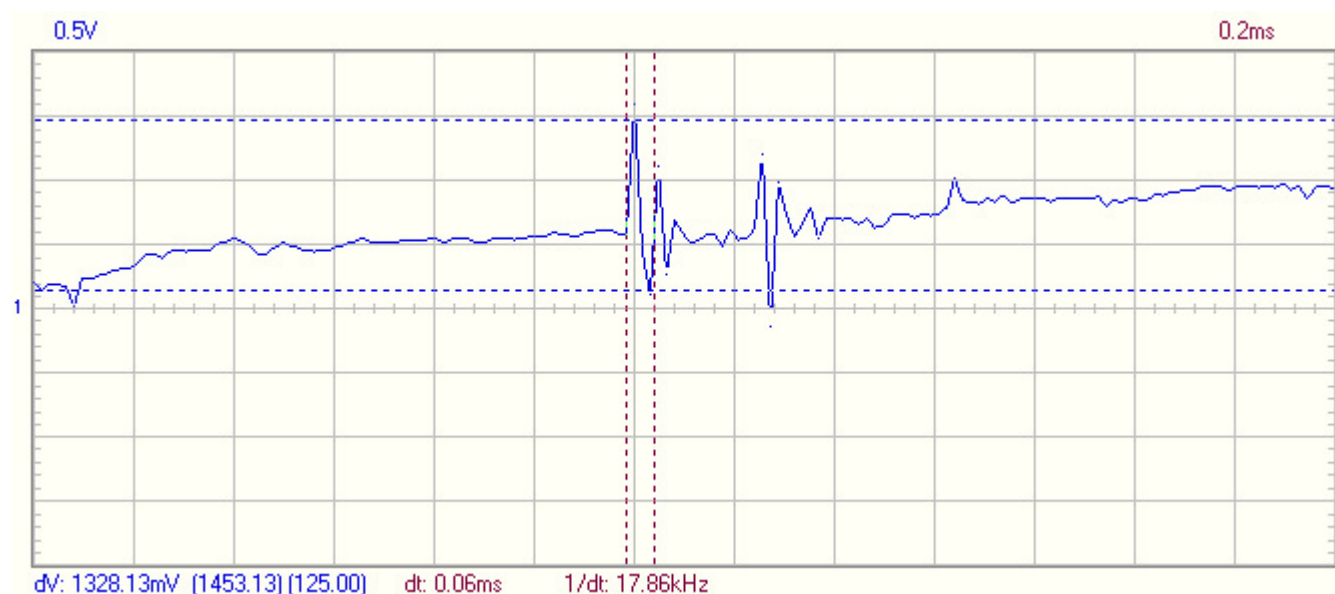
The tracing below is a closeup of the transient, which appears to have a fundamental frequency of 17 kHz and a size of 1.3 Volts in 60 microSeconds, for a slew rate of 21,600 V/Sec:

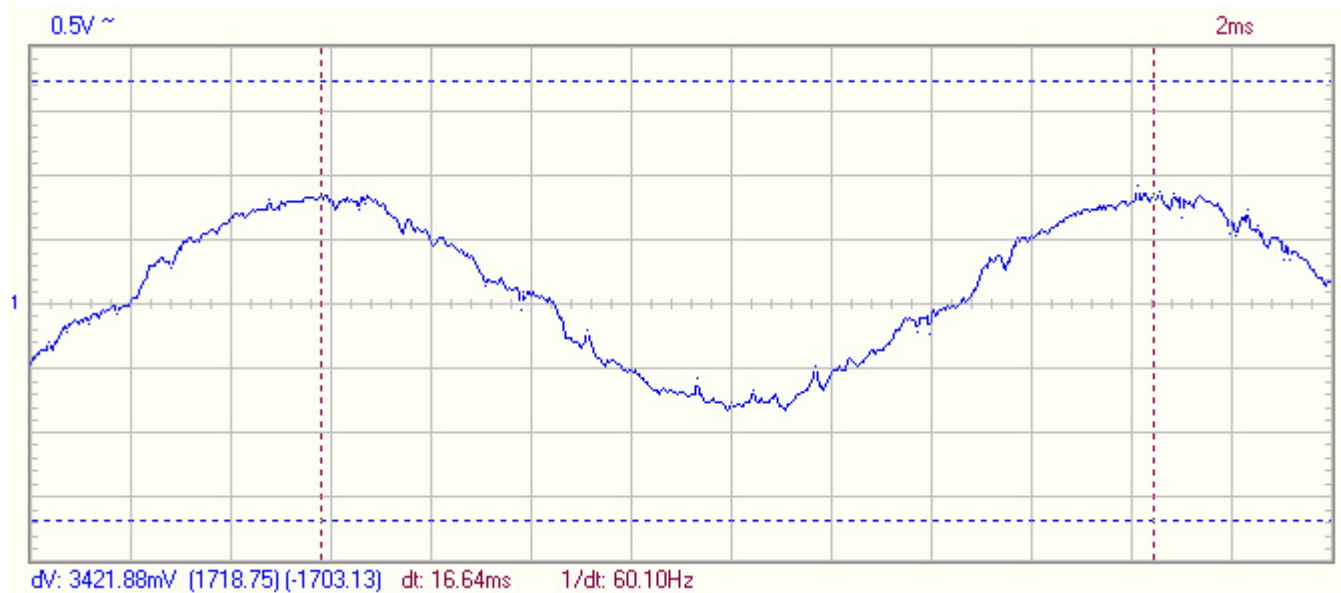
The first tracing was taken at the home of a client who has opted out of the PG&E smart meter program. Her smart meter was replaced with a GE analog electro-mechanical electric meter, which contained no apparent electronic components upon visual inspection. Known sources of dirty electricity within the home, such as dimmer switches and compact fluorescent lamps, were turned off. Notice the lack of any significant voltage transients on the tracing and the relatively clean waveform:

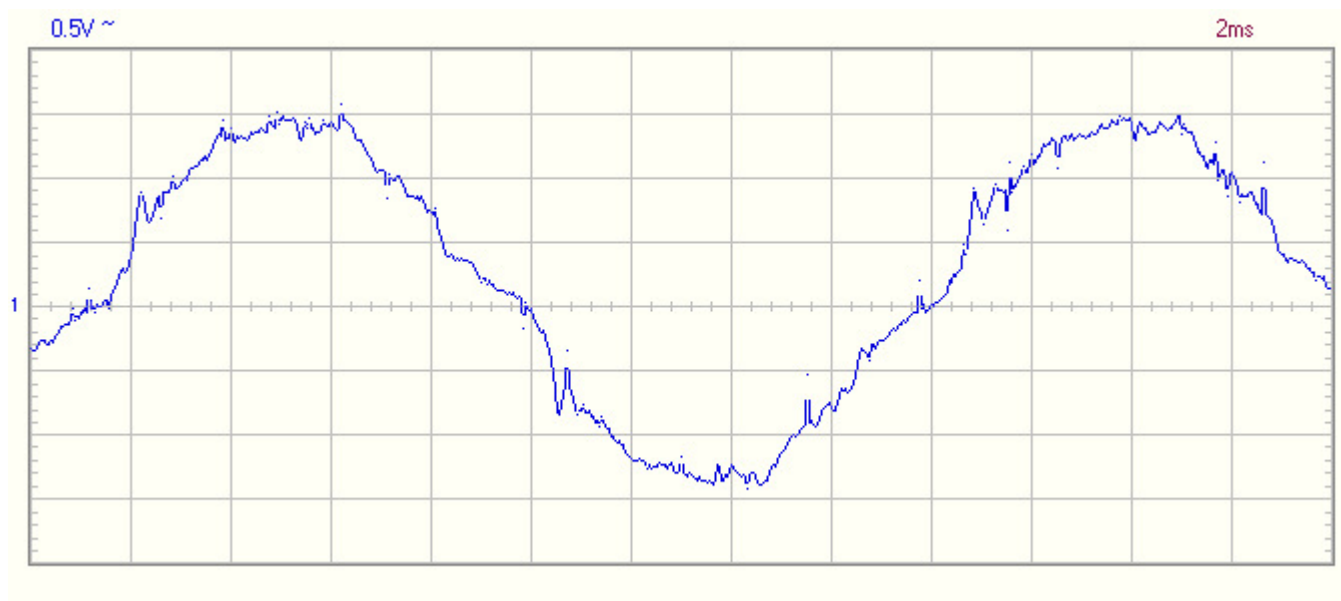
Here is the neighbor's house to the north:

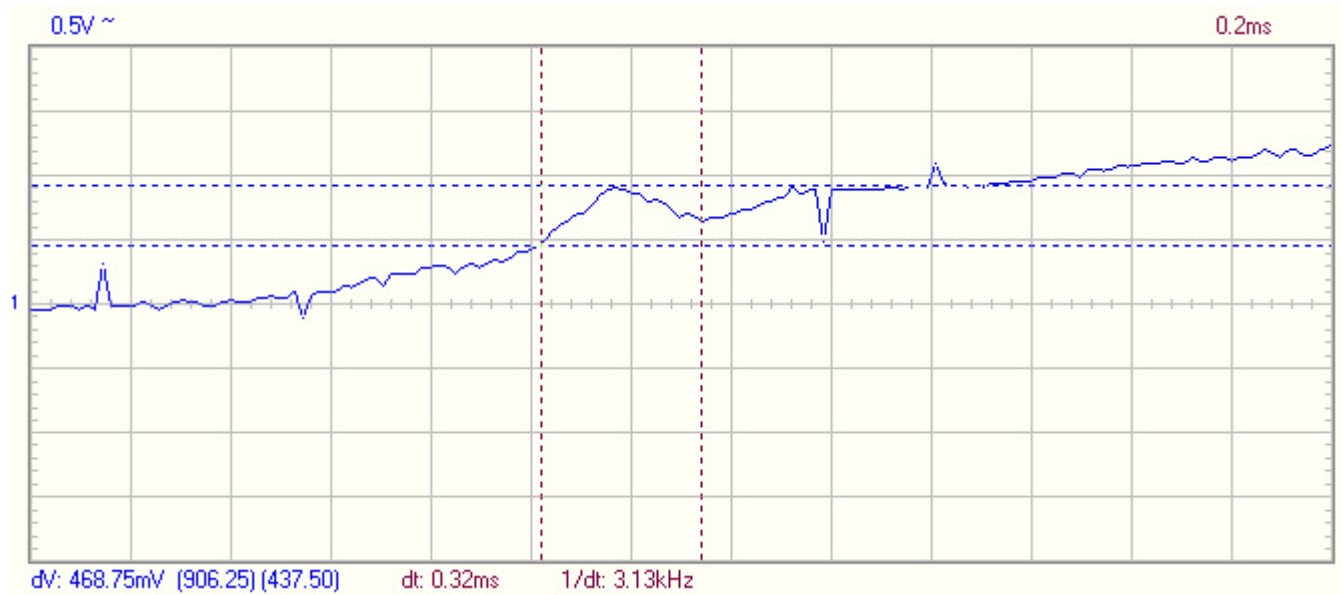
Note below that the fundamental frequency this time is 3 kHz and the height is less than half a Volt (0.47 Volt in 320 microSeconds, for a slew rate of only 1,470 V/sec — see below for the significance of these numbers):

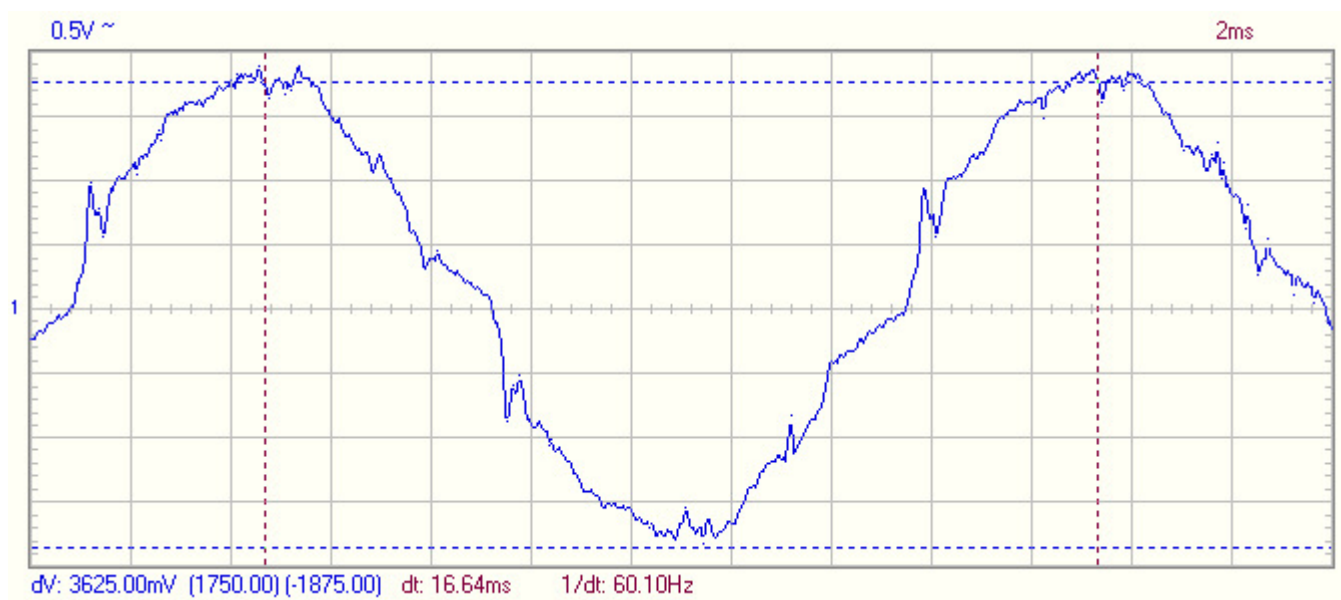
Here is the neighbor's house to the south:

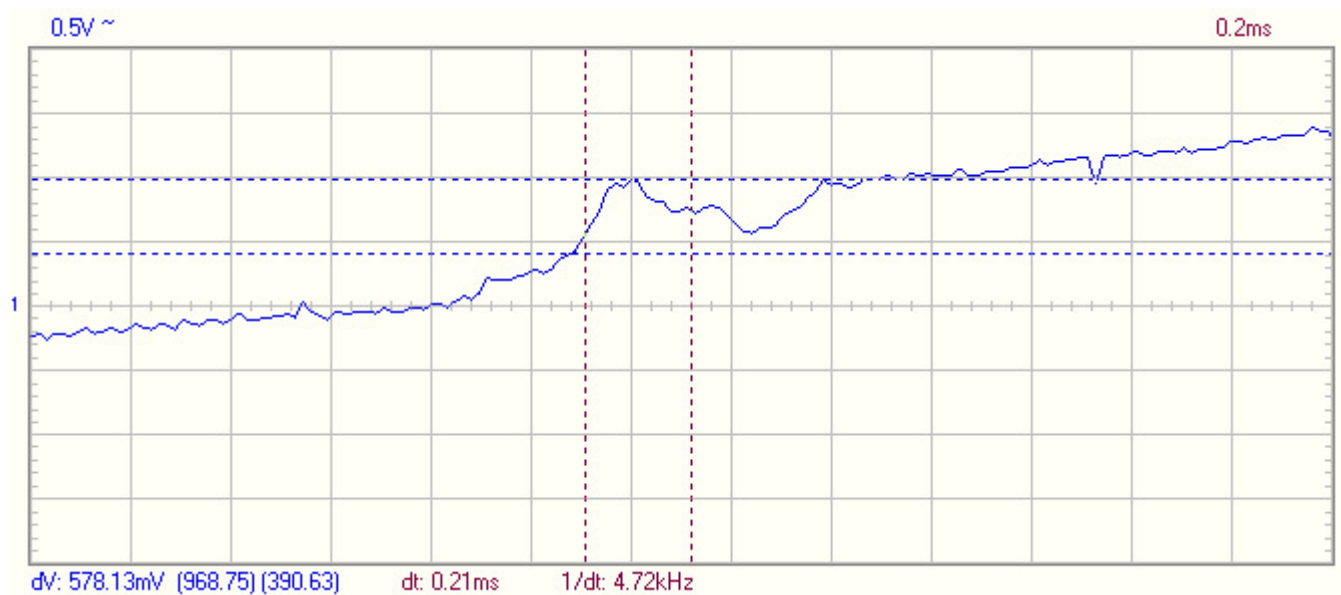
Note below, again, that the fundamental frequency is 4 kHz and the height is just over half a Volt (0.58 Volt in 210 microseconds, for a slew rate of only 2,760 V/sec):

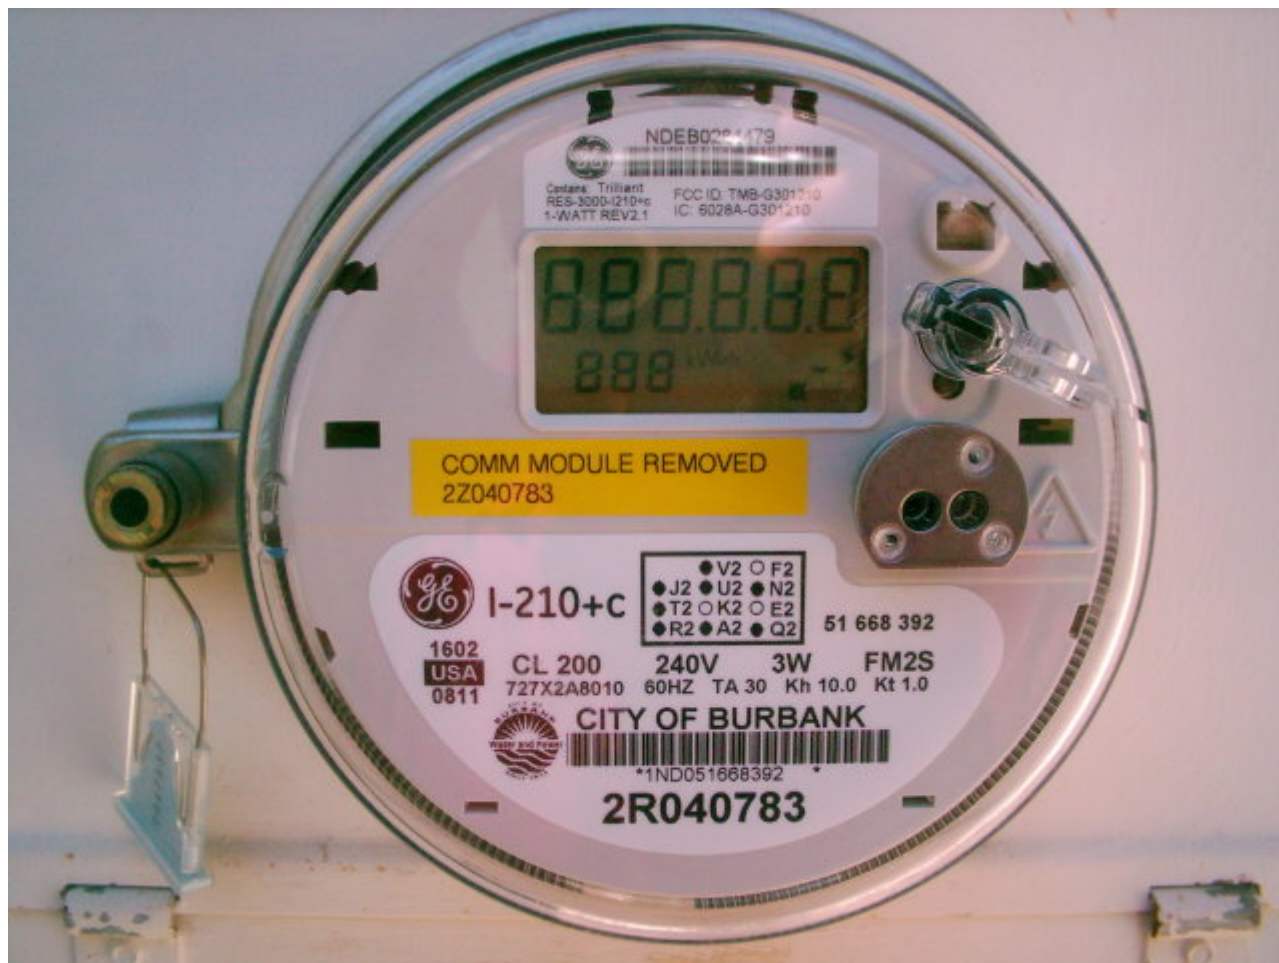
The digital non-RF meter studied on July 17th had been installed the very same day just prior to my arrival. See below:

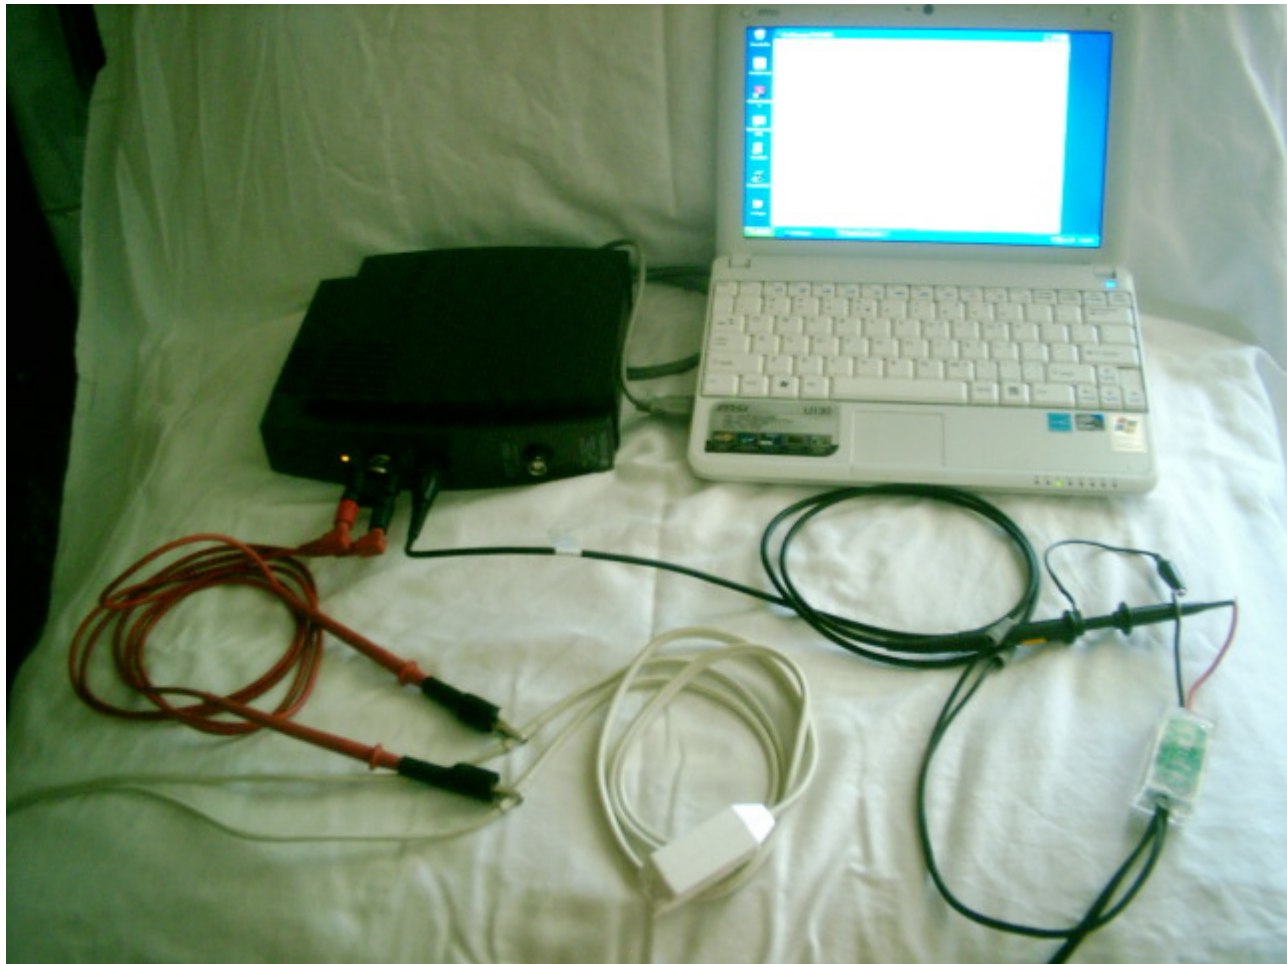
See the set-up below:

The photo shows the two leads clipped to the outer insulation of an extension cord plugged into the outlet. The two oscilloscope leads are plugged into a [Pomona 1296 connector](#) that is attached to the input for channel one (the blue tracings below) on my oscilloscope. The Stetzer attenuator filter is also plugged directly into the outlet, as I had done on my earlier study, and is attached by way of an oscilloscope probe to the input for channel two (the brown tracings below) on my oscilloscope.

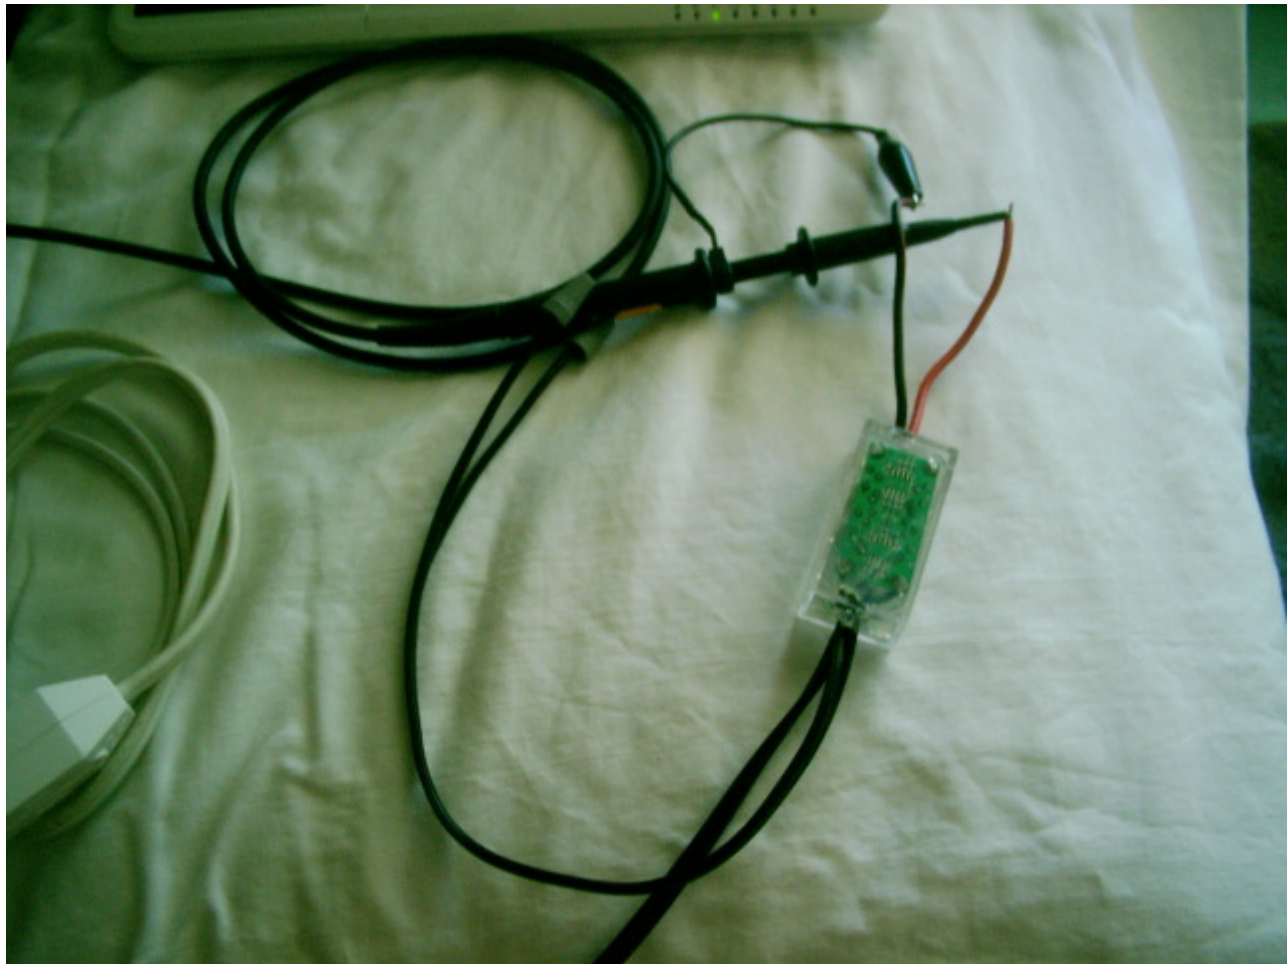
Here is a close-up of the Stetzer attenuator filter set-up. The wire trailing off the bottom of the photo is plugged directly into the outlet, and the hot conductor of the oscilloscope probe is connected to the red wire coming out of the attenuator, and the ground conductor of the oscilloscope probe is clipped to the black wire. The probe is set to 10X and connected to channel two on the scope:

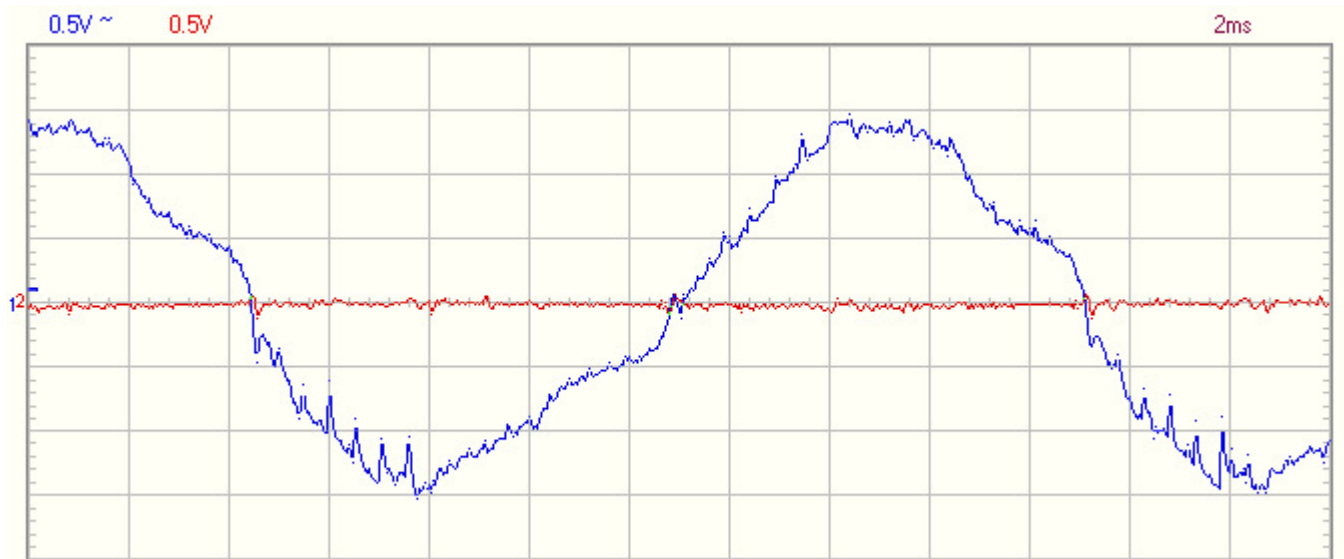
When I shut off all other circuits except the one that powered the outlet I was plugged into, both waveforms looked a little cleaner (less spikes, less saw-toothed appearance), however you can see that there is still a little roughness or electronic noise in the portion of each cycle leading to a peak, particularly the minus (downward) peak:

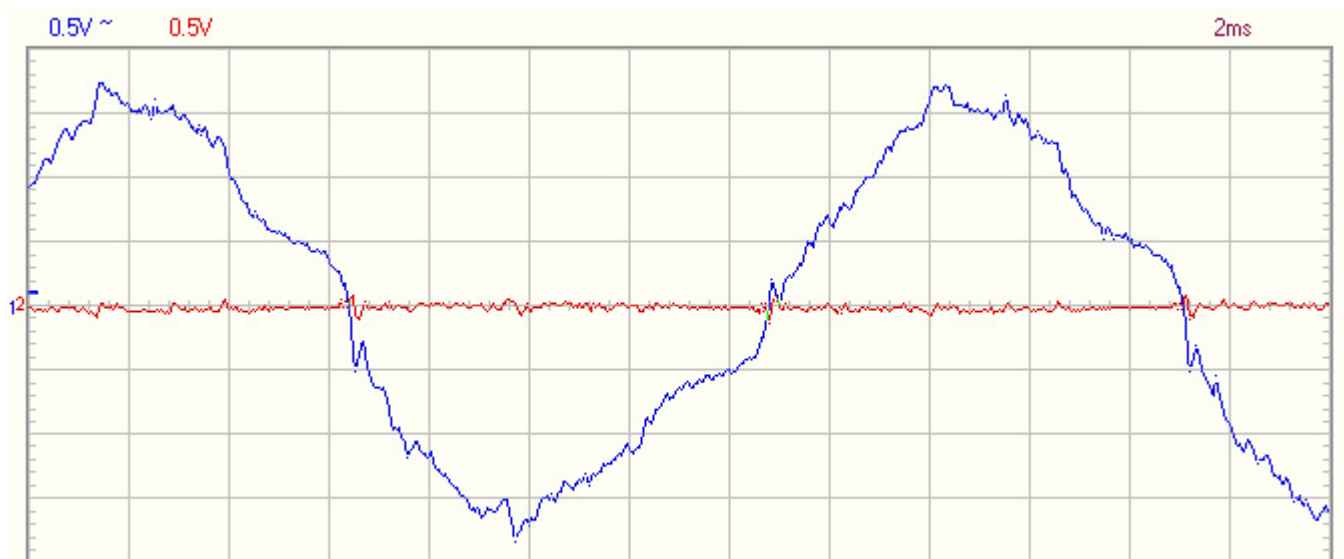
That roughness disappears when we unplugged a transformer for a laptop computer (which was off, but the transformer was plugged in) that was plugged into the same outlet as my test equipment:

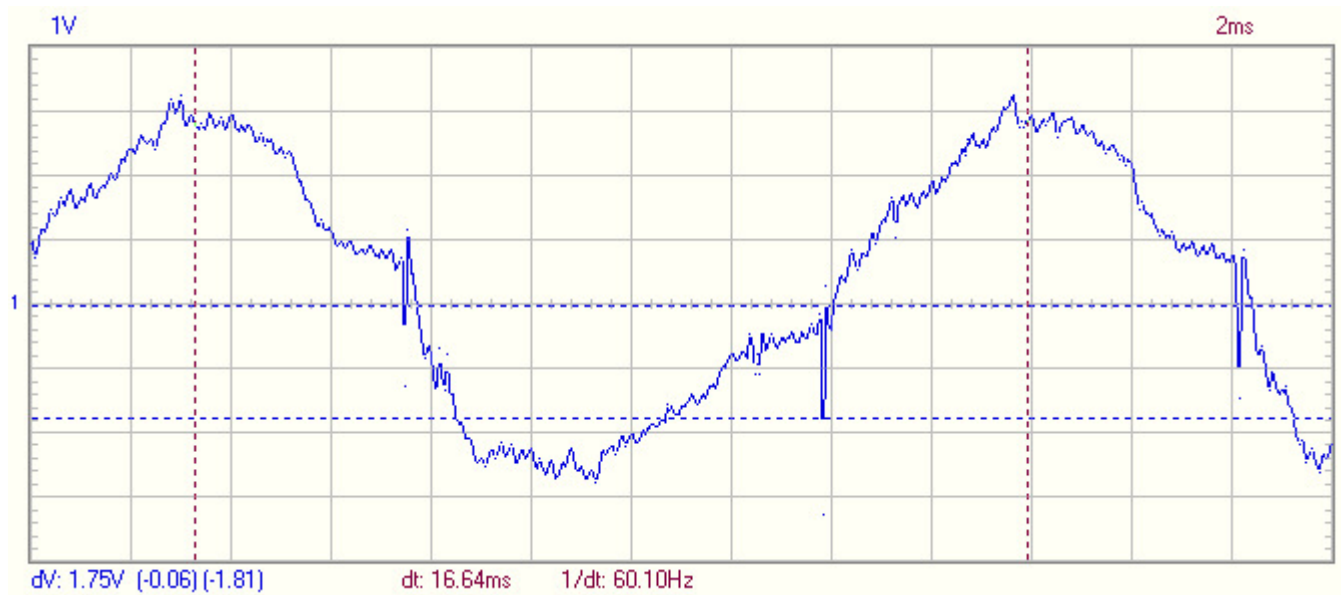
I then asked the homeowner to turn on a dimmer switch in her dining room in which we were sitting, which is a known source of dirty power, and we immediately saw the appearance of the following recurring harmonic distortion or frequency (this image was actually taken on July 24th, and the input from channel two was not present):

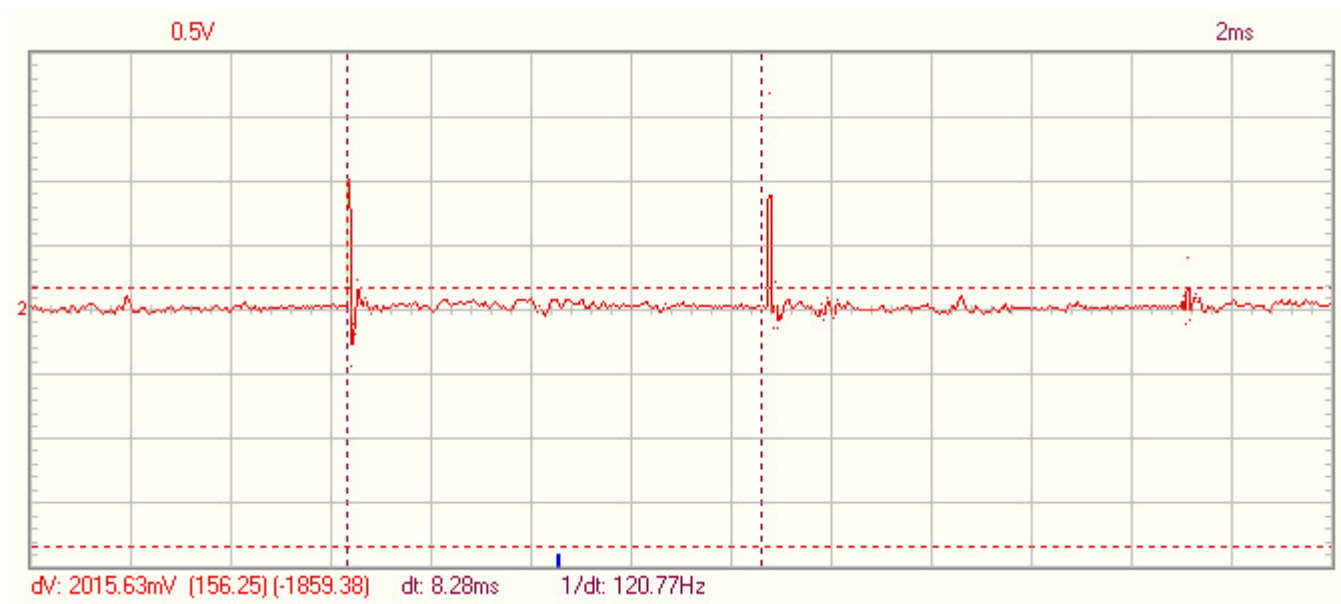
Here is the same waveform tracing taken at the same time of channel two by itself, showing the same recurring harmonic from the dimmer switch but without the 60 Hz sine waveform, which was flattened by the Stetzer attenuator:

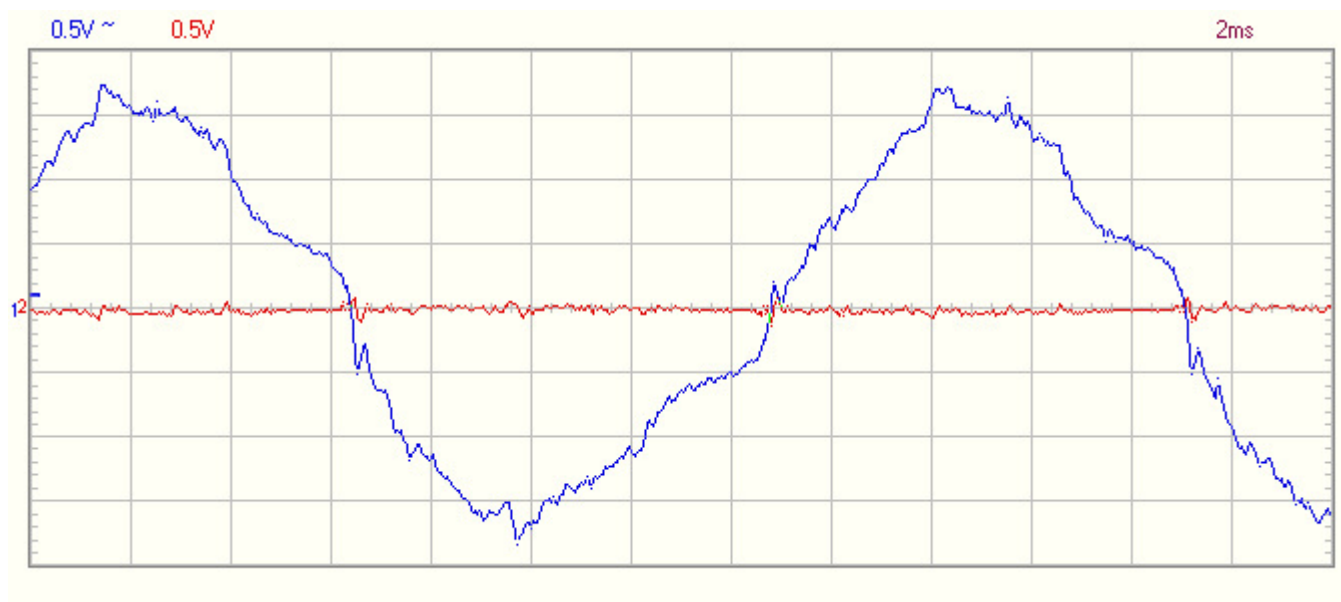
This proves that the new testing protocol I am using is capable of showing recurring harmonic waveform distortions when present from a source of dirty power. Once again, here is the same waveform with the dimmer switch turned back off:

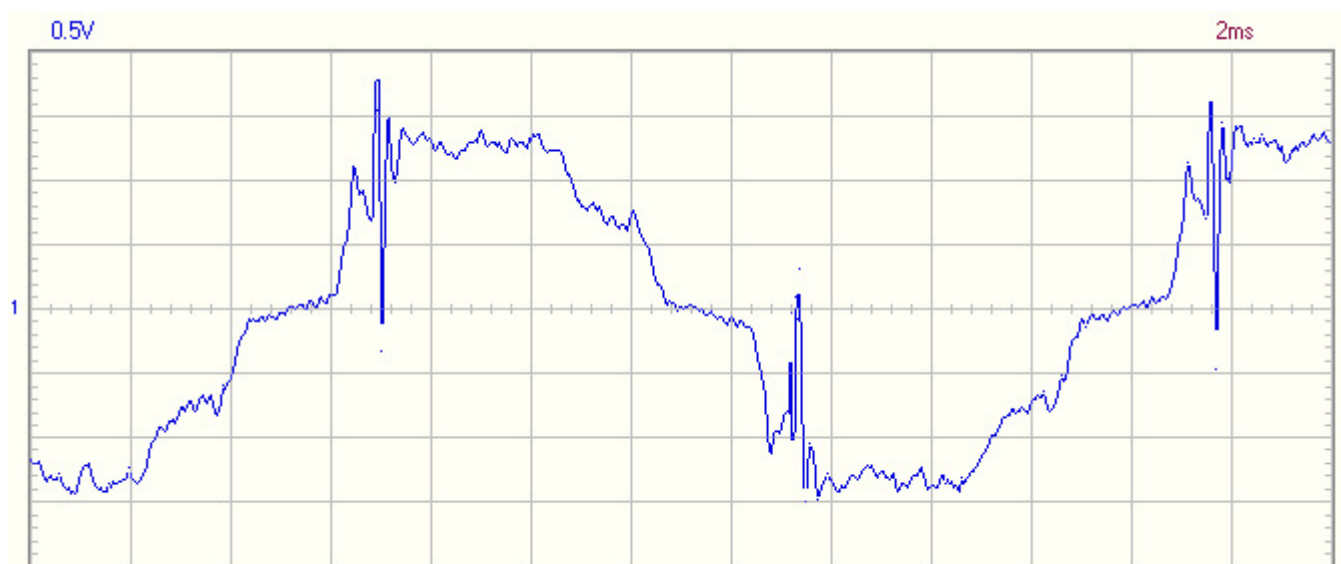
To once again demonstrate that the new protocol does demonstrate voltage harmonics when present, the following tracing shows the same circuit but this time with a dimmer switch turned on in an adjacent room. Notice the large, short, sharp repeating harmonics just before the height of each peak that measure almost 2 Volts high (almost four vertical squares at half a Volt per square).

I had seen these harmonics before in this house in the previous study and they are also present on the waveform tracings using the new protocol. They disappear when the dimmer switch is turned off, and are therefore not from the GE smart meter.

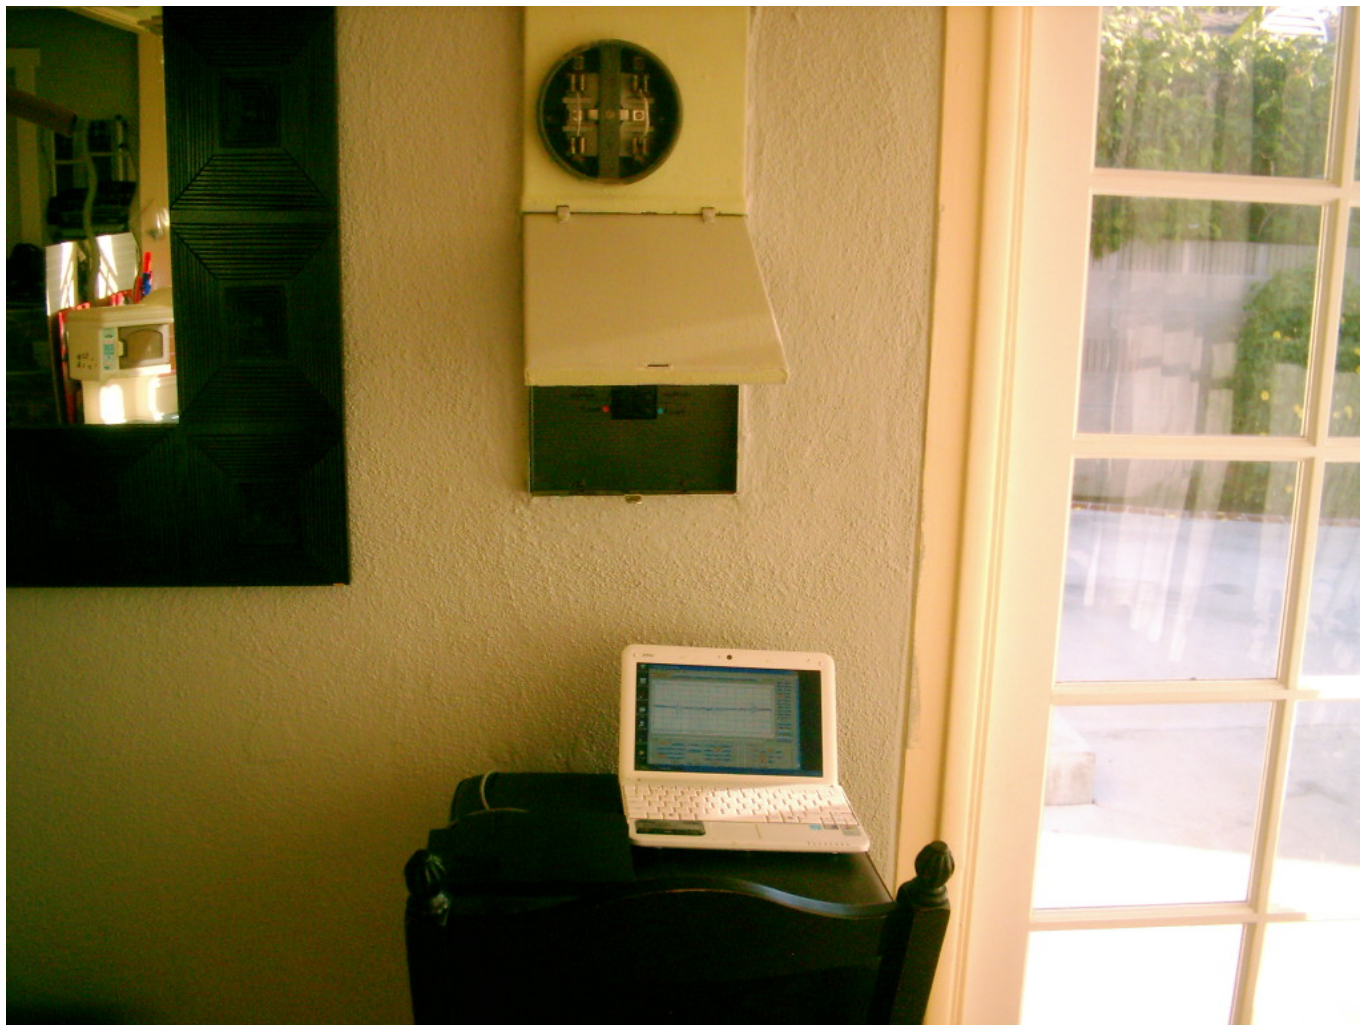
Here is the set-up showing the oscilloscope on the left and the laptop on the right, plugged into an outlet beneath the panel. That outlet was powered by the only circuit breaker switched on and nothing else was plugged into the only other outlet on that circuit:

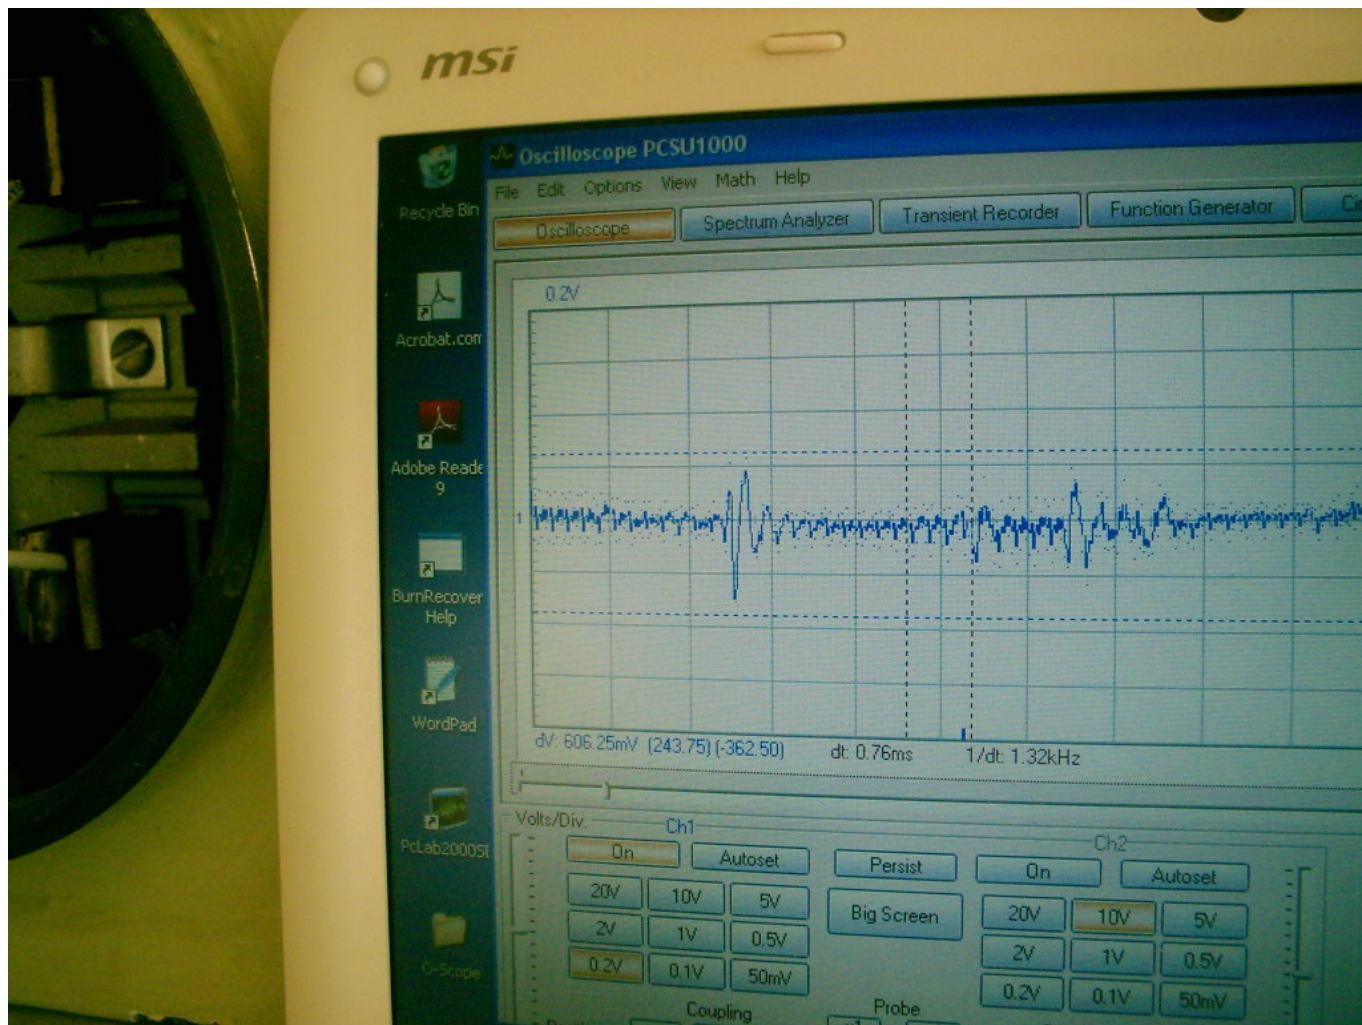
Here is the oscilloscope held next to the empty meter base, showing the presence of the voltage harmonics even with the smart meter removed:

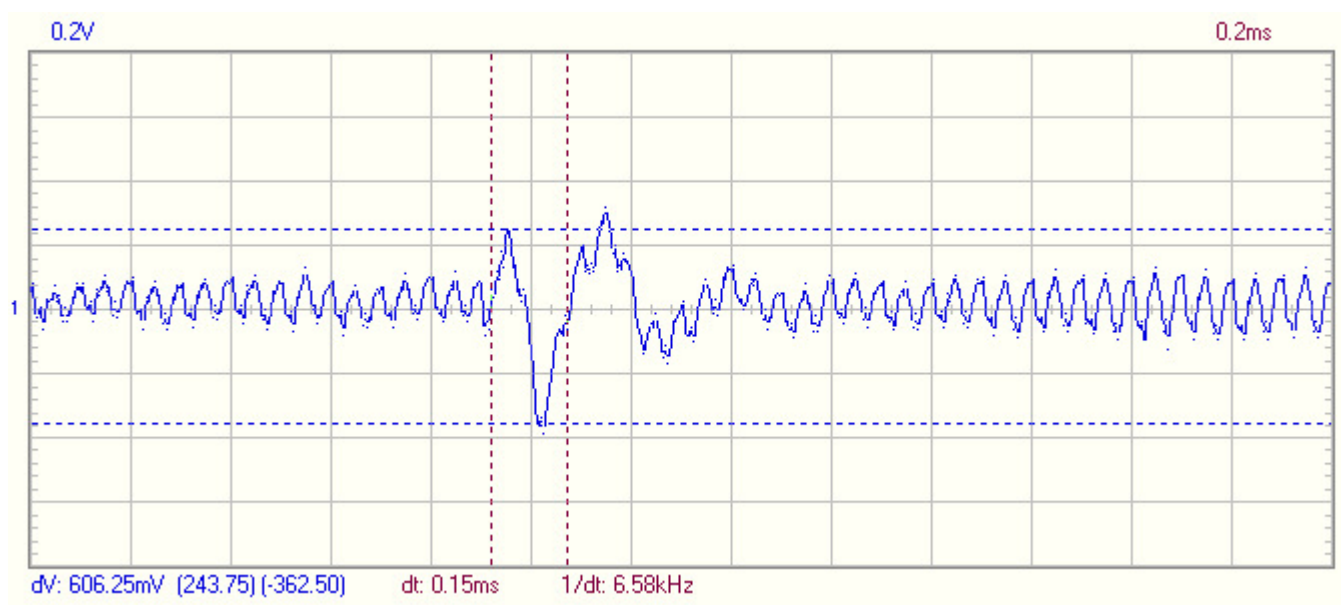
The following is the waveform tracing seen in the photo, at 0.2 milliSeconds per division. The voltage size is 0.6 Volts:

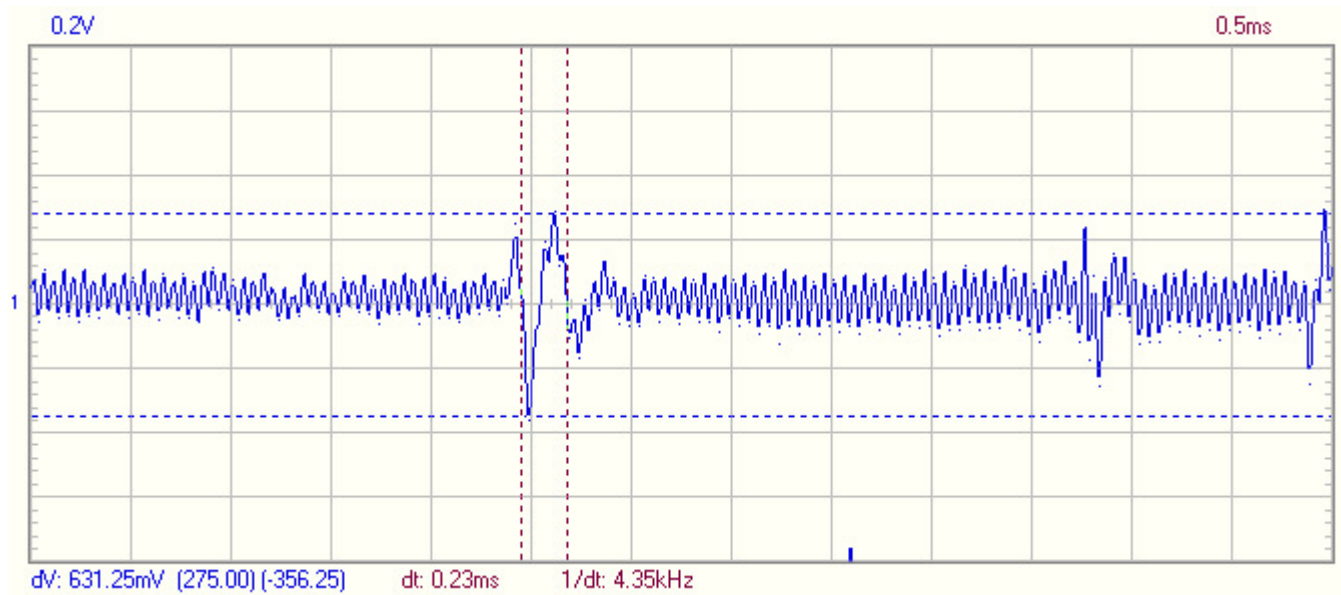
The following is the same waveform tracing at 0.5 milliSeconds per division, again with the smart meter out:

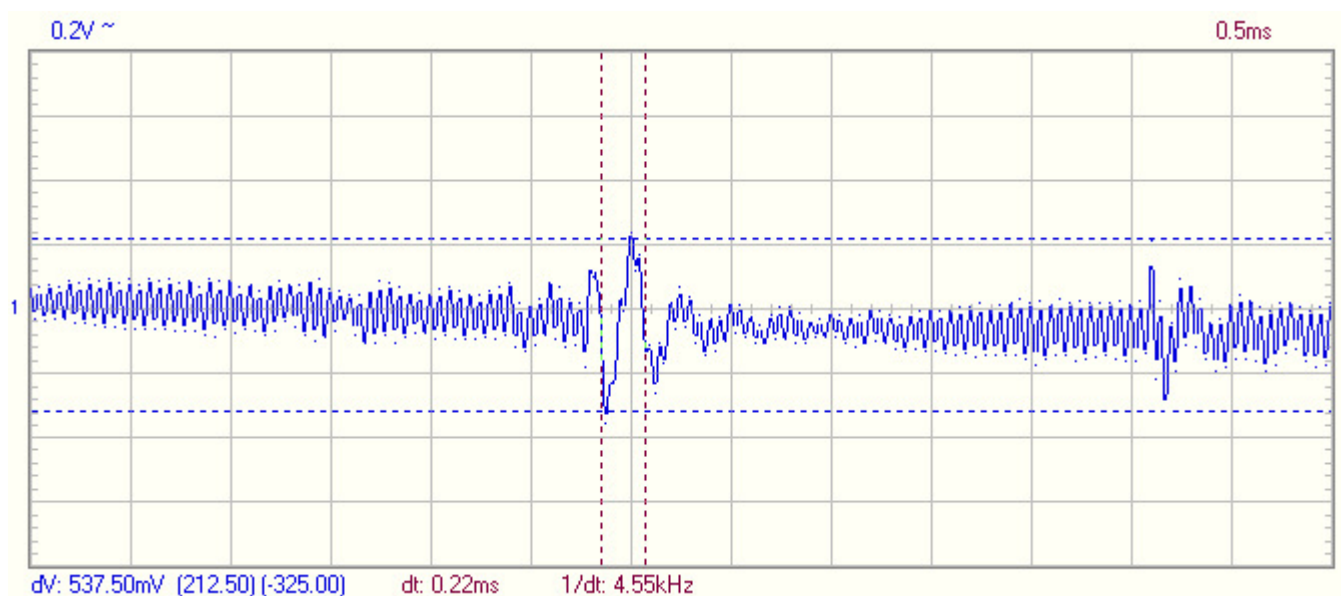
Compare that to the waveform tracing at 0.5 milliSeconds per division *before* the smart meter was removed, at a time when we thought the voltage harmonics were coming directly from this Itron smart meter. Notice that the waveform and voltage spike above are virtually identical to when the smart meter is removed, shown below:

This proves that the same voltage harmonics were still present on the power company's incoming electricity with the smart meter removed, indicating the harmonics were from some source of dirty power in a neighbor's home and not from the Itron smart meter in the home I was measuring.

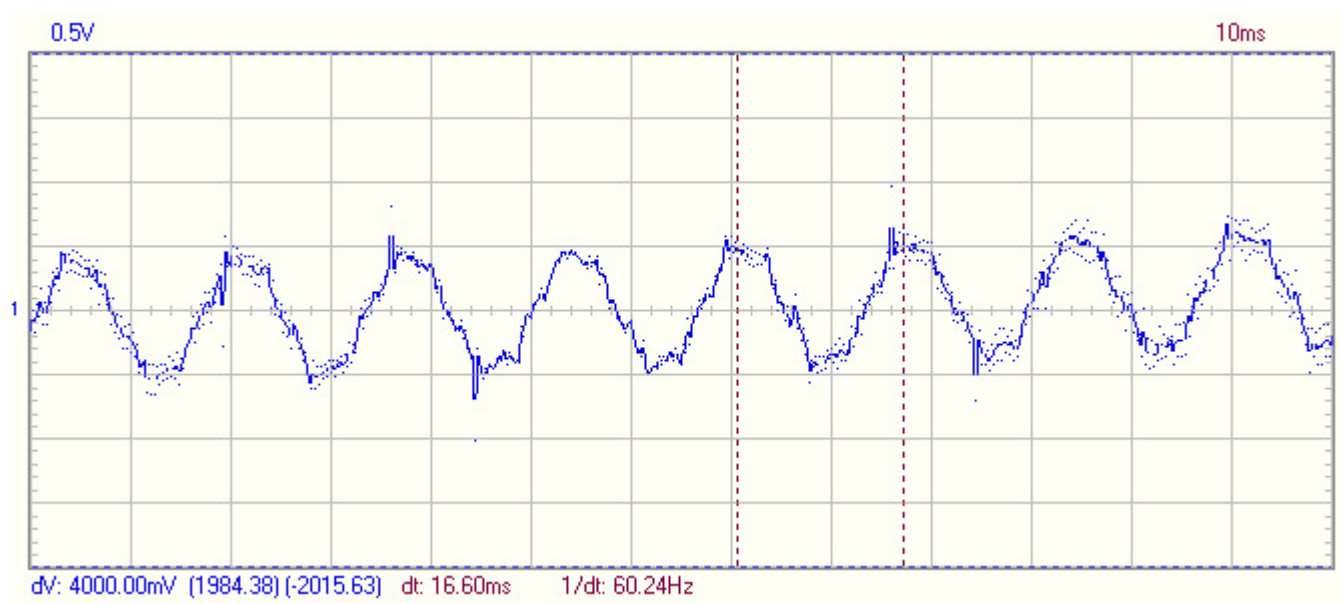
I also measured the presence of the voltage harmonics on the 60 Hz sine wave while standing outside on a step ladder halfway between the house and the transformer on a utility pole. I used a telescopic antenna attached directly to the oscilloscope input and held within one inch of the insulated phase conductors of the utility service drop. Since the Stetzer attenuator was not in place and we were measuring frequencies through the air with an antenna, the tracing shows the characteristic 60 Hz sine waveform. Notice a spike on virtually every positive and negative peak:

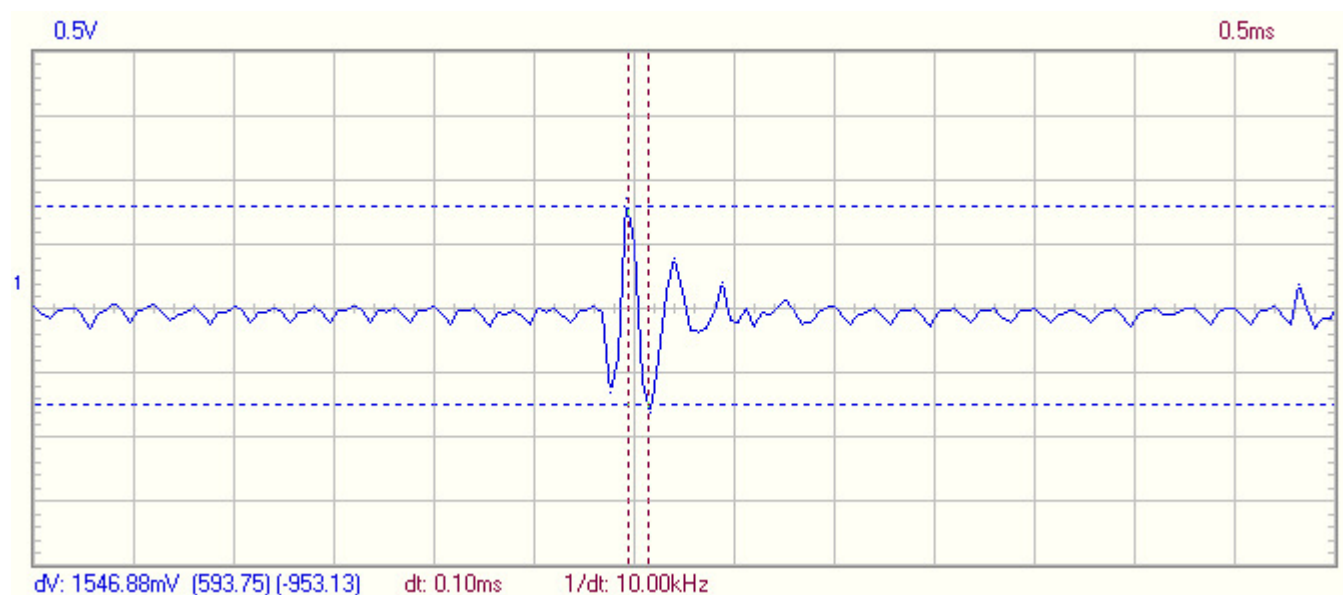
One image below shows these voltage harmonics to have a fundamental frequency of 5kHz. There is a transient of 1.5 Volts in 100 microseconds, for a slew of 15,000 Volts/second:
