# **Study to Determine the Presence of Dirty Electricity from Smart Electric Meters in Southern California**

written by Oram Miller | 3 June 2015

Reports exist of dirty electricity from switched mode power supplies in smart electric meters in the Pacific Gas & Electric (PG&E) service area of Northern and Central California (see below). In an effort to try to document the existence of dirty electricity from the brands of smart meters used by electric utilities in Southern California, I conducted a study of over 20 homes in May and June of 2012. The results of that study, along with oscilloscope tracings, are presented below.

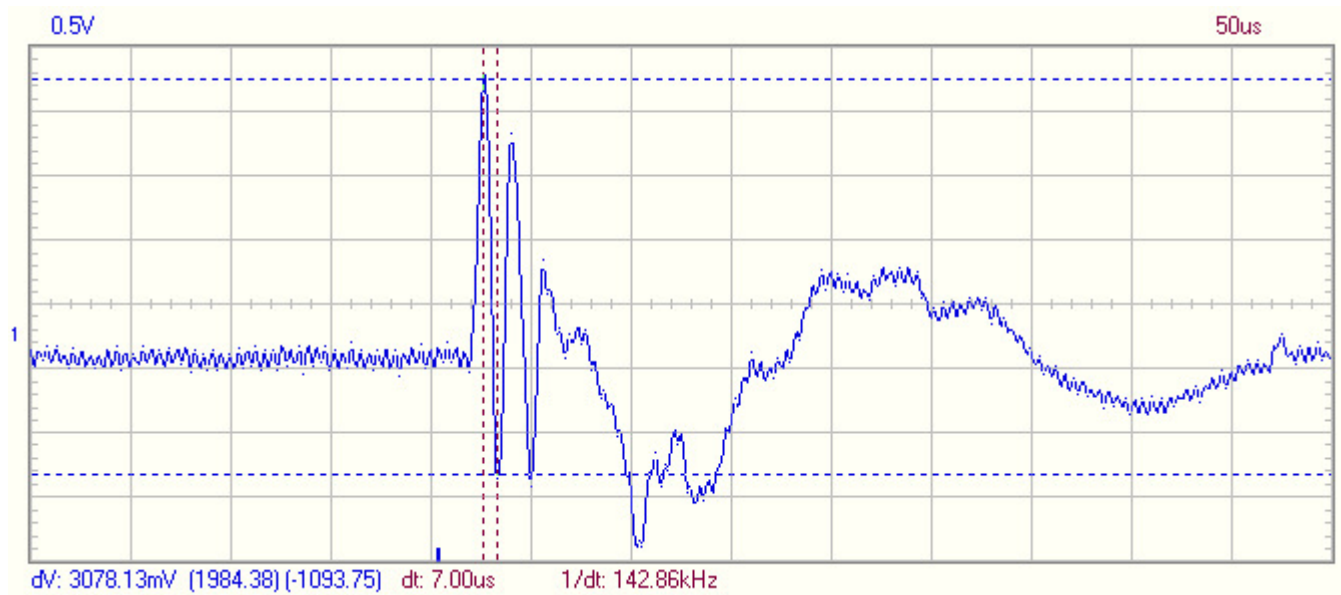
A second tracing shows voltage transients of 3.1 Volts in 7 microseconds, for a very high slew of 439,700 Volts/second. These waveforms showed the harmonics to have a fundamental frequency of 71kHz:

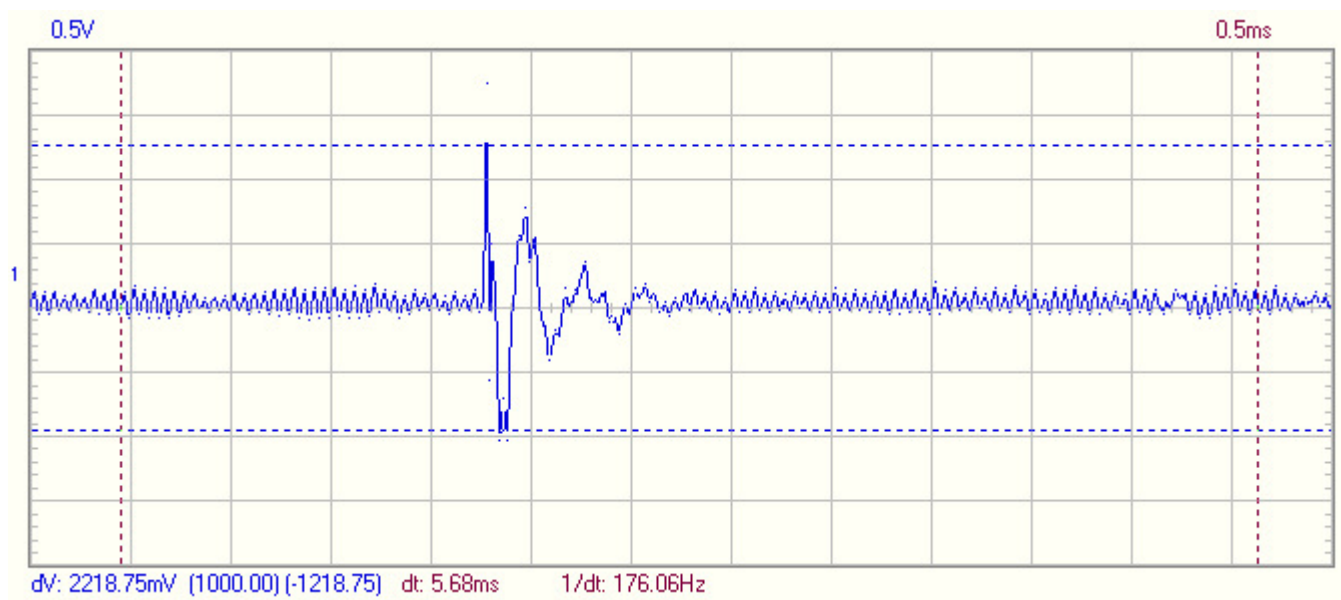
These voltage harmonics are attenuated by the insertion of a single Greenwave filter into the same outlet the Stetzer attenuator and probe were plugged into. Here is the tracing before insertion of the filter:

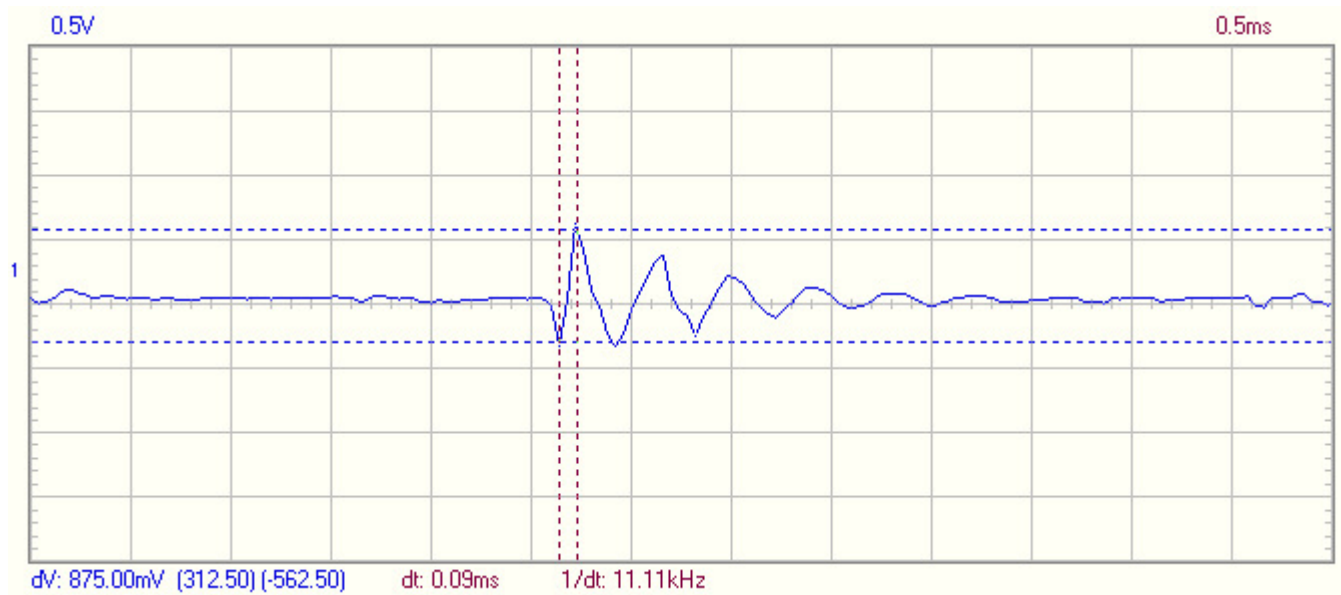
Here is the waveform after insertion of a single Greenwave filter, showing the attenuation, or lessening of the height of voltage harmonics from 2.2 down to 0.87 Volts, as well as a clearing of the low-level, background noise on the line:

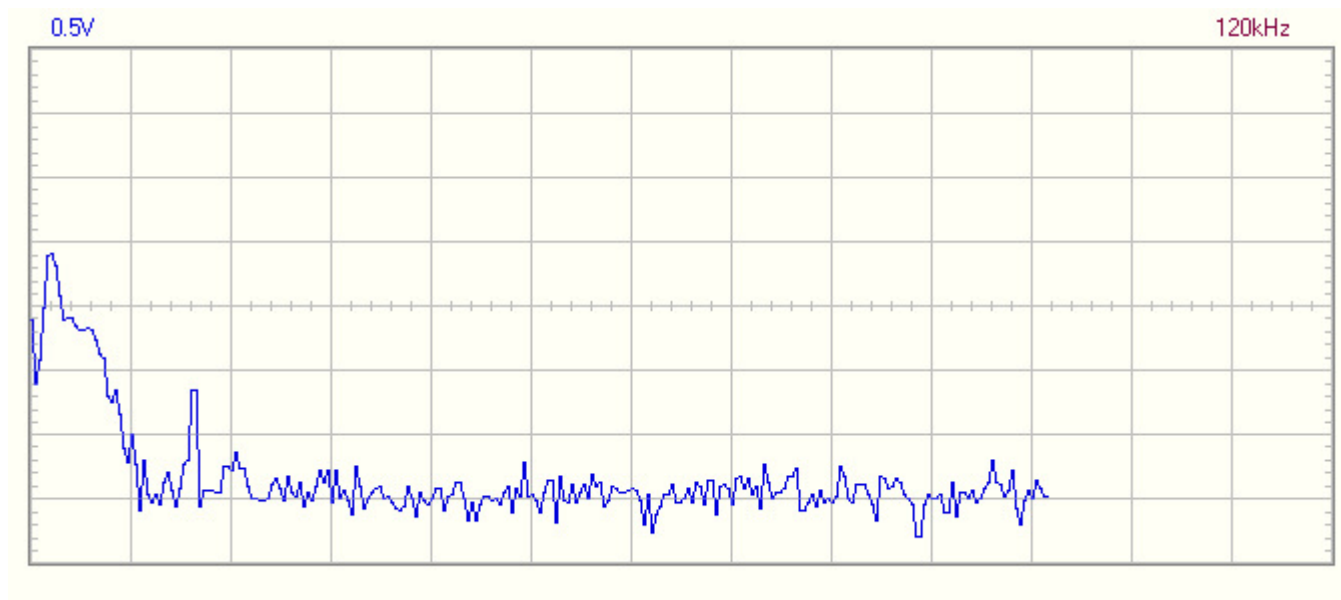
Here is the same analysis with a single Greenwave filter inserted, showing a clearing of the noise at many frequencies:

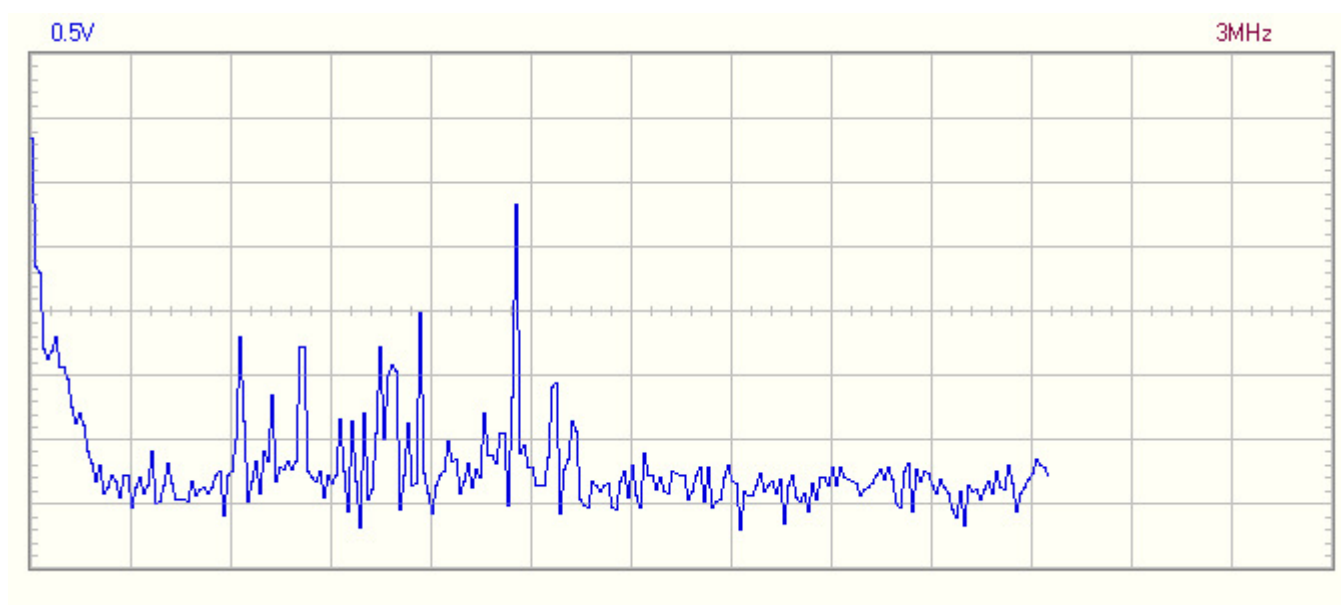
Here is the waveform from 0 to 3MHz without a Greenwave filter (each division is 300kHz wide):

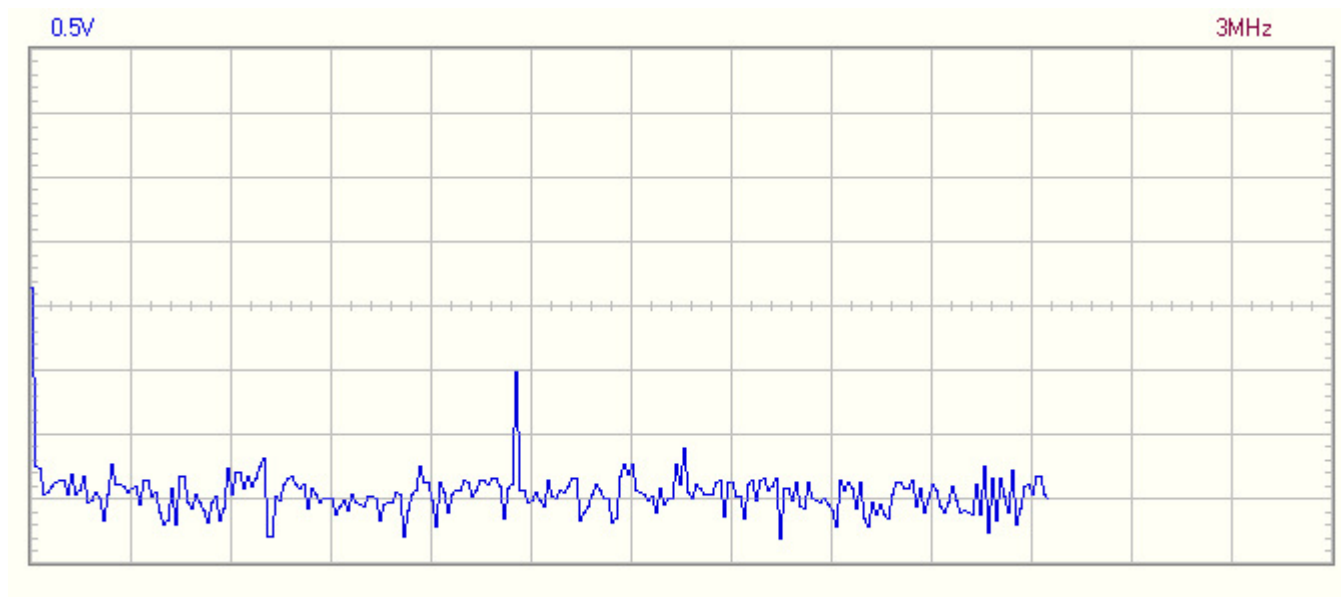
Here is the same analysis with a single Greenwave filter inserted, again showing significant clearing of most noise except for one spike at approximately 1.4MHz:

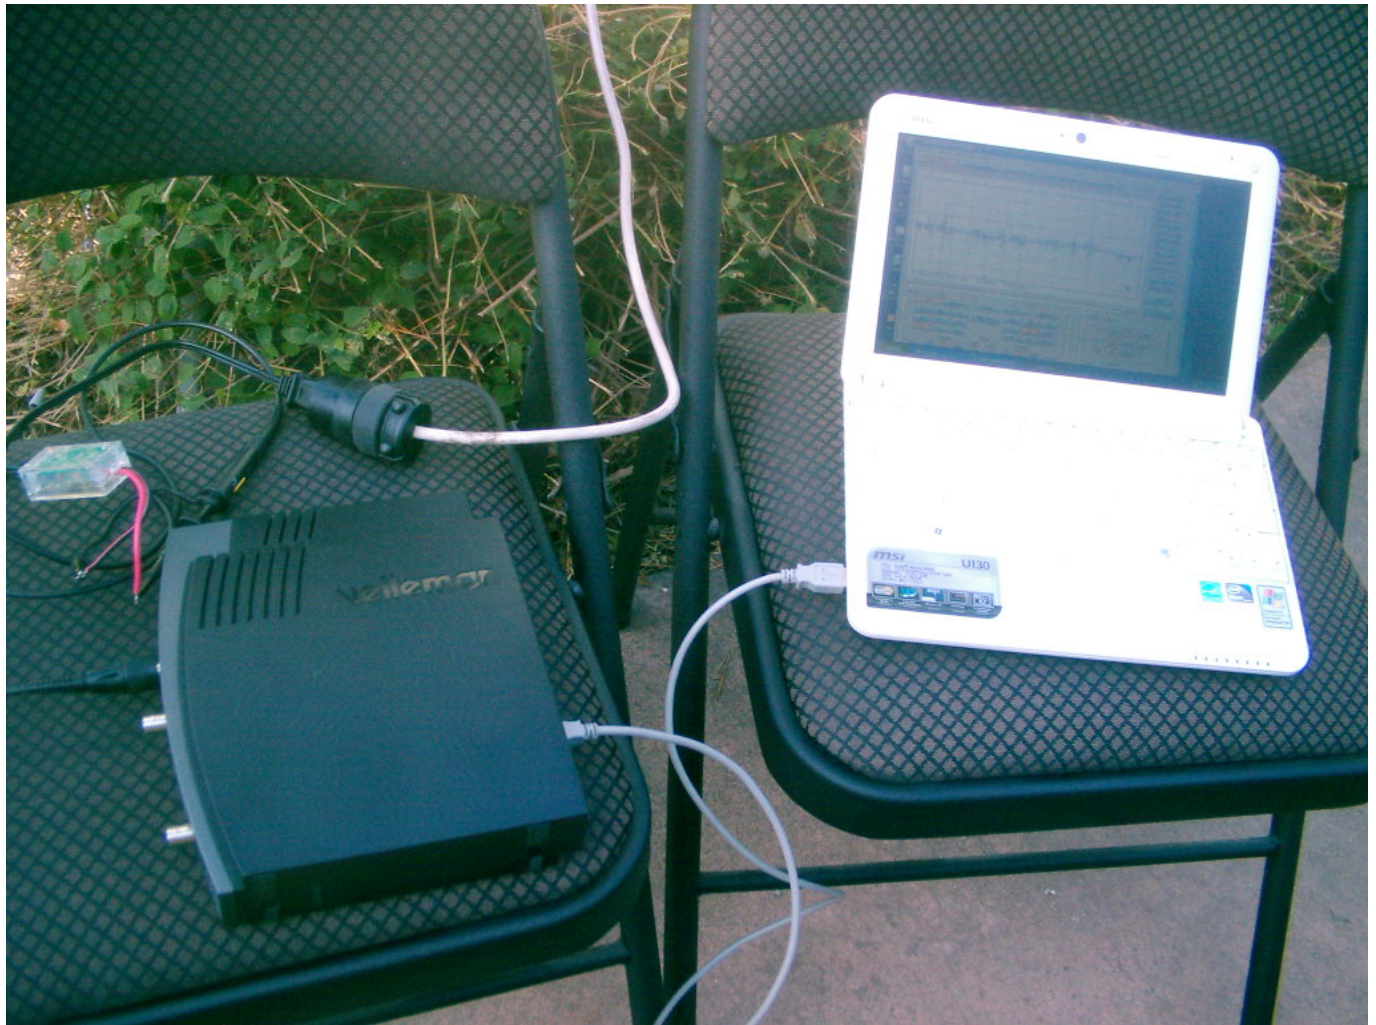
In this last photo, the oscilloscope and Stetzer attenuator are both on the left:

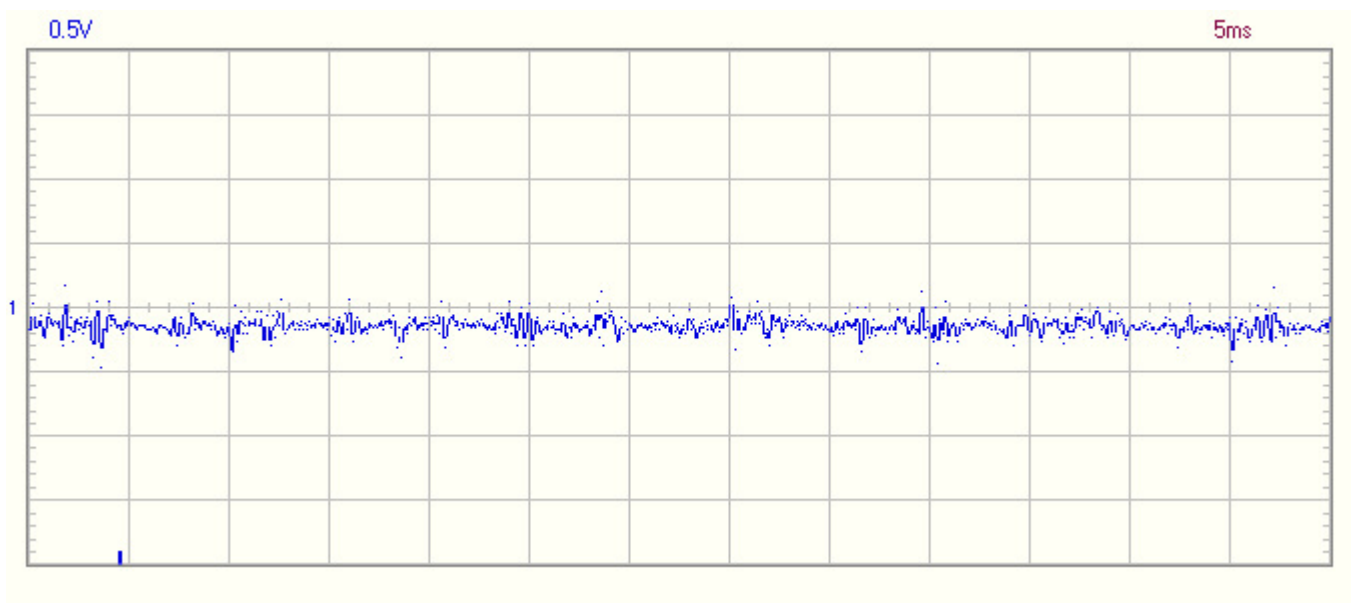
Below are images showing waveform tracings from both phases of the utility service drop measured at the panel. The first is from phase A:

Neither of these tracings shows any significant voltage harmonics in the path of incoming electric power right after the Itron smart meter.

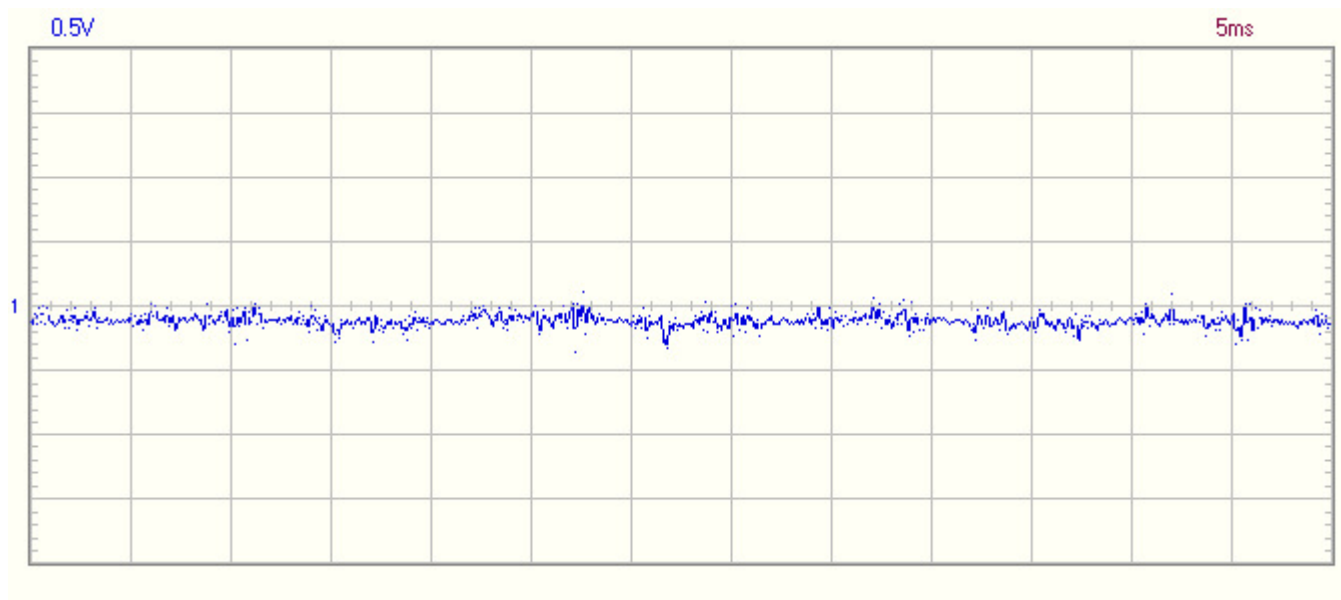
This next tracing is from phase B:

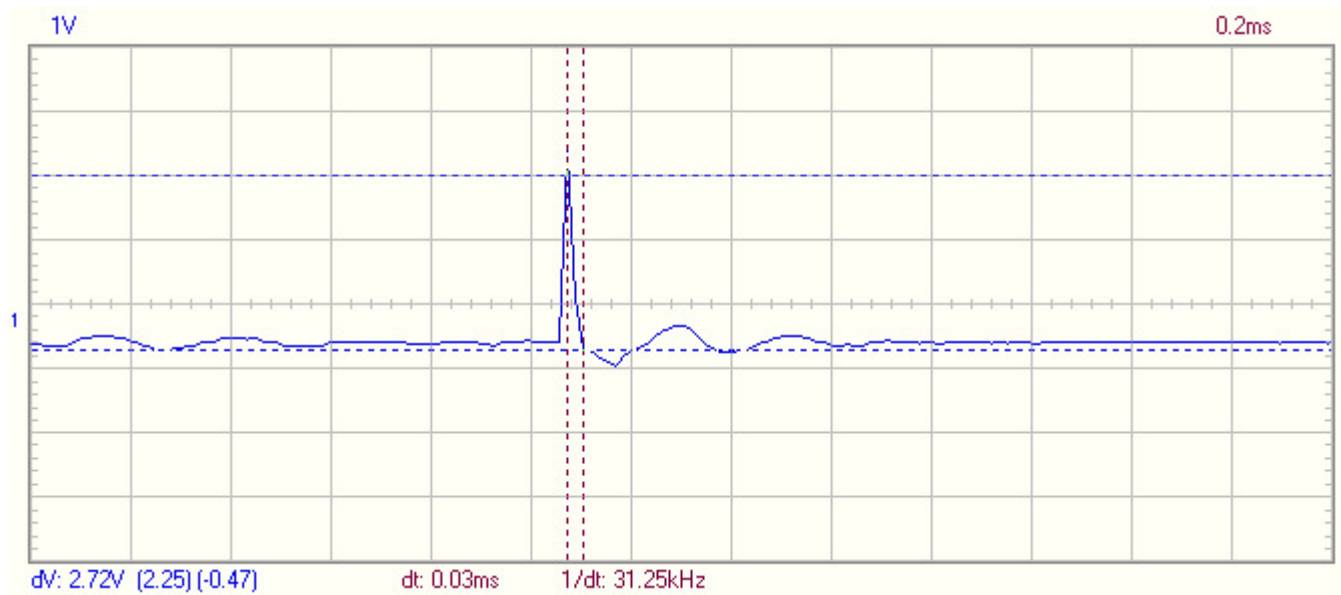
These harmonics had a primary frequency of 15.6kHz. The voltage transient was 2.72 Volts in 30 microseconds for a slew of 90,670 Volts/second. This had the same short duration, sharpness and similar frequency as the harmonics reported with the Landis Gyr meters in Northern California. A sample spike looked as follows:

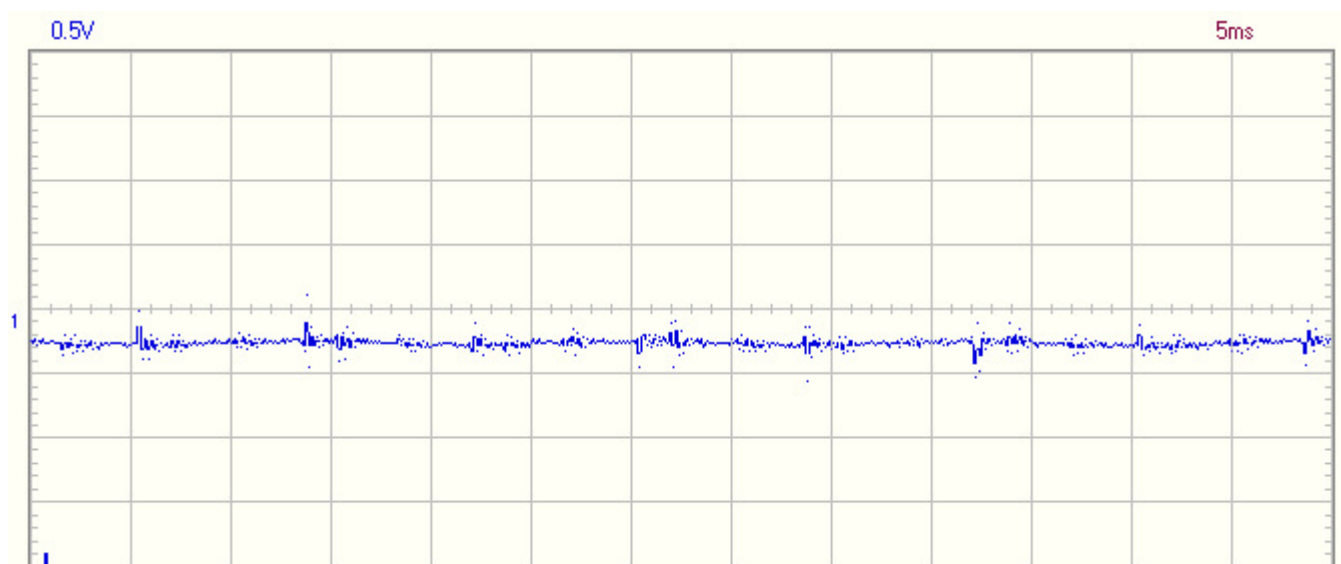
Here is a tracing taken at the same circuit back on May 25th again in the master bedroom, this time with the touch lamp turned off. Compare this to the tracing before the last one, where each division is 5 milliseconds wide and each division is 0.5 Volts high. The large harmonics have disappeared and are therefore not from the Itron smart meter:

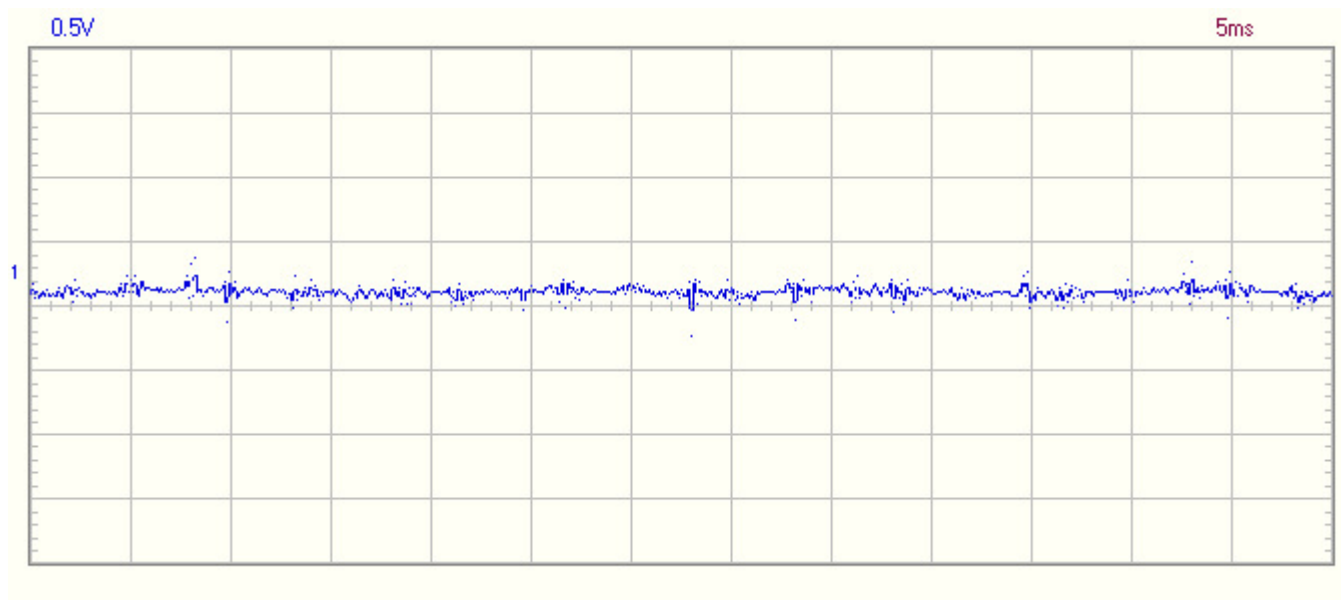
Here is a tracing taken at the same location with the touch lamp turned off but otherwise normal loads on in the house, again showing no harmonics of significance (each division is 5 milliseconds wide):

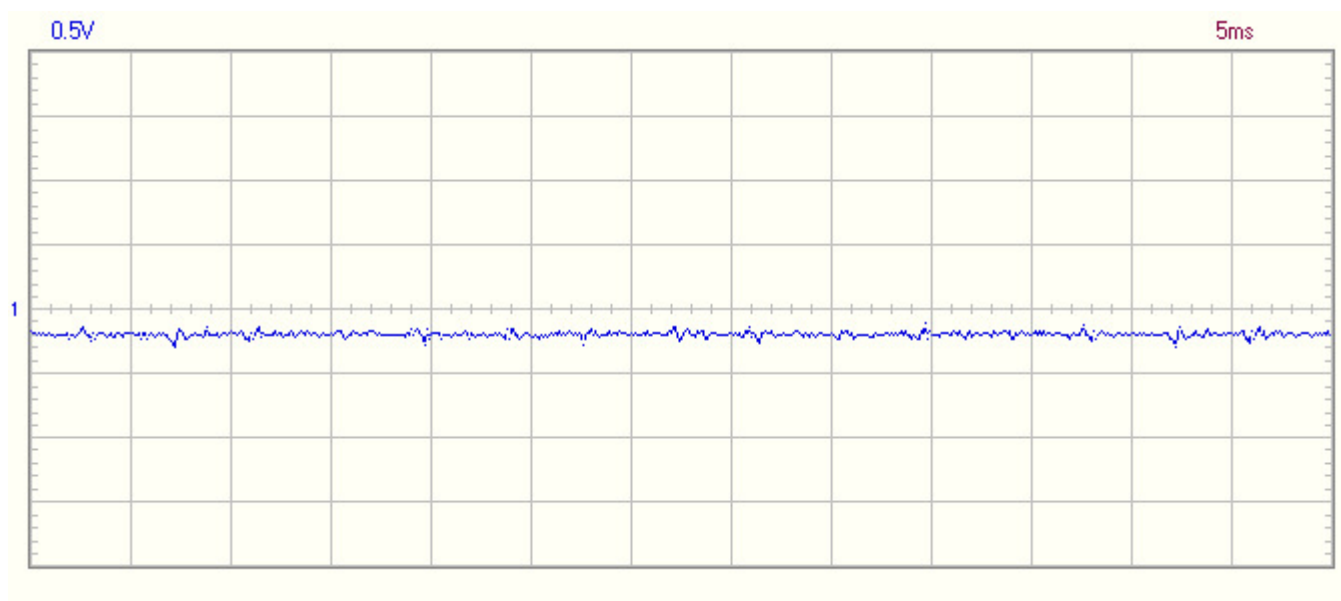
The next tracing was taken on May 29, 2012 at a home in Glendale in the Glendale Water and Power service area with an Itron Openway smart meter. All other circuits were left on. The homeowner is not symptomatic from EMF sources. There are no apparent voltage harmonics similar to those noted in Northern California (each division is 5 milliseconds wide):

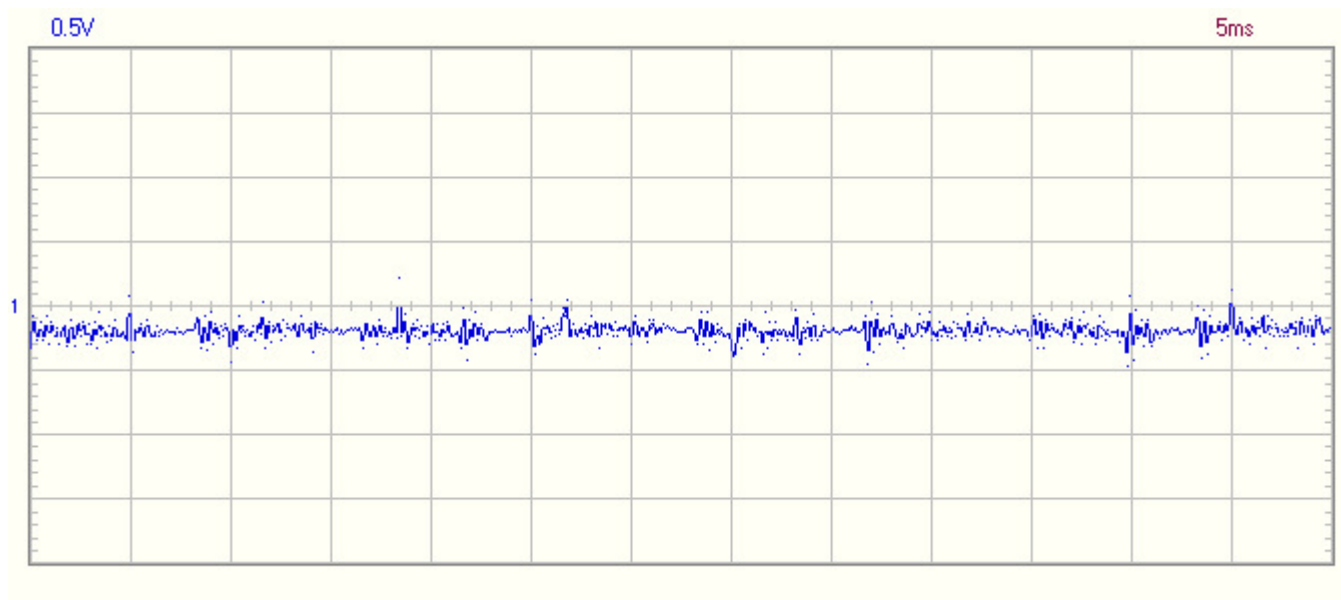
The next tracing was taken on May 22, 2012 at another home in Glendale in the Glendale Water and Power service area with an Itron Openway smart meter. All other circuits were left on. The homeowner is not symptomatic from EMF sources. Again, there are no apparent voltage harmonics similar to those noted in Northern California (each division is 5 milliseconds wide):

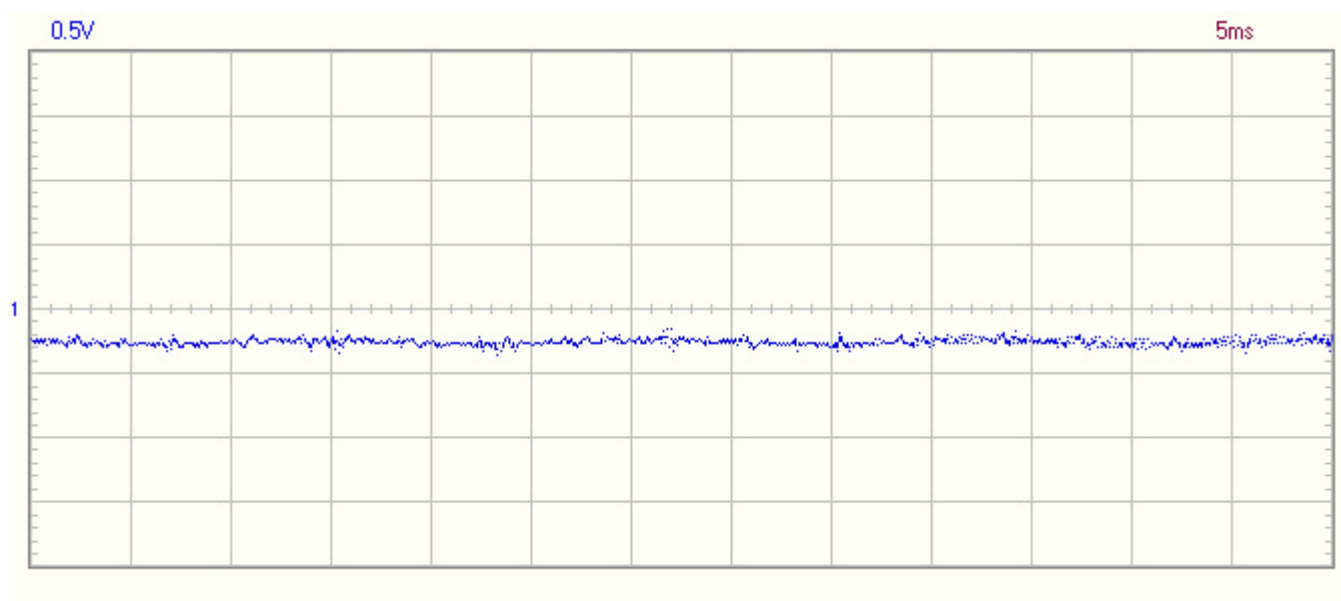
The next tracing was taken on May 29, 2012 at a third home in Glendale in the Glendale Water and Power service area with an Itron Openway smart meter. All other circuits were left on. The homeowner is not symptomatic from EMF sources. Again, there are no apparent voltage harmonics similar to those noted in Northern California (each division is 5 milliseconds wide):

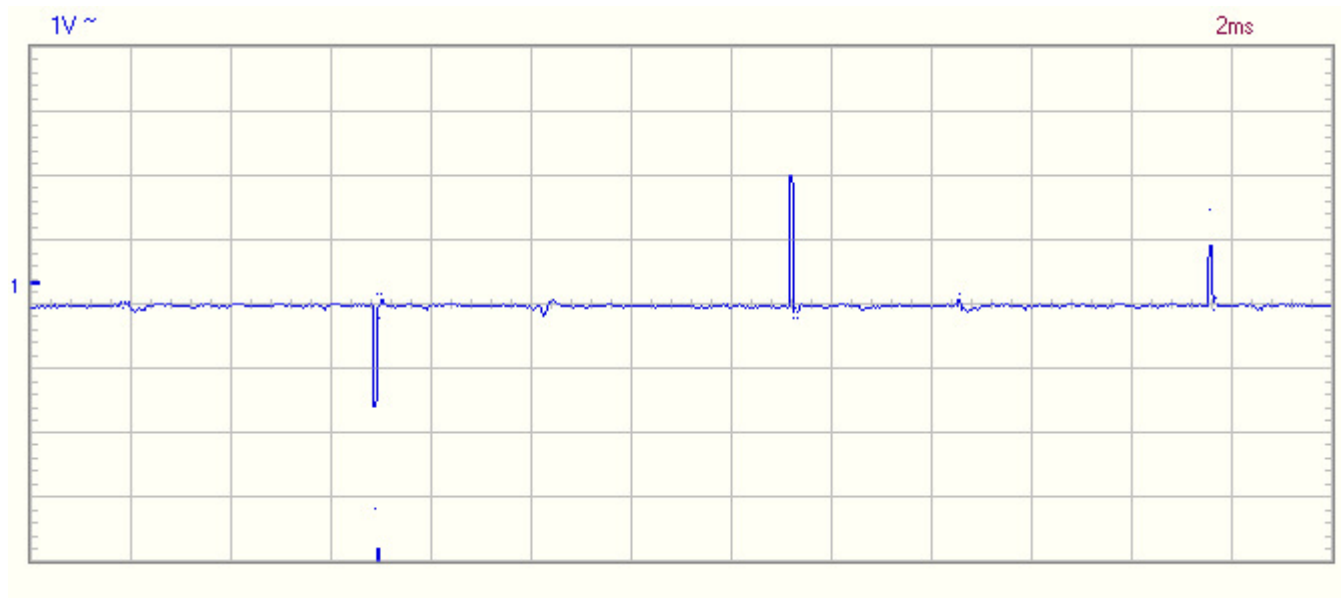
The next tracing was taken on May 17, 2012 at a home in Burbank in the Burbank Water and Power service area with a GE / Trilliant smart meter. All other circuits were left on. The homeowner is not symptomatic from EMF sources. Notice the voltage harmonics, as high as roughly 2 Volts, that I first thought were possibly produced by the Trillaint smart meter. What I did not know until the following week was that a dimmer switch was on in an adjacent room (each division is 2 milliseconds wide):

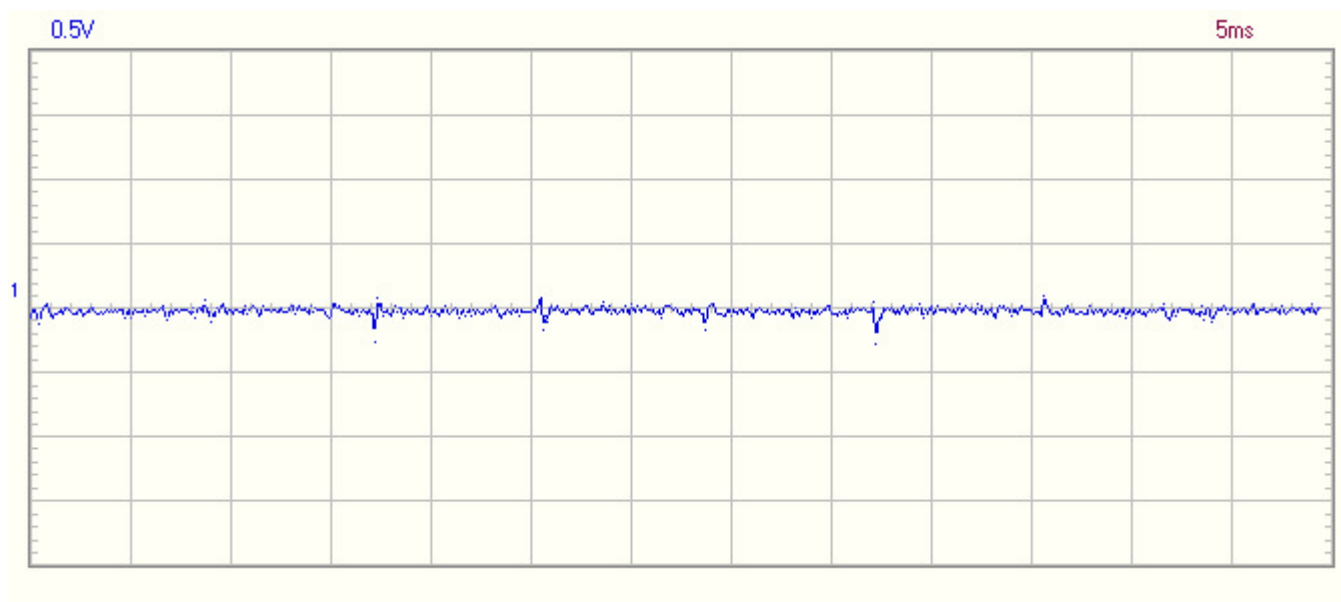
The next tracing was taken the following week at the same home in Burbank when I returned and discovered the dimmer switch. This tracing shows the disappearance of the voltage harmonics with the dimmer switch turned off (each division is 5 milliseconds wide):

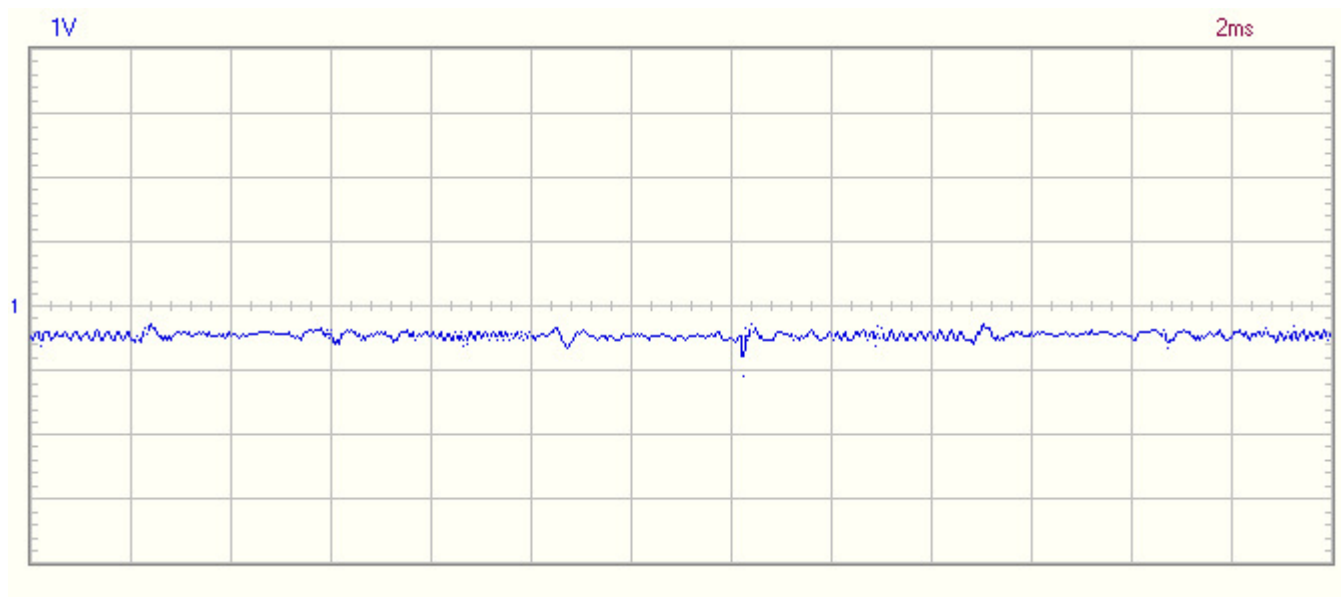
The next tracing was taken on May 17, 2012 at a second home in Burbank in the Burbank Water and Power service area with a Trilliant smart meter. All other circuits were left on. The homeowner is not symptomatic from EMF sources (each division is 2 milliseconds wide):

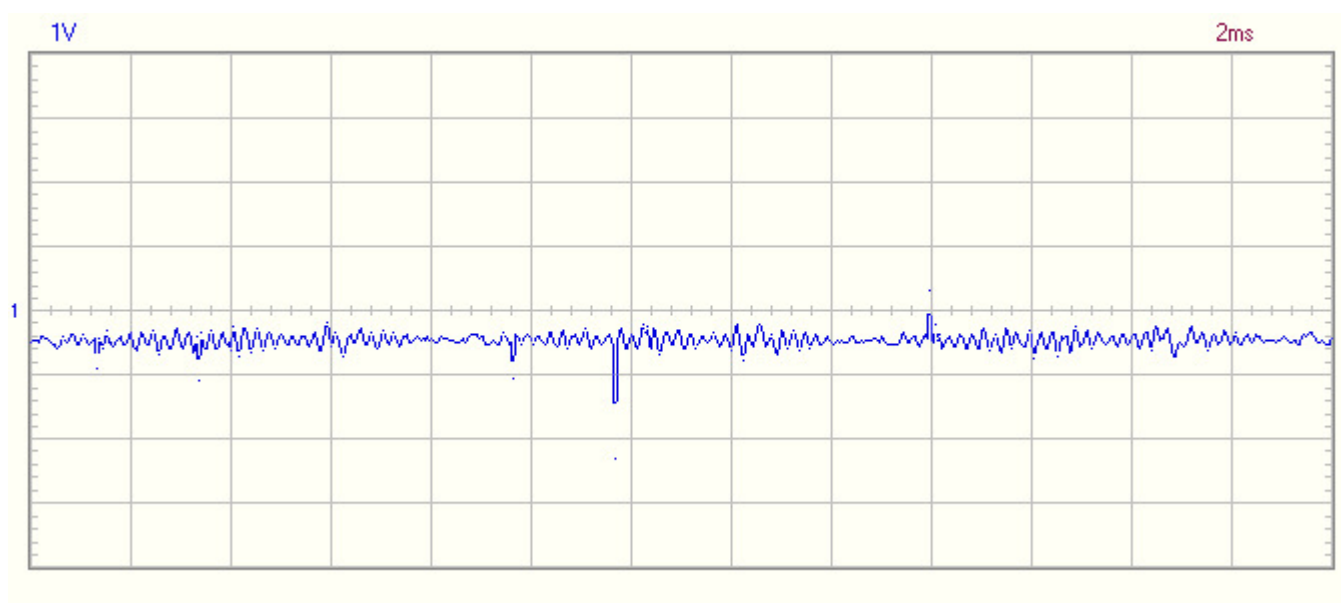
The second tracing was taken on May 17, 2012 at the same home in Burbank, however on a different circuit than the first one shown above. All other circuits were left on. You will notice the presence of one spike of roughly 1.6 Volts in height, however, it does not appear at the regular periodicity (once every 120 Hz) you would expect from a switched mode power supply. Also, at this house, I did not have the time to shut off circuits or fluorescent lights, or unplug appliances to try to isolate this effect:
