# [Study to Determine the Presence of Dirty Electricity from Smart Electric Meters in Southern California](#)

written by Oram Miller | 3 June 2015

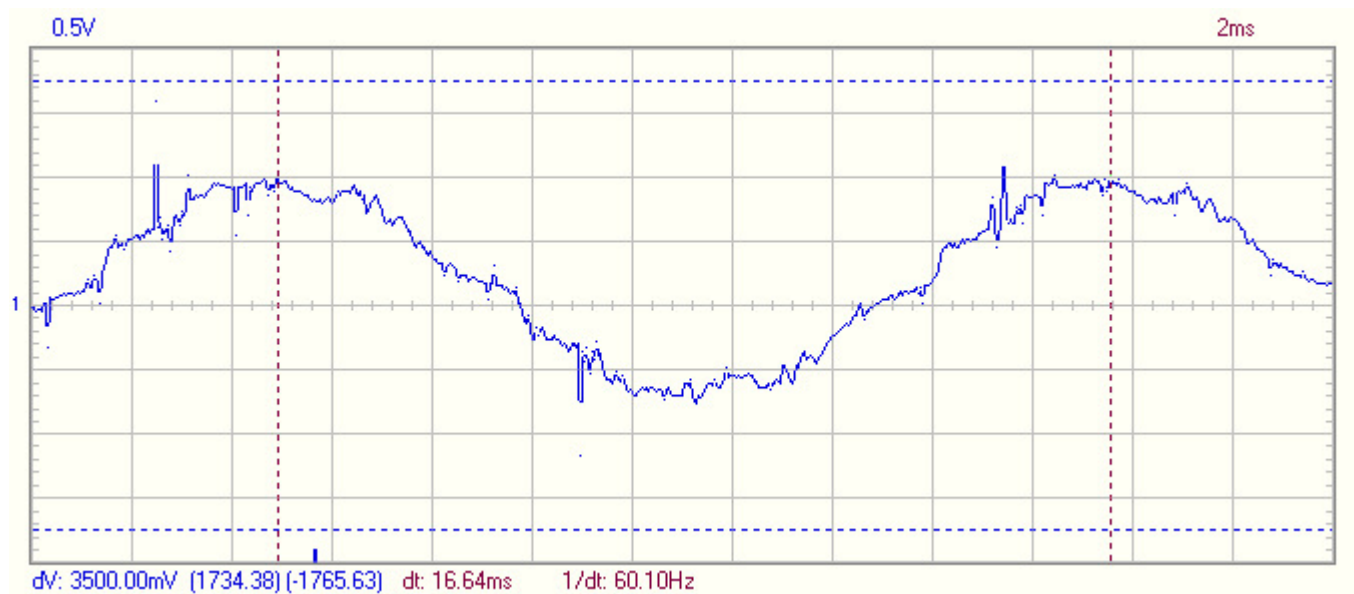
The first tracing shows the oscilloscope tracing at a home with a Landys+Gyr smart meter in Moro Bay taken on July 29th. Dimmer switches, which are a source themselves of dirty electricity, were turned off. Notice the voltage transient on the portion of the sine wave preceding each peak, which may, indeed, be due to the Landys+Gyr smart meter (although I was not able to seek out and isolate other possible sources of dirty electricity in the home):

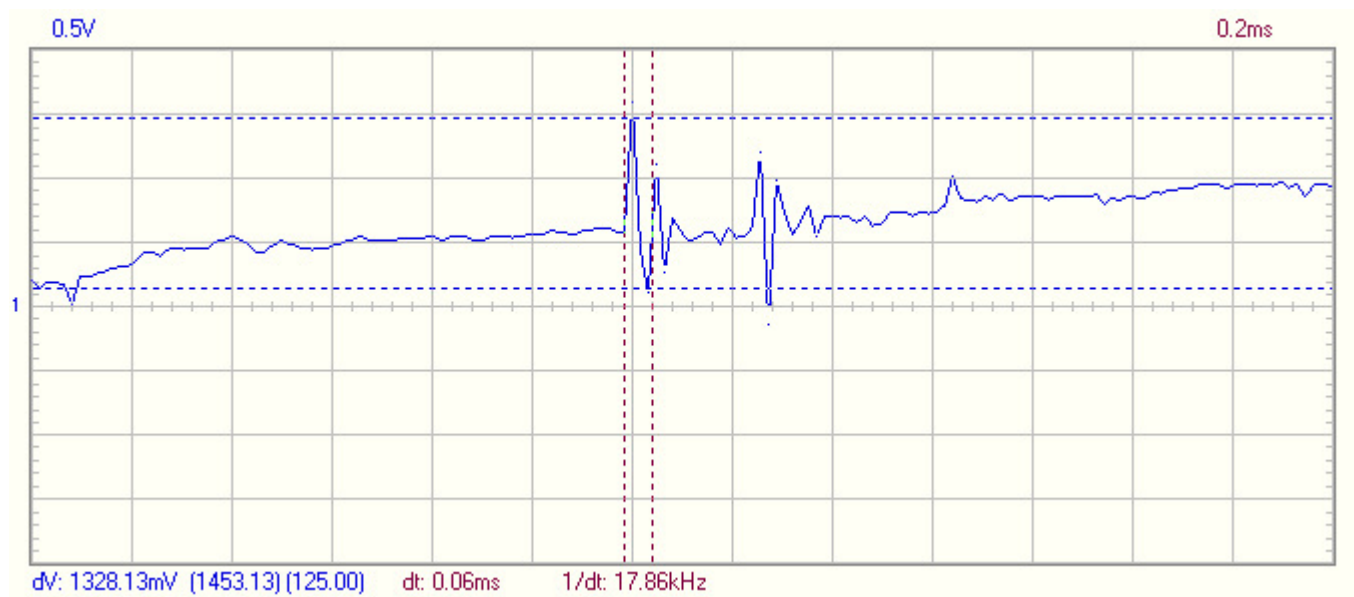
The tracing below is a closeup of the transient, which appears to have a fundamental frequency of 17 kHz and a size of 1.3 Volts in 60 microSeconds, for a slew rate of 21,600 V/Sec:

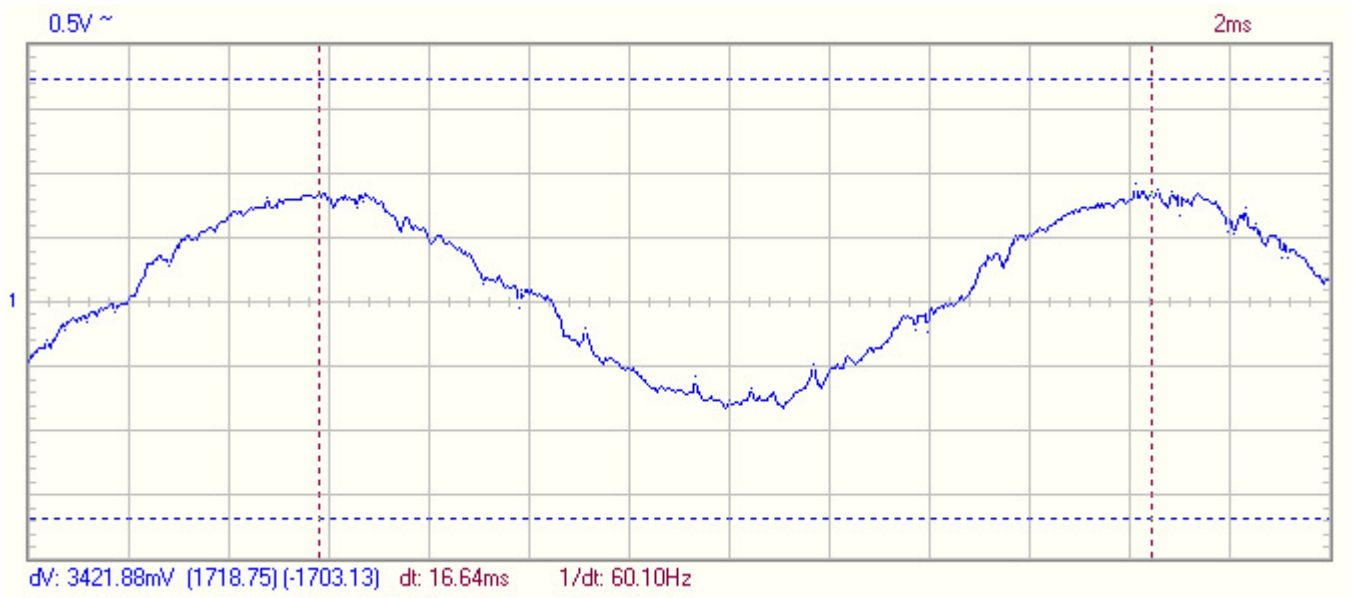
The first tracing was taken at the home of a client who has opted out of the PG&E smart meter program. Her smart meter was replaced with a GE analog electro-mechanical electric meter, which contained no apparent electronic components upon visual inspection. Known sources of dirty electricity within the home, such as dimmer switches and compact fluorescent lamps, were turned off. Notice the lack of any significant voltage transients on the tracing and the relatively clean waveform:

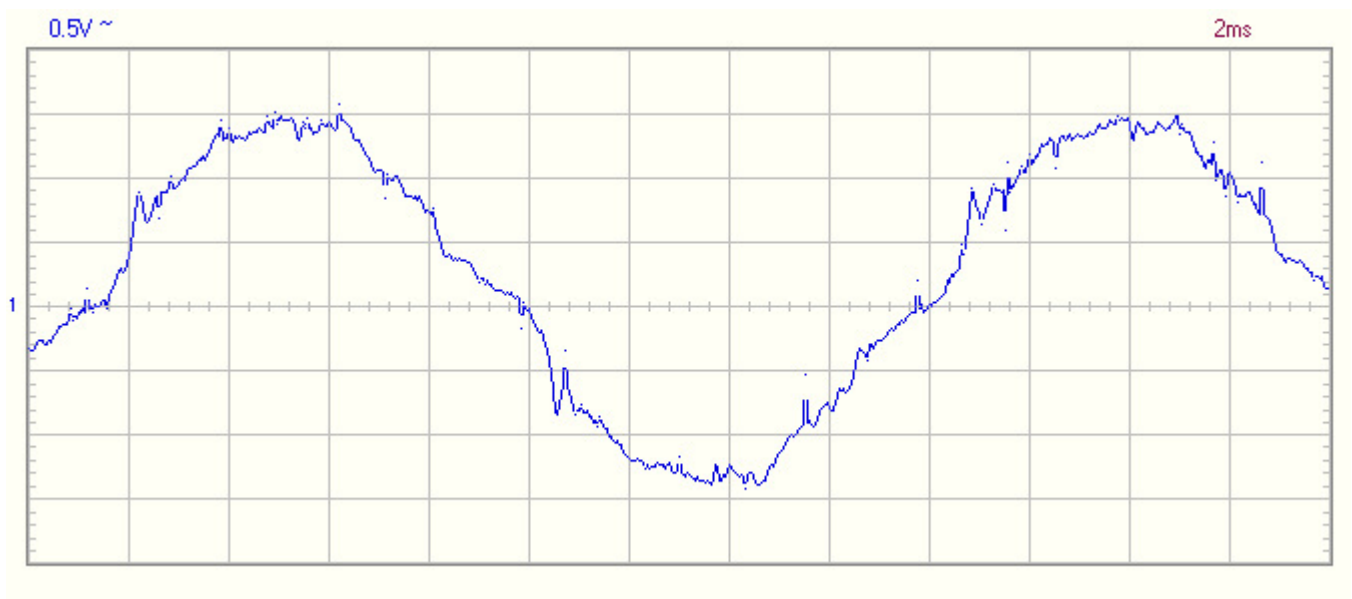
Note that in both cases, there is also a small voltage transient again seen in the accompanying tracing for each house on the portion of the sine wave before each peak:

Here is the neighbor's house to the north:

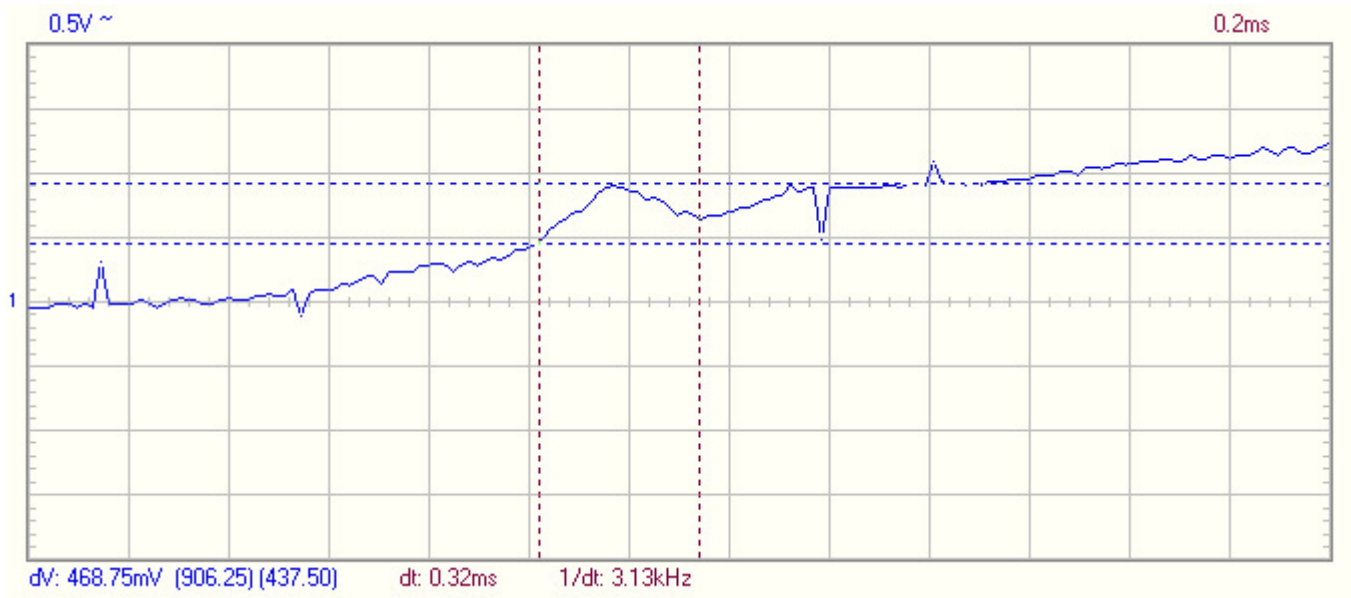
Note below that the fundamental frequency this time is 3 kHz and the height is less than half a Volt (0.47 Volt in 320 microSeconds, for a slew rate of only 1,470 V/sec — see below for the significance of these numbers):

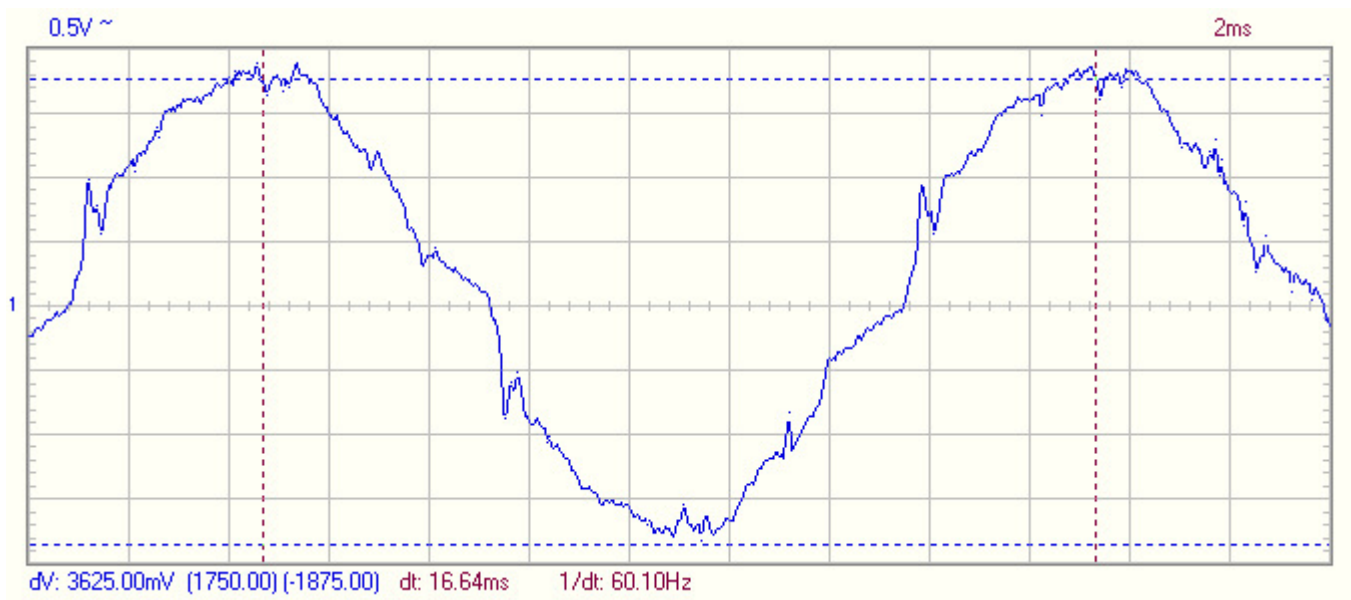
Here is the neighbor's house to the south:

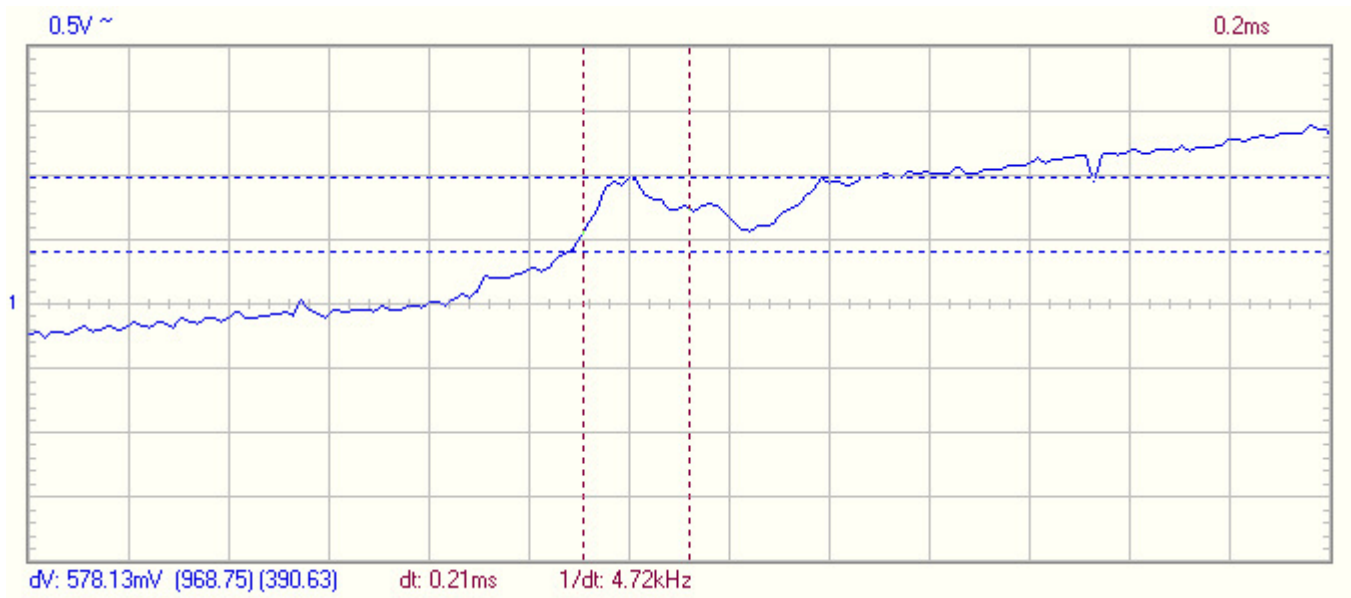
Note below, again, that the fundamental frequency is 4 kHz and the height is just over half a Volt (0.58 Volt in 210 microSeconds, for a slew rate of only 2,760 V/sec):

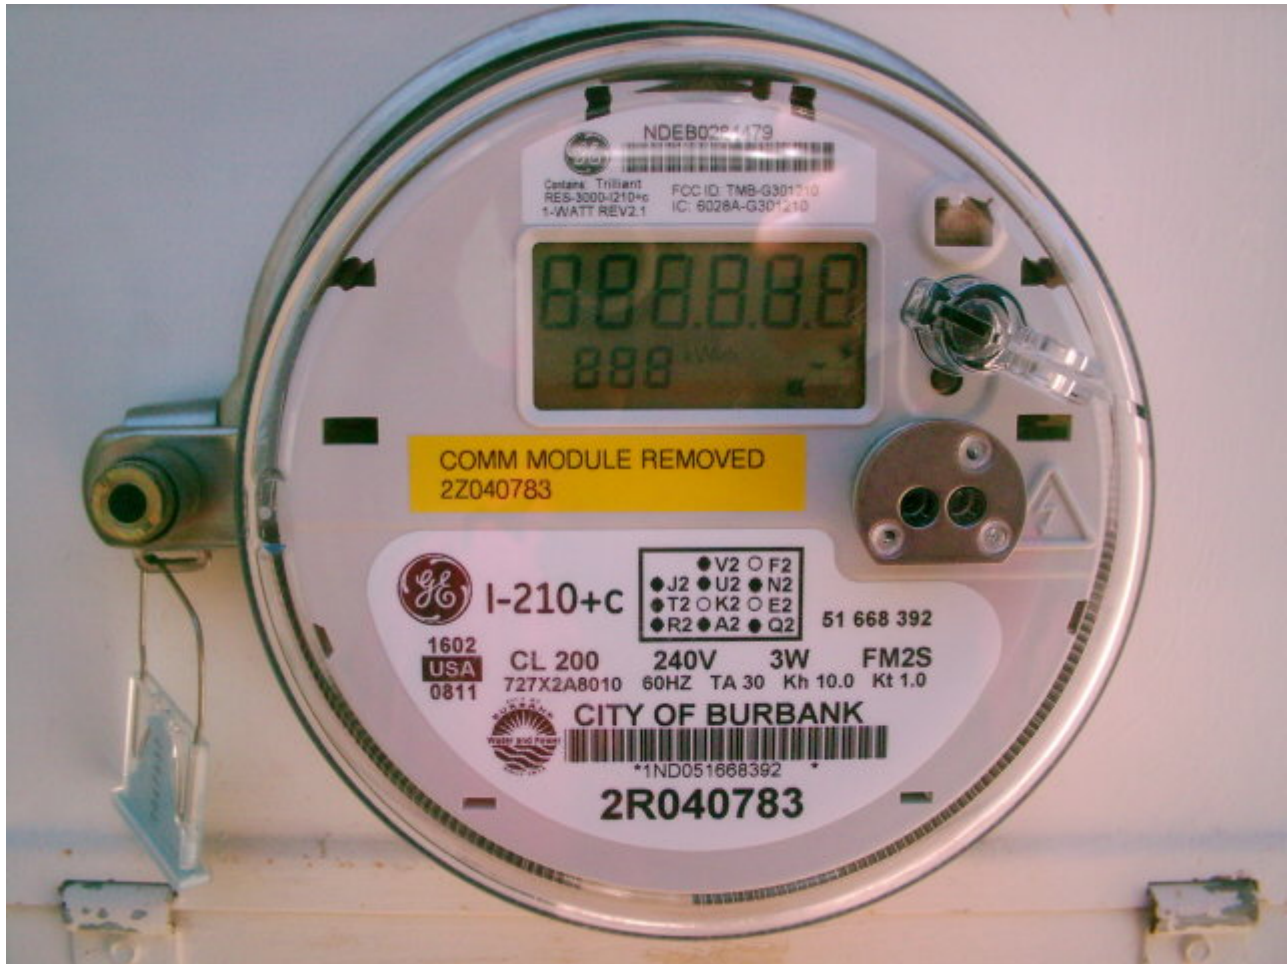
The digital non-RF meter studied on July 17th had been installed the very same day just prior to my arrival. See below:

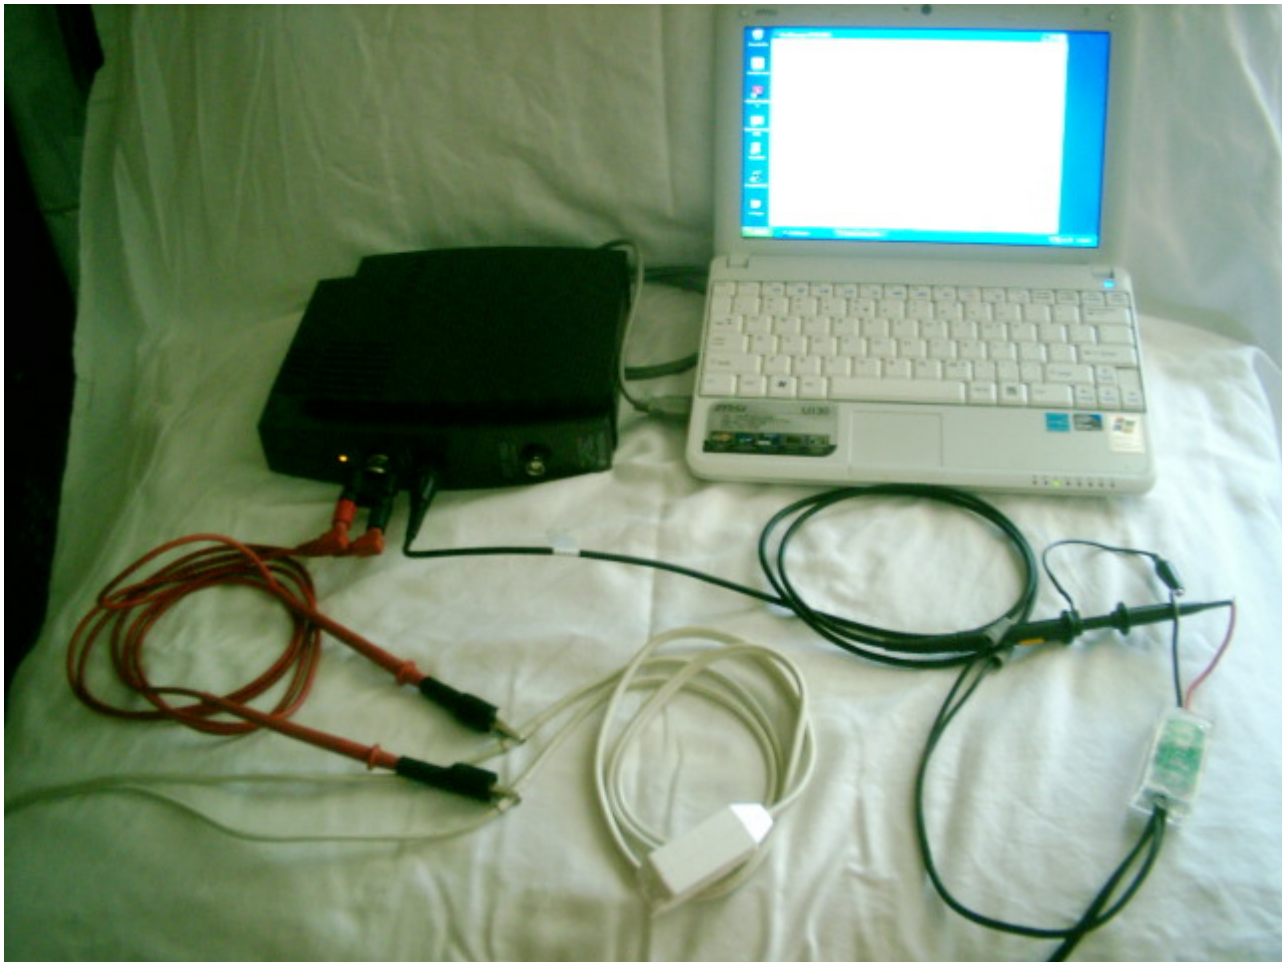
See the set-up below:

The photo shows the two leads clipped to the outer insulation of an extension cord plugged into the outlet. The two oscilloscope leads are plugged into a [Pomona 1296 connector](#) that is attached to the input for channel one (the blue tracings below) on my oscilloscope. The Stetzer attenuator filter is also plugged directly into the outlet, as I had done on my earlier study, and is attached by way of an oscilloscope probe to the input for channel two (the brown tracings below) on my oscilloscope.

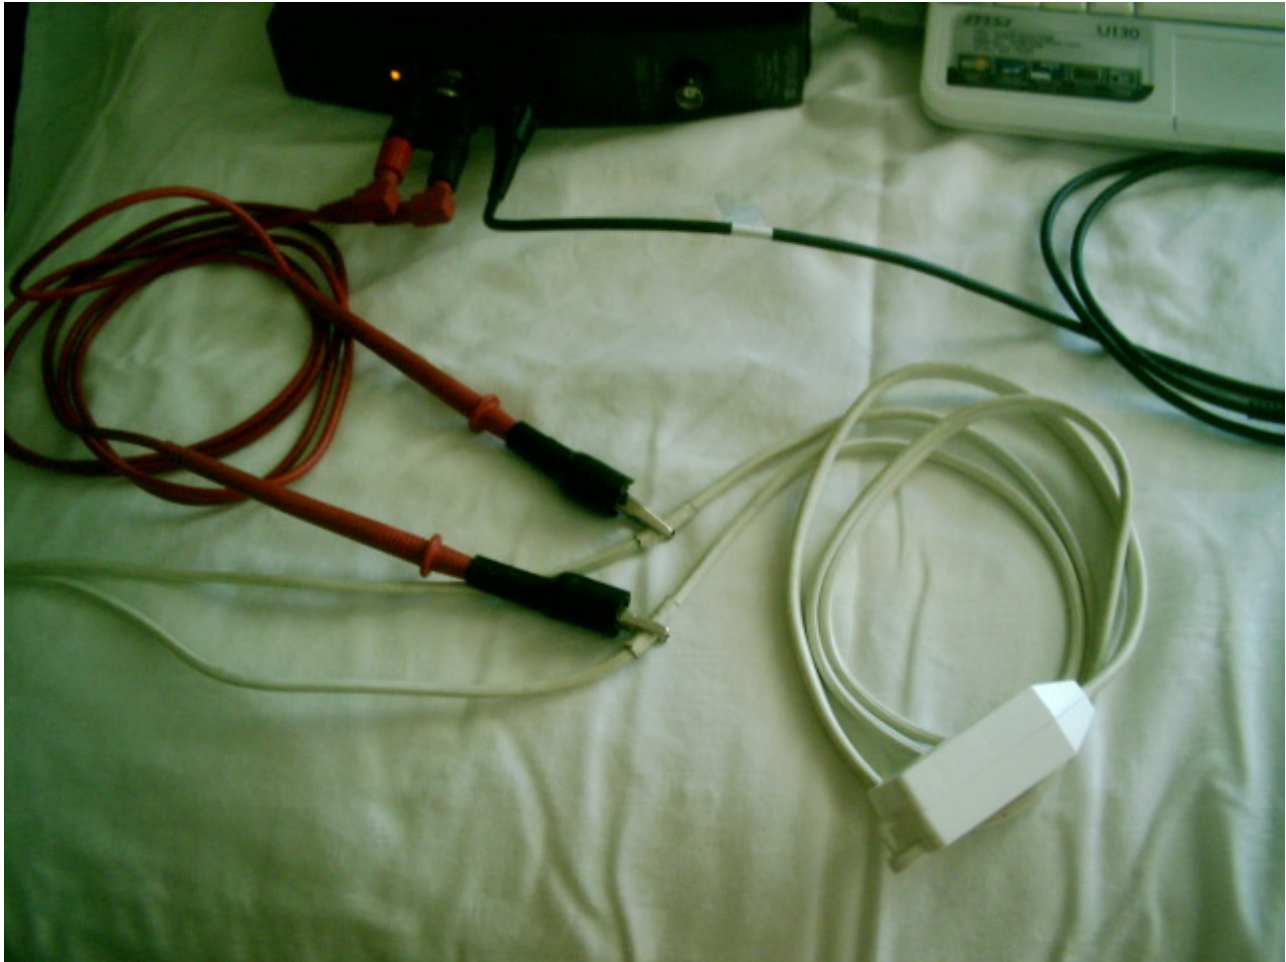
Here is a close-up of the twin leads connected to the extension cord (I wrapped white electrician's tape around the wires of the extension cord so that the clips of the alligator clip would not pierce the insulation and touch the 120 Volt hot wire, which would damage the scope):

I found that it is important to connect the lead clipped to the hot wire of the extension cord into the red input of the Pomona connector, and that you connect the lead clipped to the neutral wire into the black input of the Pomona connector.

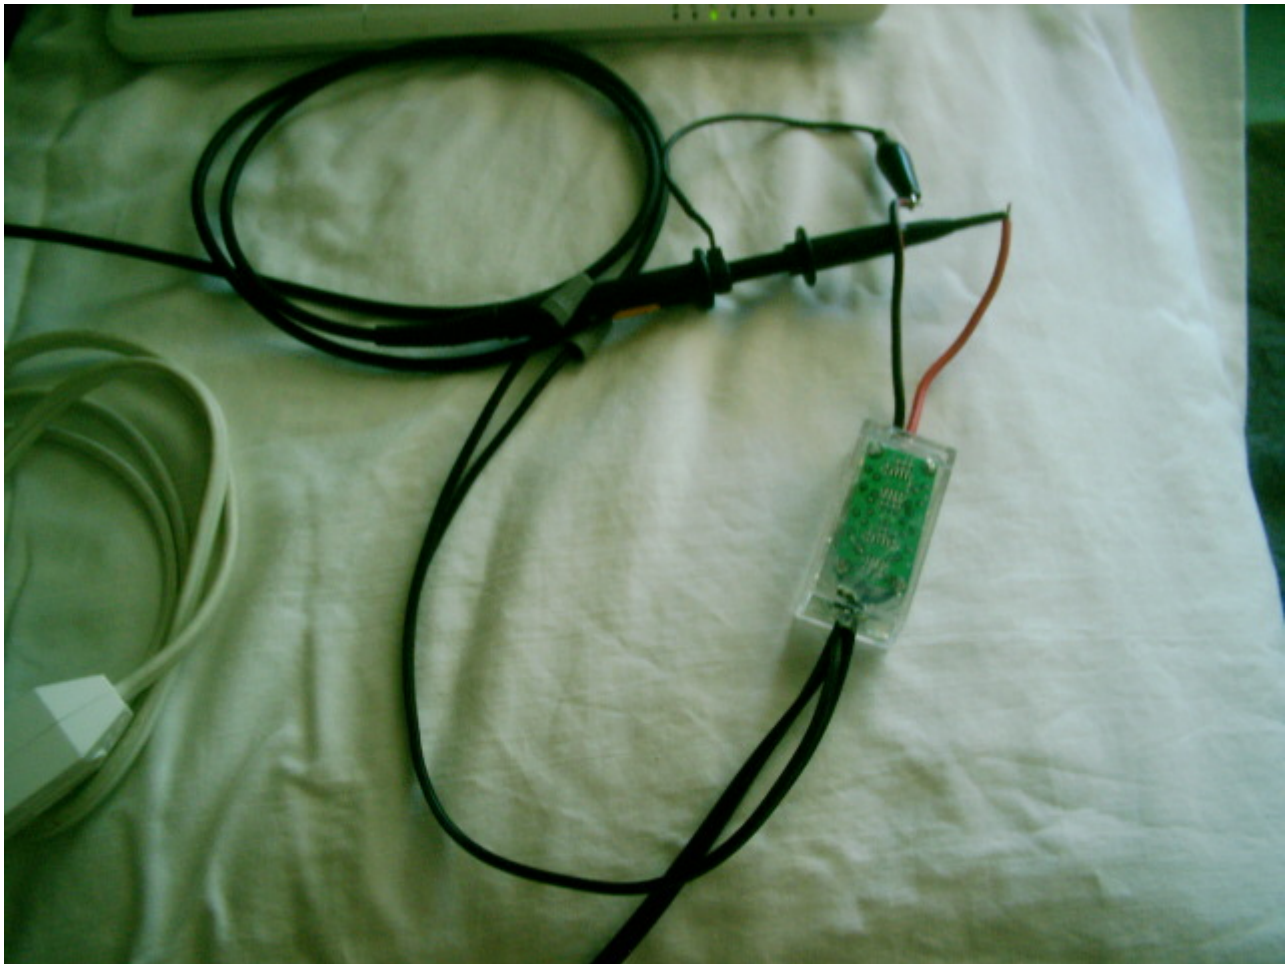
Here is a close-up of the Stetzer attenuator filter set-up. The wire trailing off the bottom of the photo is plugged directly into the outlet, and the hot conductor of the oscilloscope probe is connected to the red wire coming out of the attenuator, and the ground conductor of the oscilloscope probe is clipped to the black wire. The probe is set to 10X and connected to channel two on the scope:

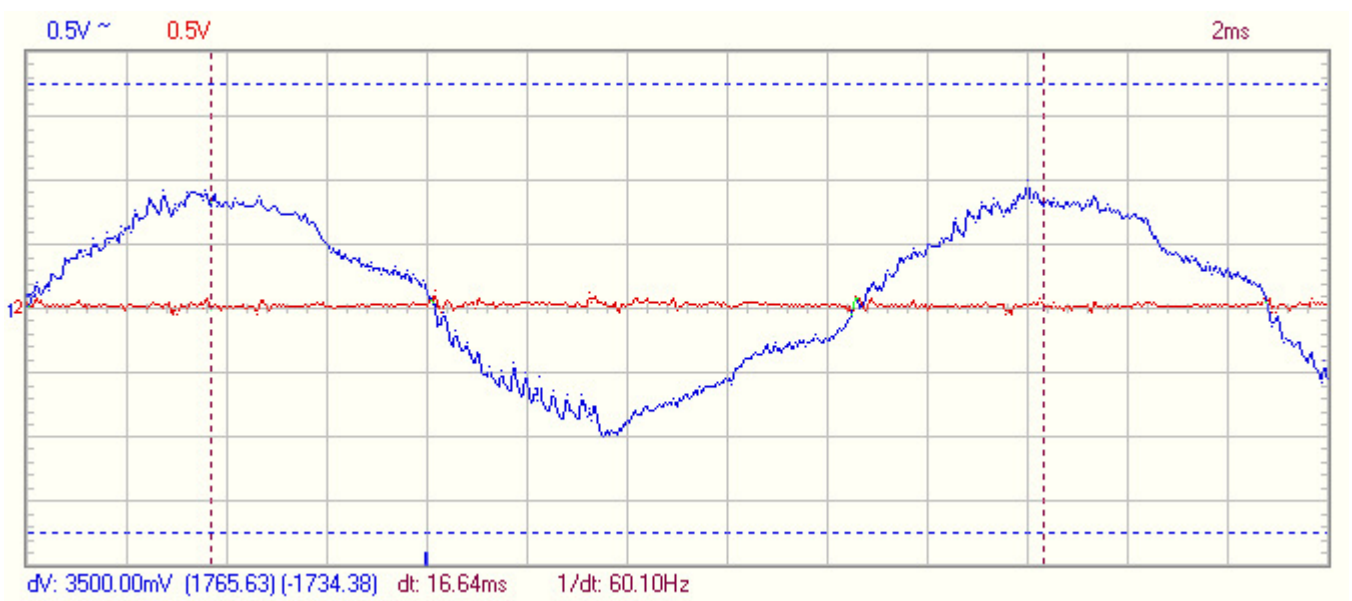
This first image is the initial waveform tracing with all circuits on and loads on in the house:

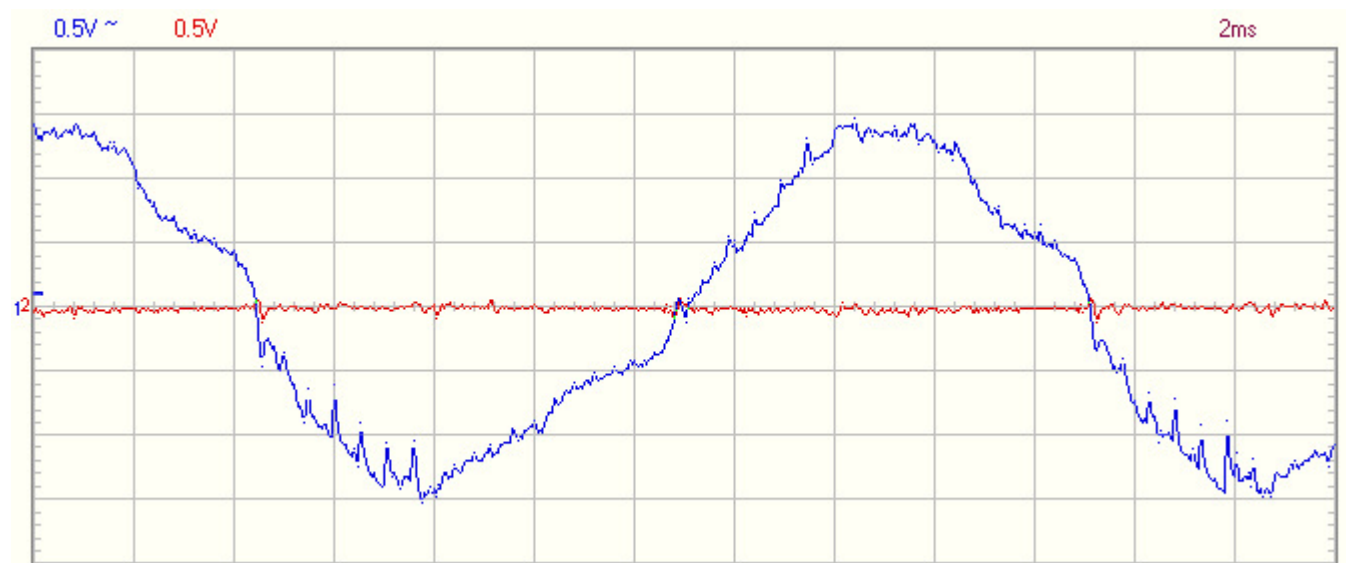
When I shut off all other circuits except the one that powered the outlet I was plugged into, both waveforms looked a little cleaner (less spikes, less saw-toothed appearance), however you can see that there is still a little roughness or electronic noise in the portion of each cycle leading to a peak, particularly the minus (downward) peak:

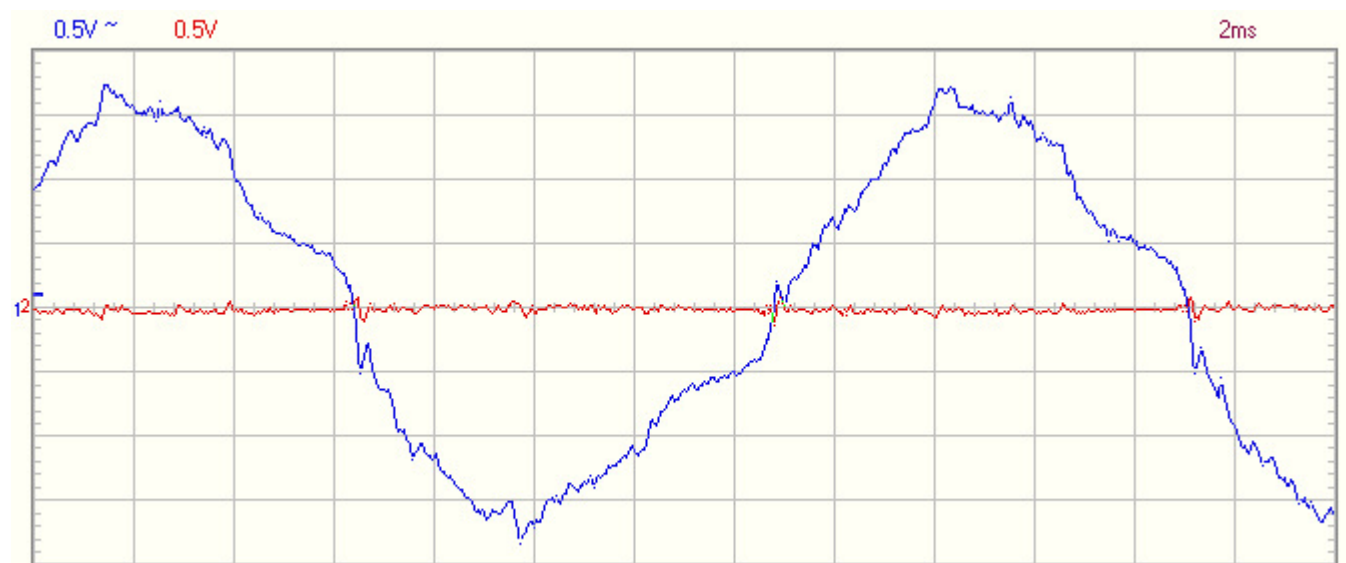
That roughness disappears when we unplugged a transformer for a laptop computer (which was off, but the transformer was plugged in) that was plugged into the same outlet as my test equipment:

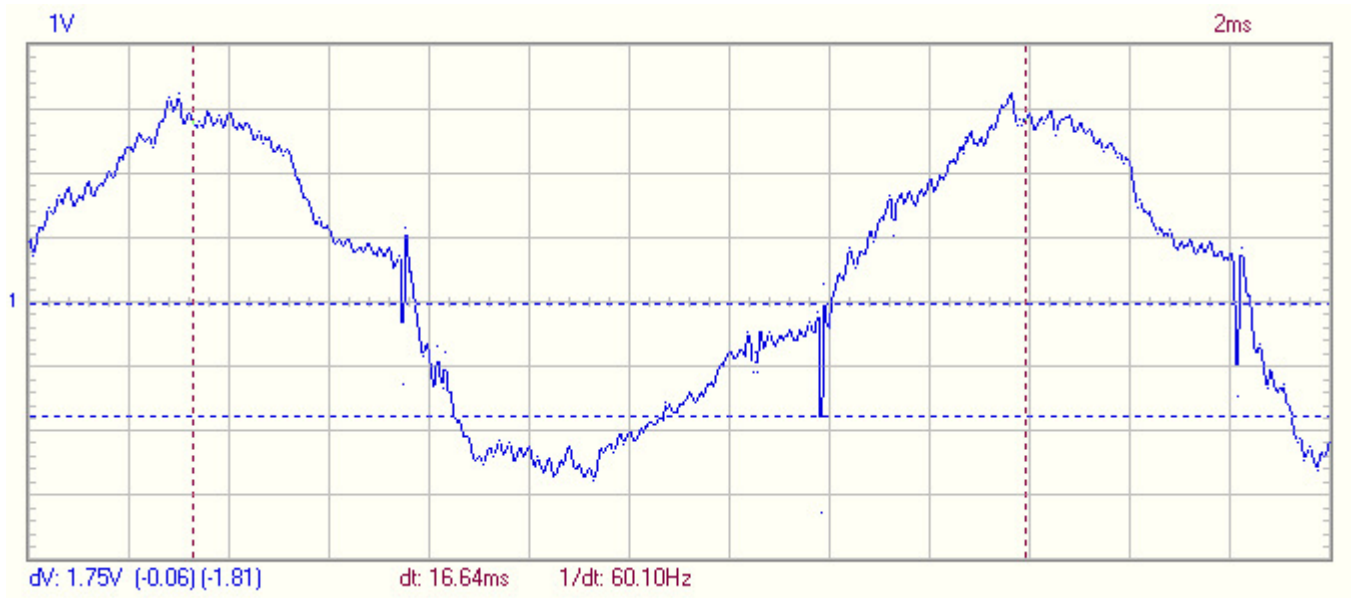
I then asked the homeowner to turn on a dimmer switch in her dining room in which we were sitting, which is a known source of dirty power, and we immediately saw the appearance of the following recurring harmonic distortion or frequency (this image was actually taken on July 24th, and the input from channel two was not present):

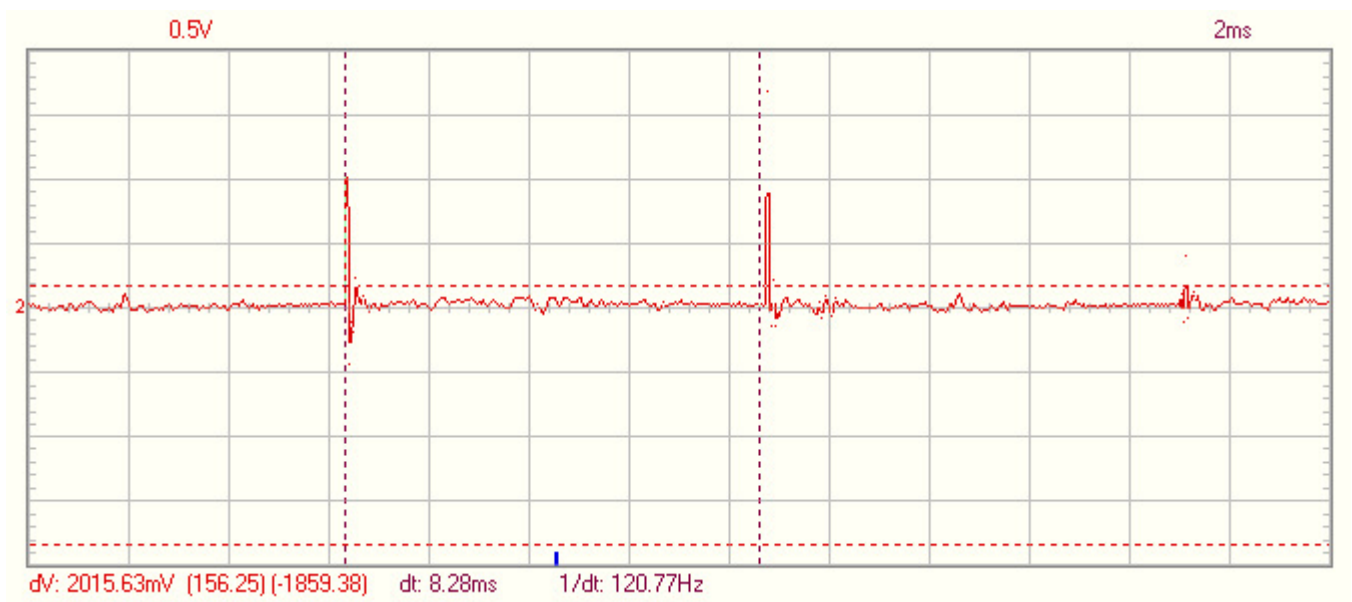
Here is the same waveform tracing taken at the same time of channel two by itself, showing the same recurring harmonic from the dimmer switch but without the 60 Hz sine waveform, which was flattened by the Stetzer attenuator:

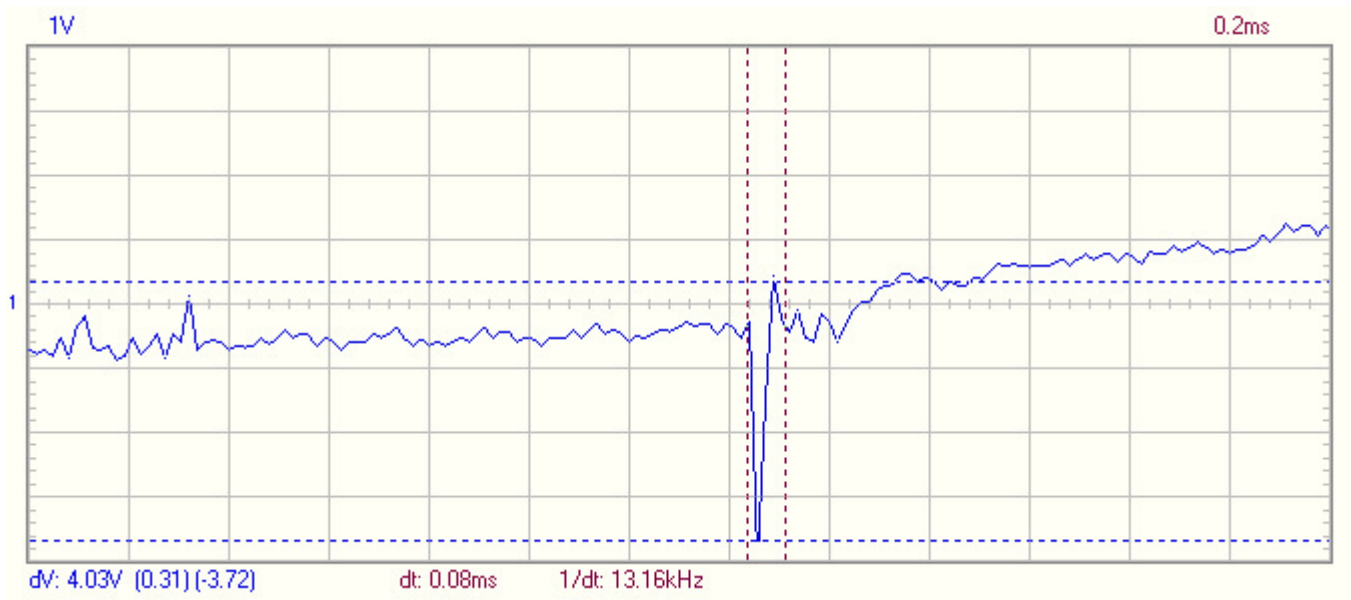
Below is a “close-up” showing the same spike at one-tenth the time frame (0.2 milliSeconds rather than 2ms), to help you see it in more detail. You can see how large and sharp (compact) it is.

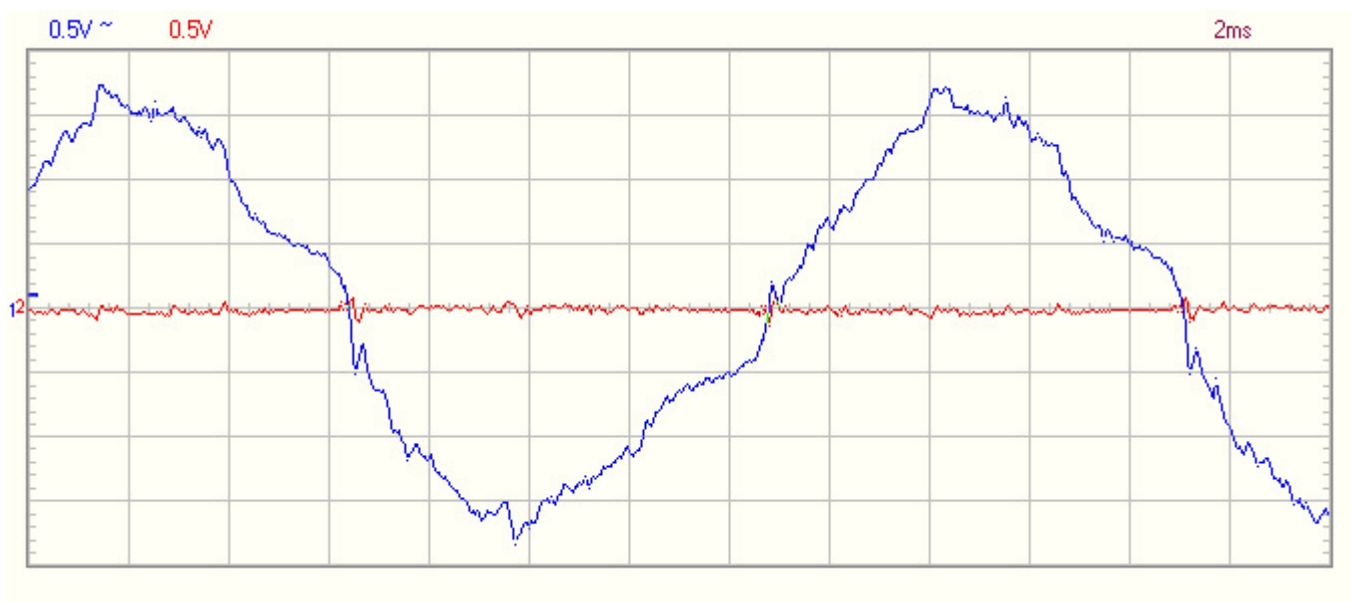
This proves that the new testing protocol I am using is capable of showing recurring harmonic waveform distortions when present from a source of dirty power. Once again, here is the same waveform with the dimmer switch turned back off:

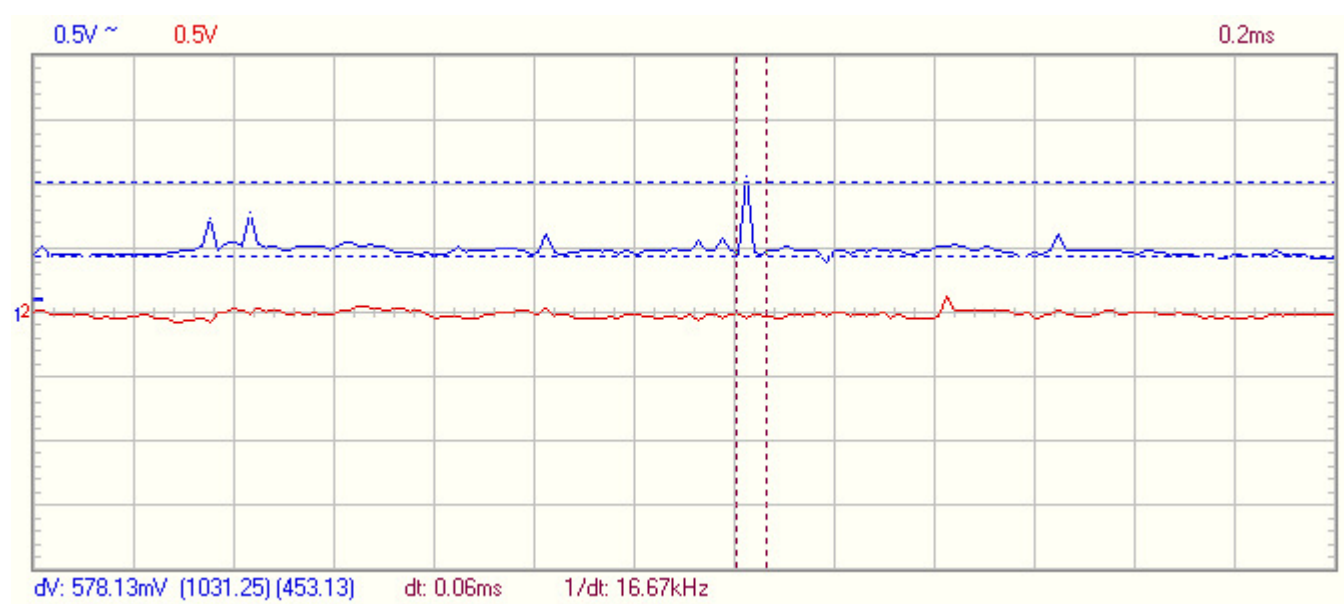
In fact, I analyzed the only "spike" I could find at the top and bottom of each peak in any tracing with the dimmer switch off, and came up with the following waveform tracing:

In this tracing, I changed the time setting from 2 milliSeconds (ms) per box to 0.2 milliSeconds, meaning each box measures one-tenth the time of the previous tracing. 0.2 milliSeconds (ms) is the same as 200 microSeconds (us), which is the same setting that Rob used in his third image where he isolates the large, short, sharp recurring spike that he believes causes everyone such problems with the smart meters used by PG&E. I set the time setting on my tracing at 0.2 ms, which is the same as Rob's 200us.

Notice that in my tracing, the one harmonic that I did isolate has a voltage height of only 578 milliVolts, or half a Volt, compared to Rob's harmonic spike of almost 2 Volts high. That means the harmonic I saw was one fourth the size of the harmonic he measured.

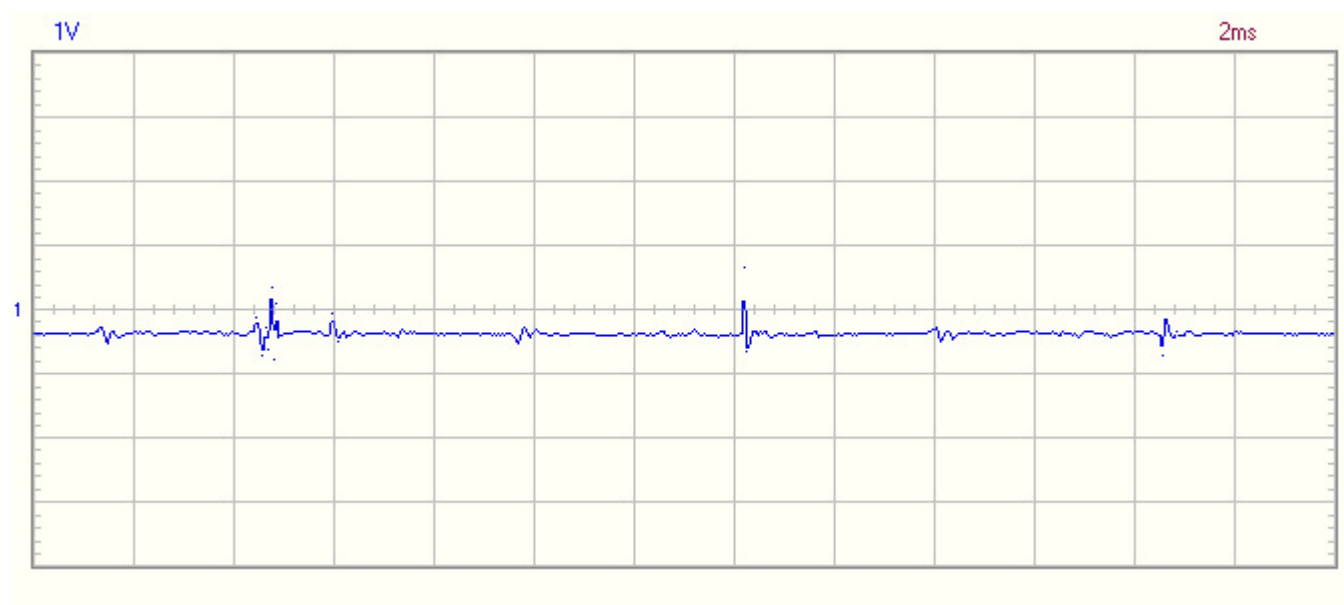
The tracing taken on May 17th shows this same harmonic:

The timing of the tracing is the same as the tracings taken on July 19th, that is, 2 milliSeconds, but the voltage height of each box in the May study was 1 Volt, rather than 0.5 Volt. That would mean the harmonics would appear somewhat smaller in the previous study.

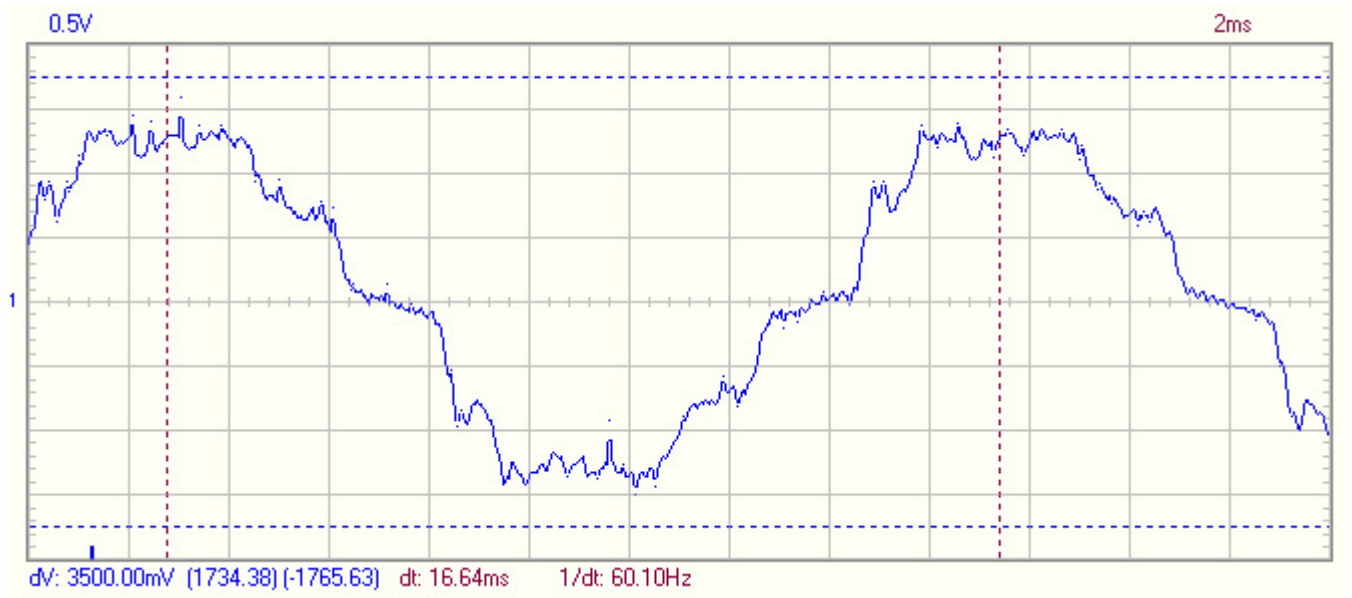
I also returned to a home in Burbank I had evaluated previously on May 17 and May 22, 2012 that has a GE / Trilliant smart meter with the communication module intact to re-evaluate it using the new protocol. The waveform from that house is shown below:

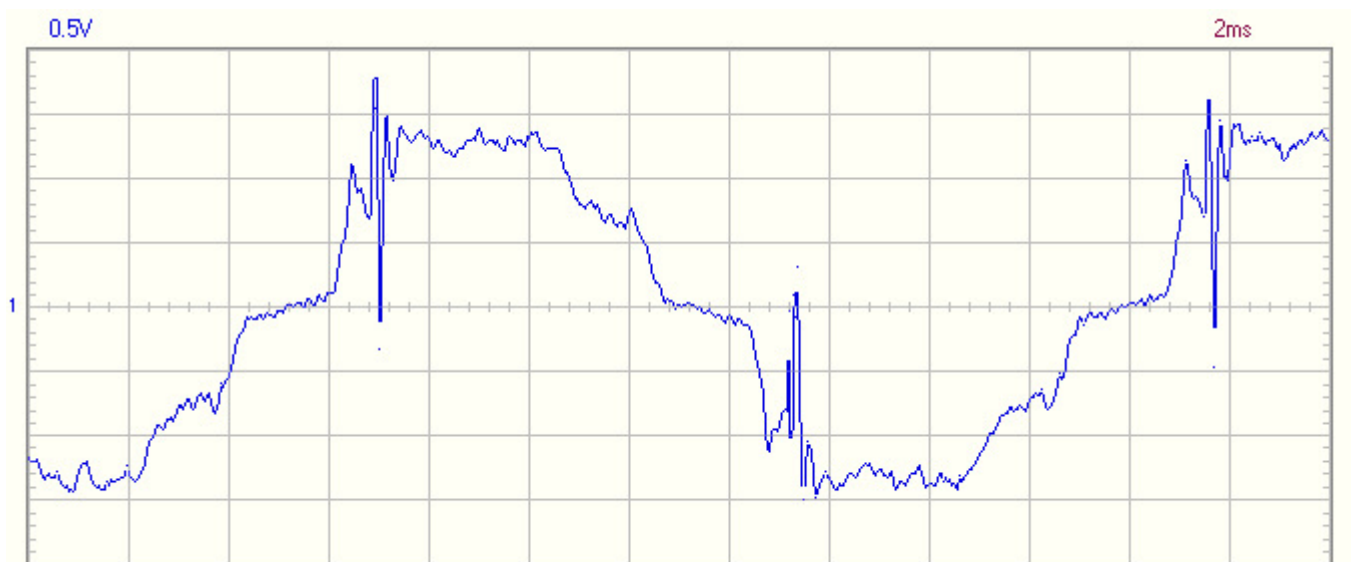
To once again demonstrate that the new protocol does demonstrate voltage harmonics when present, the following tracing shows the same circuit but this time with a dimmer switch turned on in an adjacent room. Notice the large, short, sharp repeating harmonics just before the height of each peak that measure almost 2 Volts high (almost four vertical squares at half a Volt per square).

I had seen these harmonics before in this house in the previous study and they are also present on the waveform tracings using the new protocol. They disappear when the dimmer switch is turned off, and are therefore not from the GE smart meter.

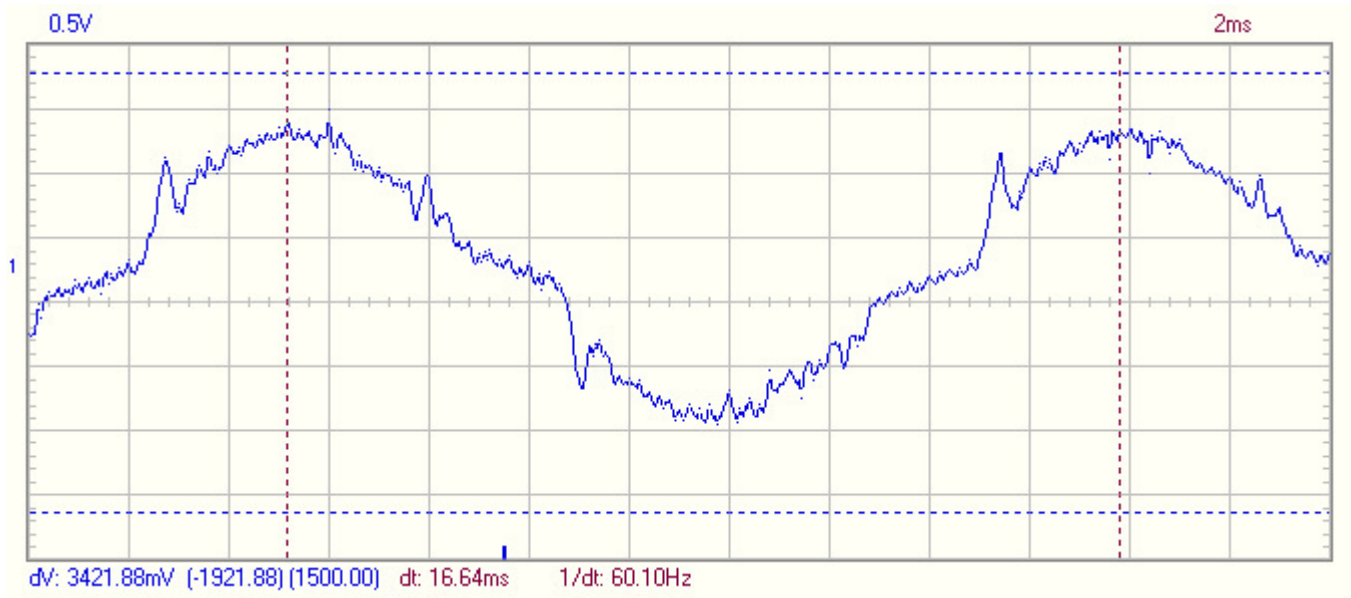
This could be assumed to be from the smart meter, however, the harmonic is not short or sharp with a fast slew rate like the harmonic shown in Rob States' image.
