# [Study to Determine the Presence of Dirty Electricity from Smart Electric Meters in Southern California](#)

written by Oram Miller | 3 June 2015

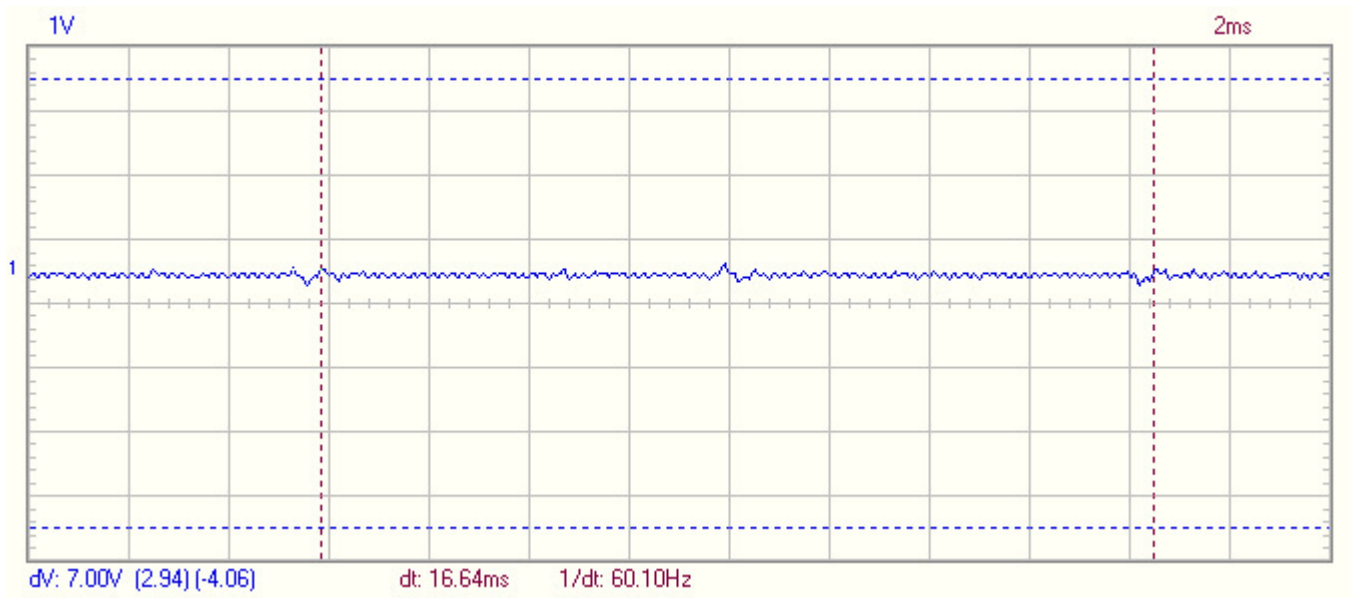
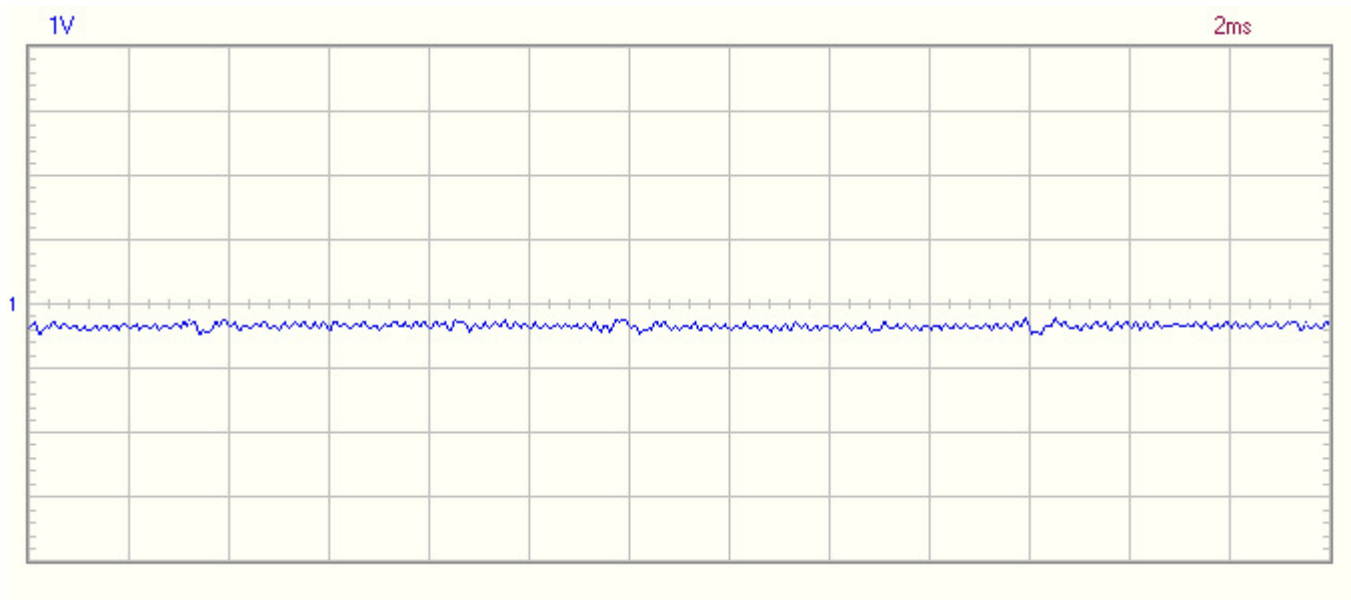
Also, the following tracing, taken the same day (July 24th), which was after installation of the GE RF-off digital meter, but this time using the old protocol with the Stetzer attenuator, looks identical to a tracing taken on May 17, 2012, prior to installation of the new digital meter.

The first tracing below was taken on July 24th and the one below it was taken in May, before the new GE digital RF-off meter was installed. Notice that the settings are the same (1 Volt, 2 milliSeconds). They are almost identical:

There appears to be no evidence of any new harmonics once the new opt out GE meter was installed that are not also present in the tracing taken before it was installed.

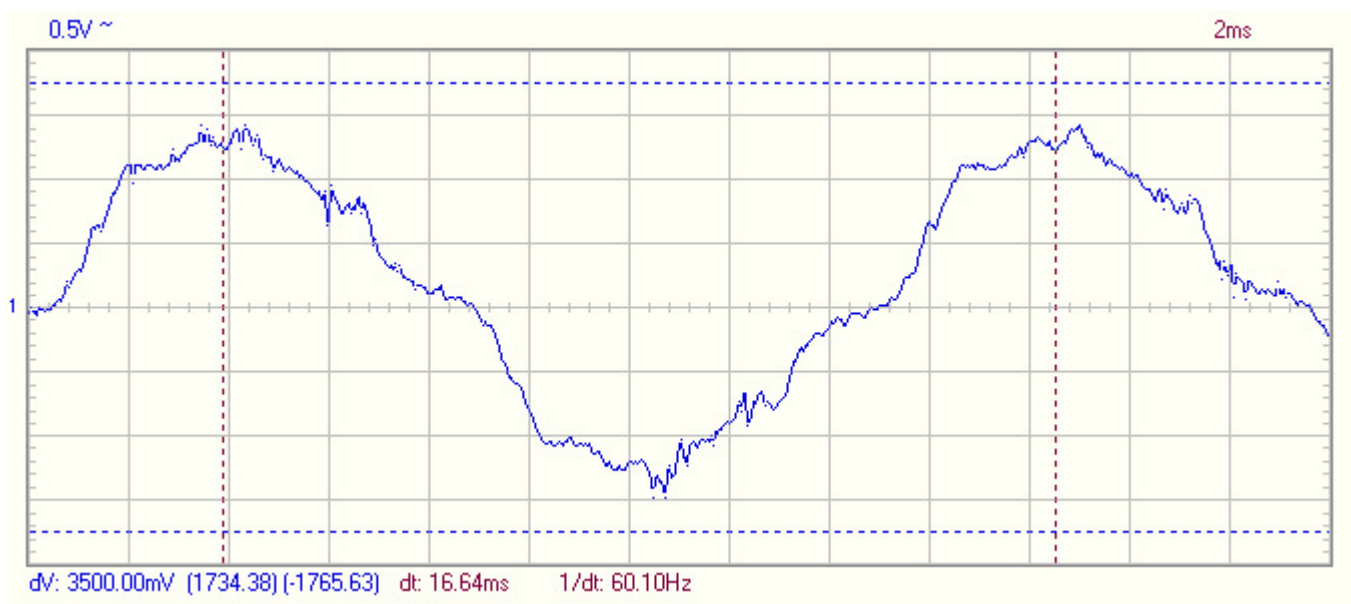
A third home with the new GE digital RF-off meter had the following tracing:

Again, there is no evidence of significant harmonic frequencies on the waveform tracing with the presence of the new digital meter.

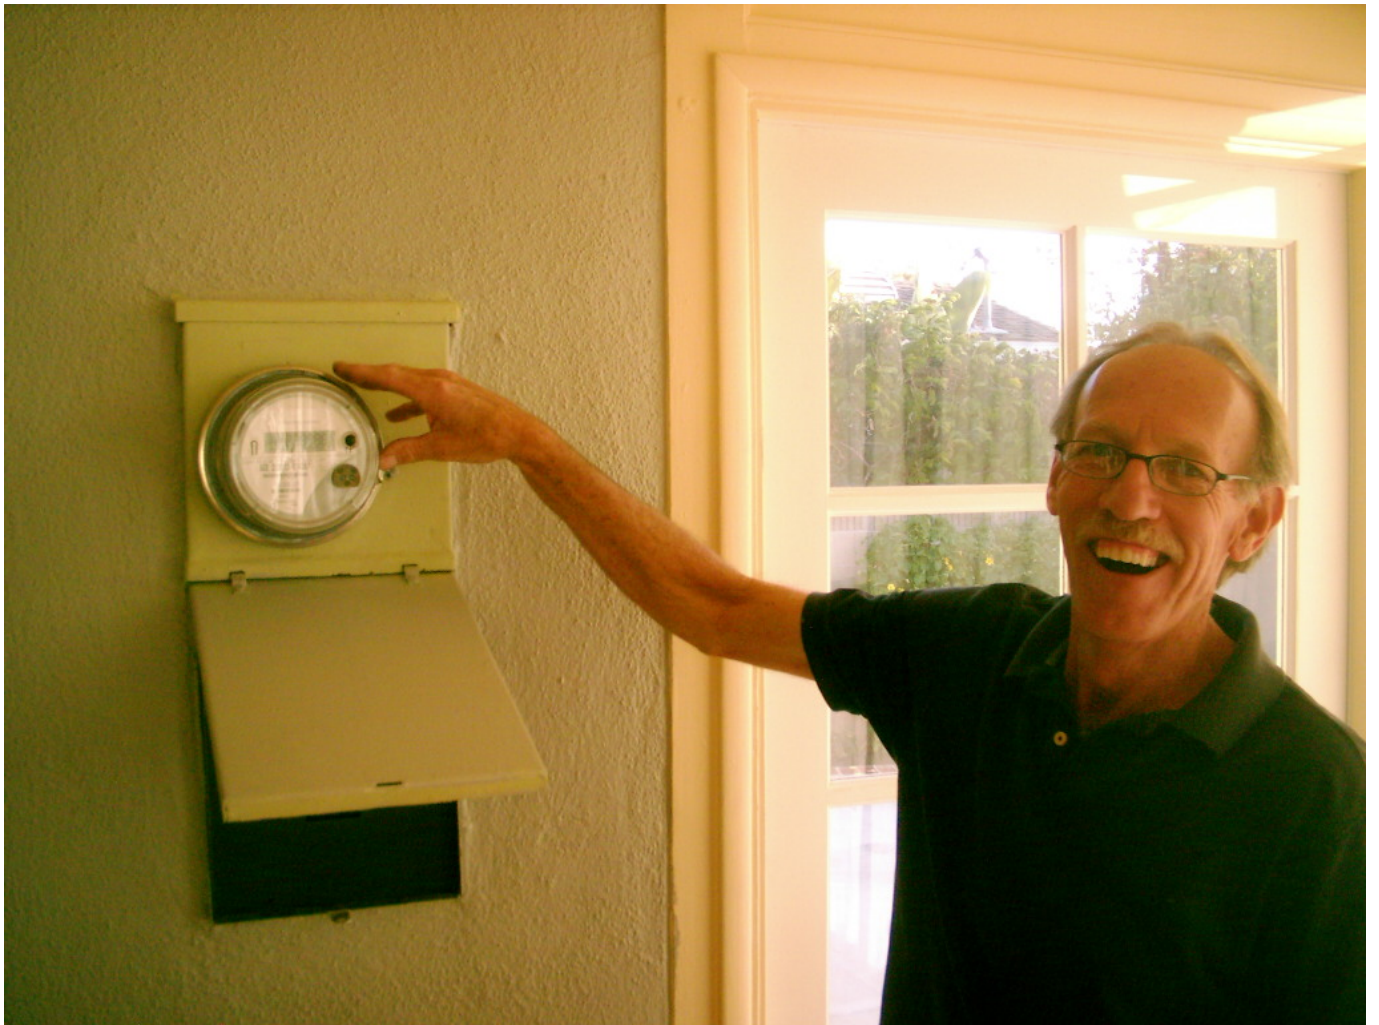
Here is electrician Gordon Bloem with the Itron smart meter in place:

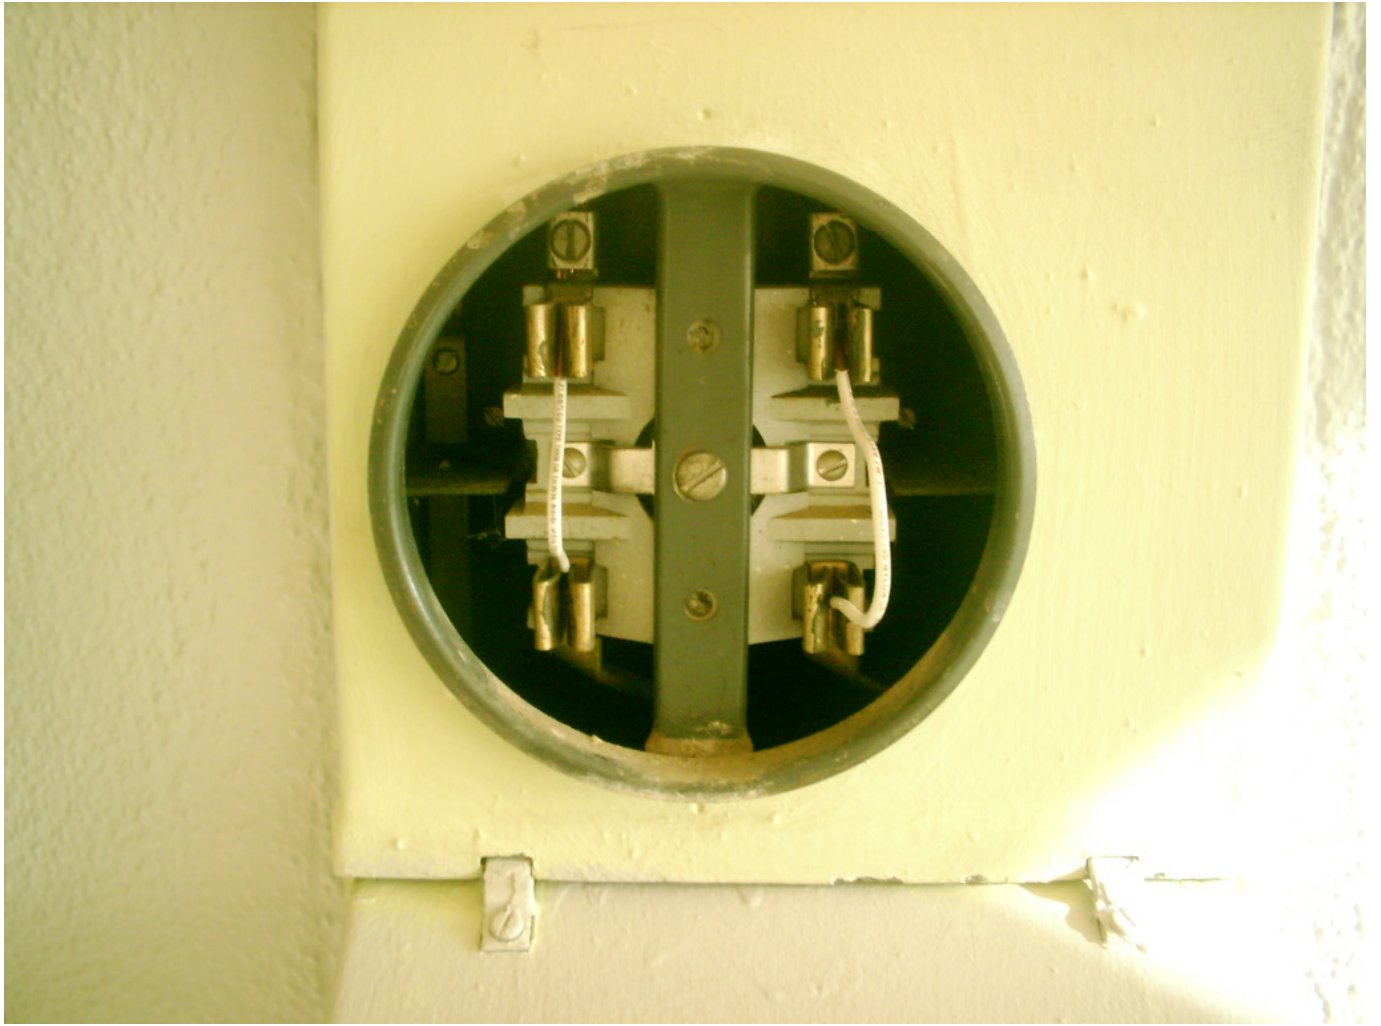
Next, Gordon removed the smart meter and inserted wires to jump the clips so that electric power could continue to come in from the utility, without the smart meter in place:

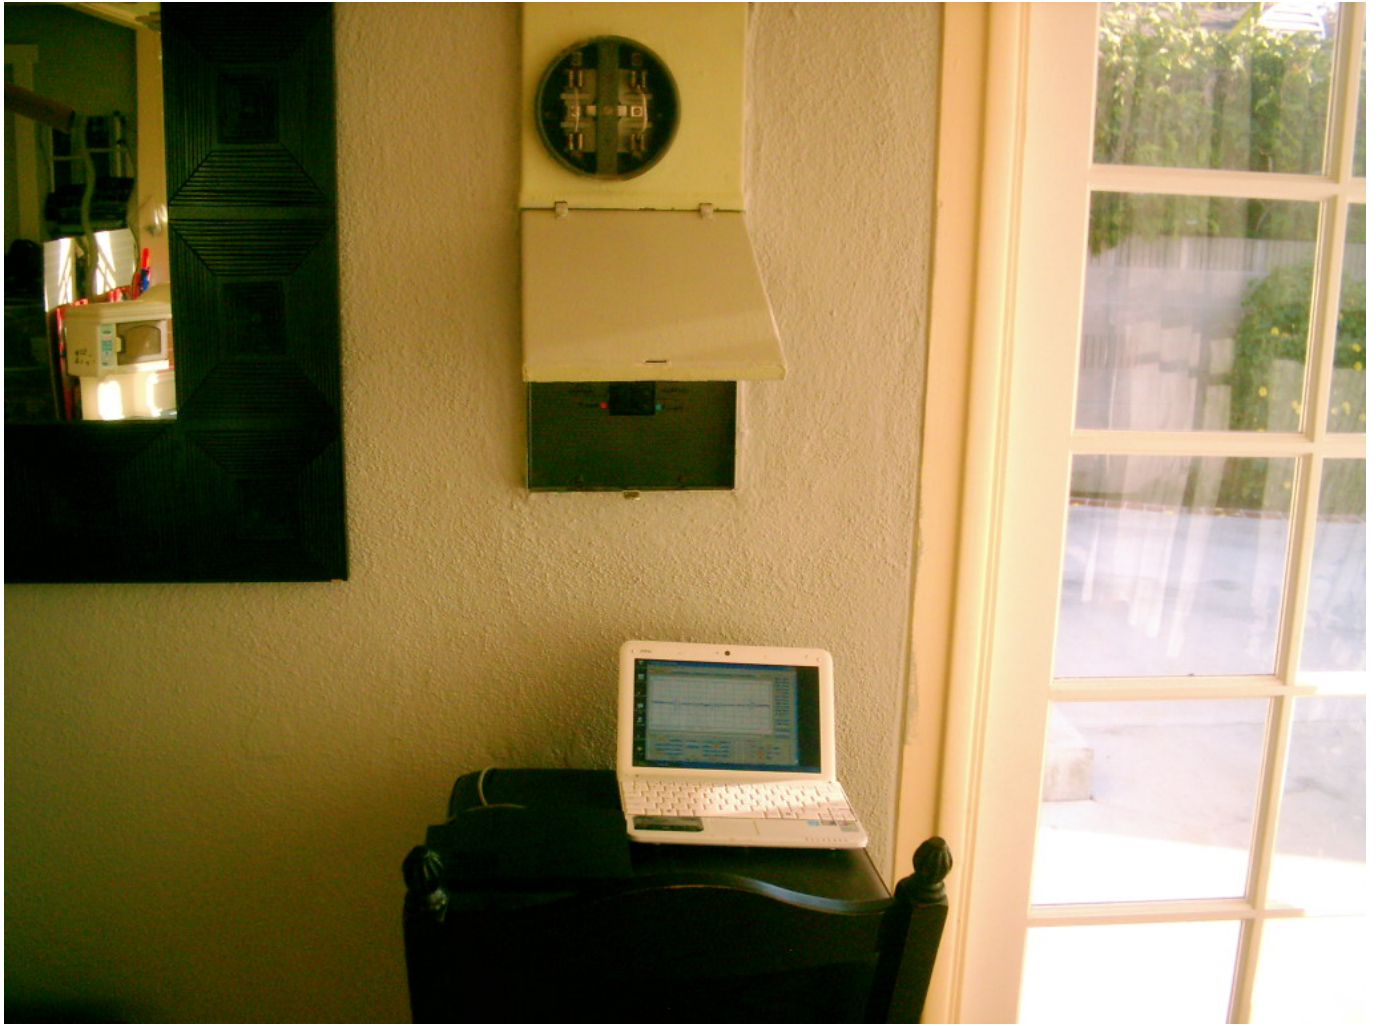
Here is the set-up showing the oscilloscope on the left and the laptop on the right, plugged into an outlet beneath the panel. That outlet was powered by the only circuit breaker switched on and nothing else was plugged into the only other outlet on that circuit:

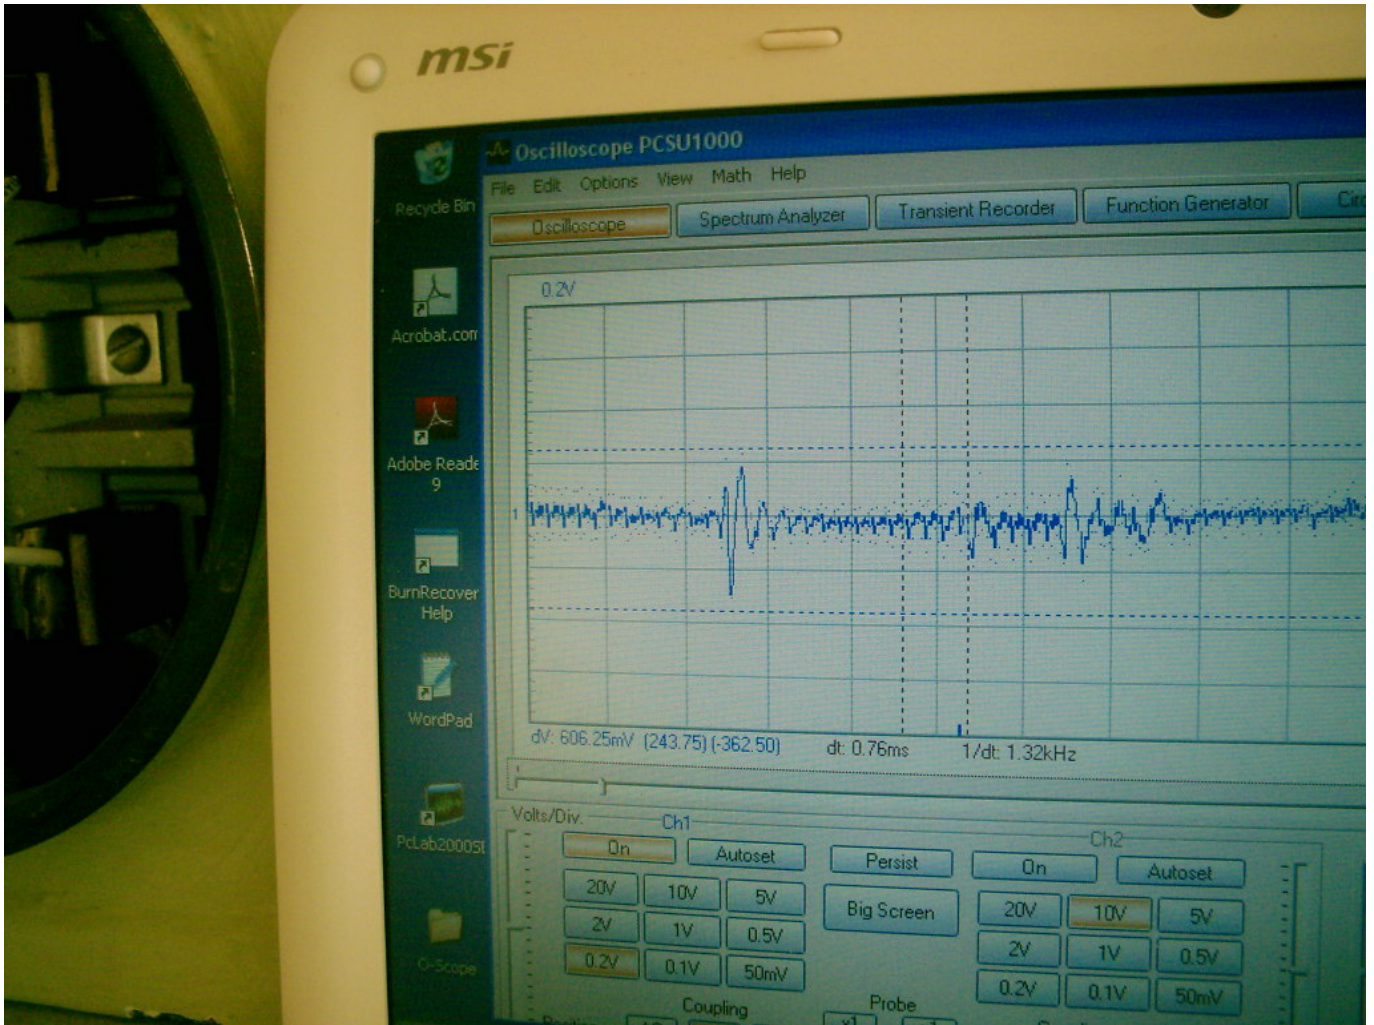
Here is the oscilloscope held next to the empty meter base, showing the presence of the voltage harmonics even with the smart meter removed:

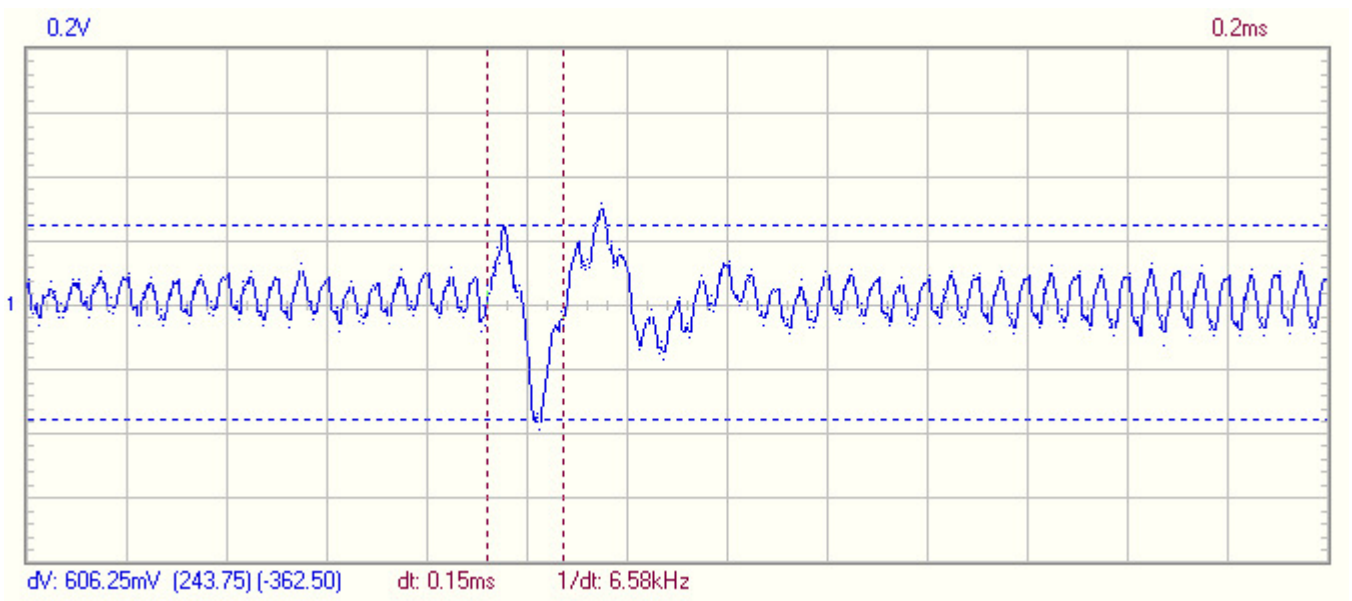
The following is the waveform tracing seen in the photo, at 0.2 milliSeconds per division. The voltage size is 0.6 Volts:

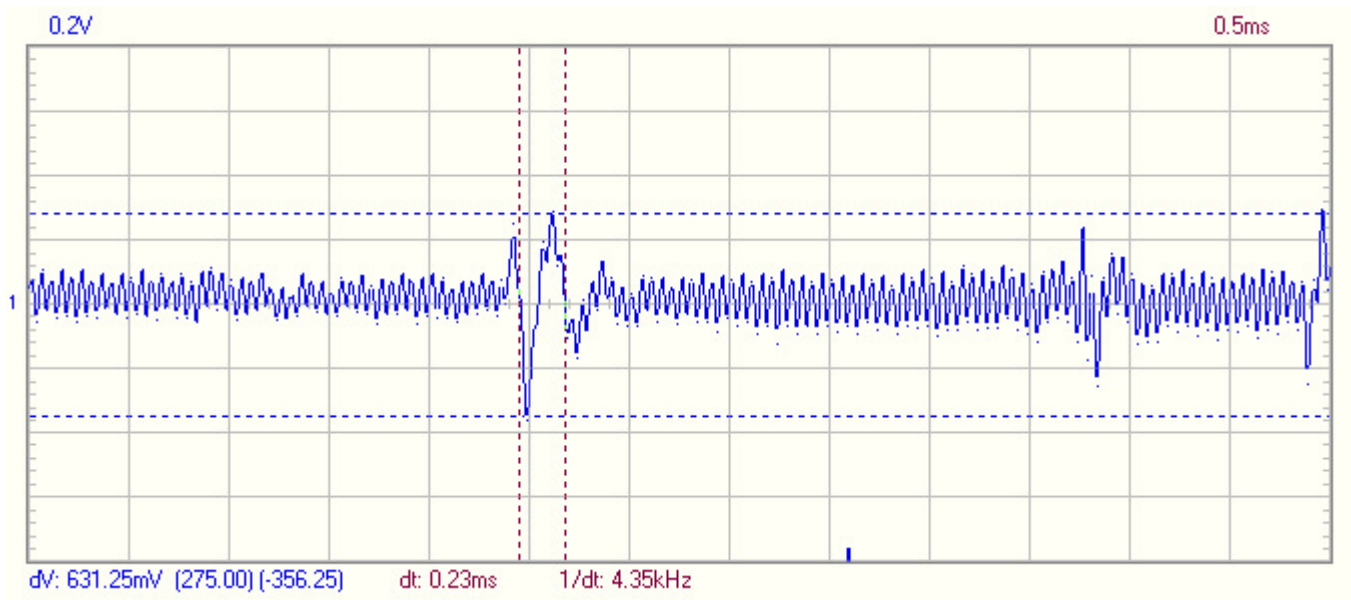
The following is the same waveform tracing at 0.5 milliSeconds per division, again with the smart meter out:

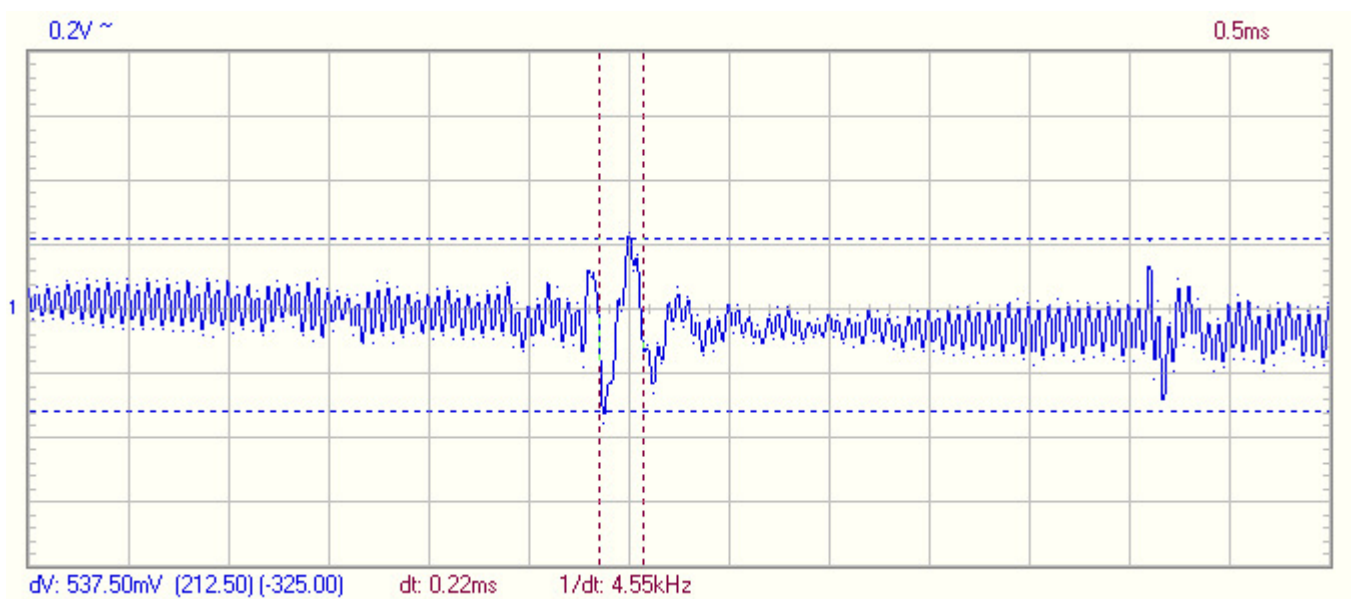
Compare that to the waveform tracing at 0.5 milliSeconds per division *before* the smart meter was removed, at a time when we thought the voltage harmonics were coming directly from this Itron smart meter. Notice that the waveform and voltage spike above are virtually identical to when the smart meter is removed, shown below:

This proves that the same voltage harmonics were still present on the power company's incoming electricity with the smart meter removed, indicating the harmonics were from some source of dirty power in a neighbor's home and not from the Itron smart meter in the home I was measuring.

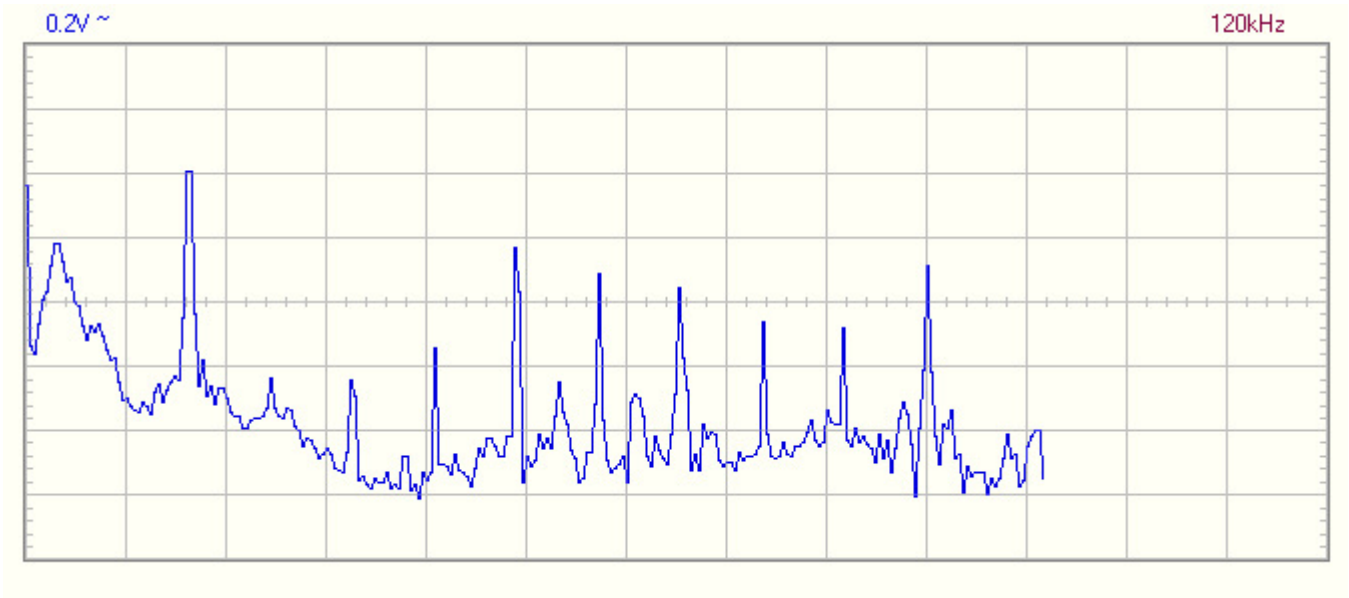
For the sake of completeness, below is a spectrum analysis of the circuit beneath the panel up to 120 Hz:

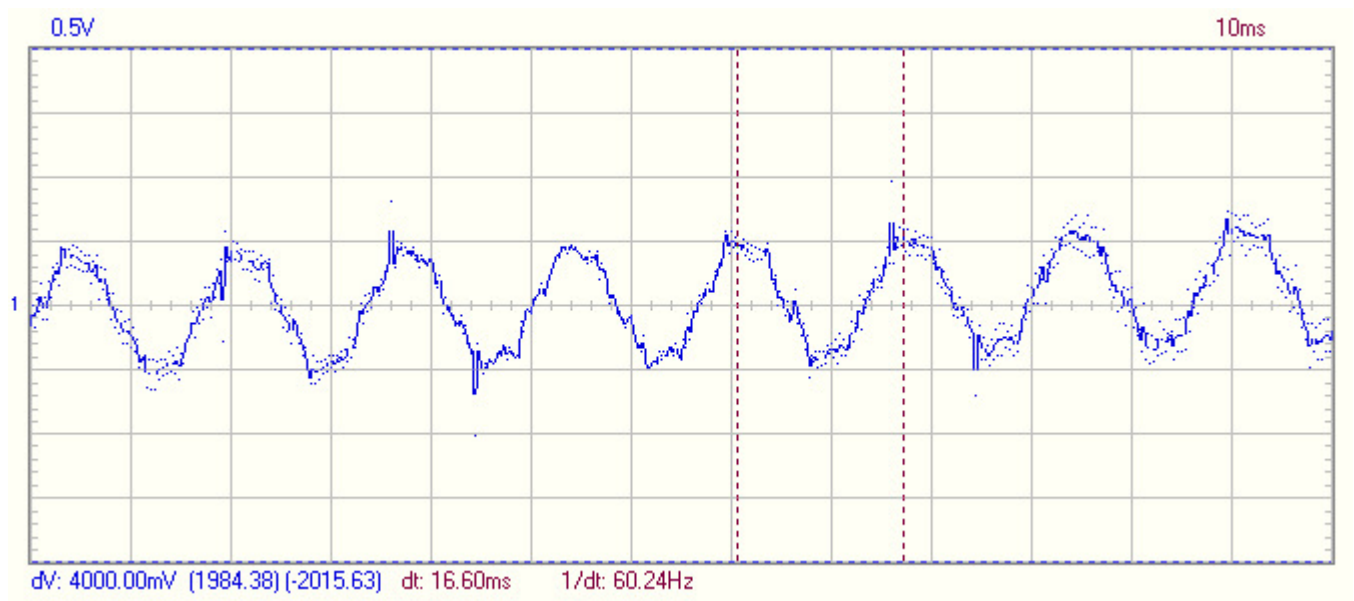
I also measured the presence of the voltage harmonics on the 60 Hz sine wave while standing outside on a step ladder halfway between the house and the transformer on a utility pole. I used a telescopic antenna attached directly to the oscilloscope input and held within one inch of the insulated phase conductors of the utility service drop. Since the Stetzer attenuator was not in place and we were measuring frequencies through the air with an antenna, the tracing shows the characteristic 60 Hz sine waveform. Notice a spike on virtually every positive and negative peak:

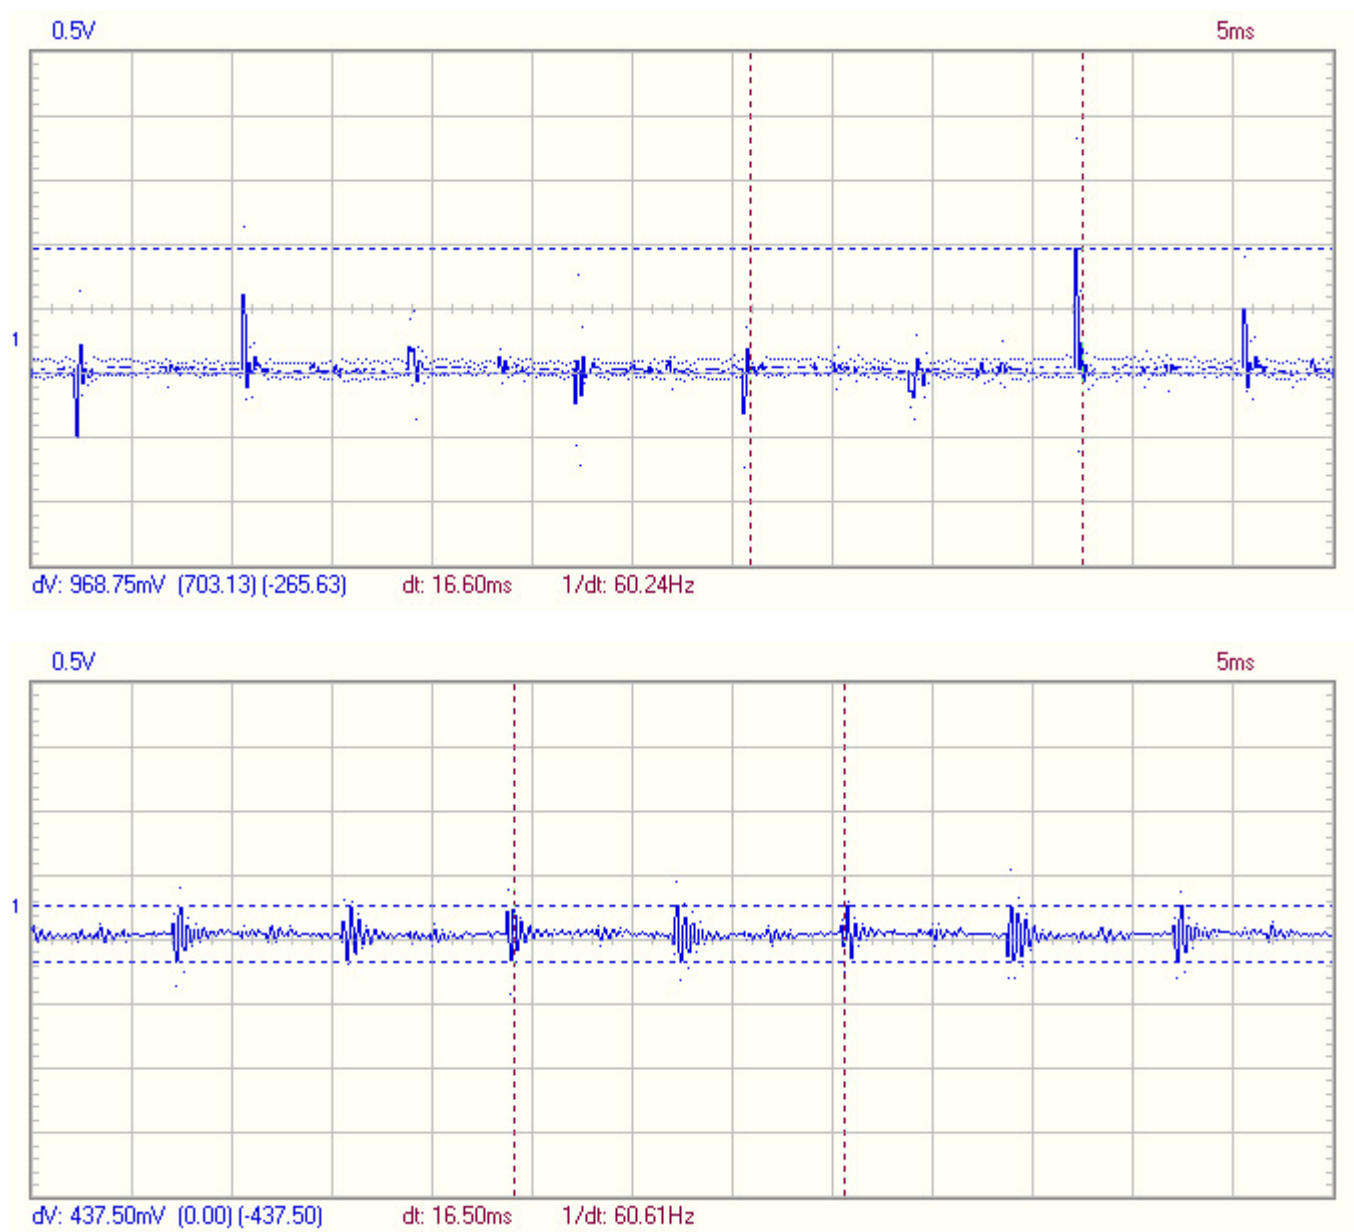
The first two images show the presence of voltage harmonics (now known to come from a source outside the house and not from the Itron smart meter). Both are taken at an outlet located under the main breaker panel with only that circuit switched on (Note: each division is 5 milliSeconds wide):

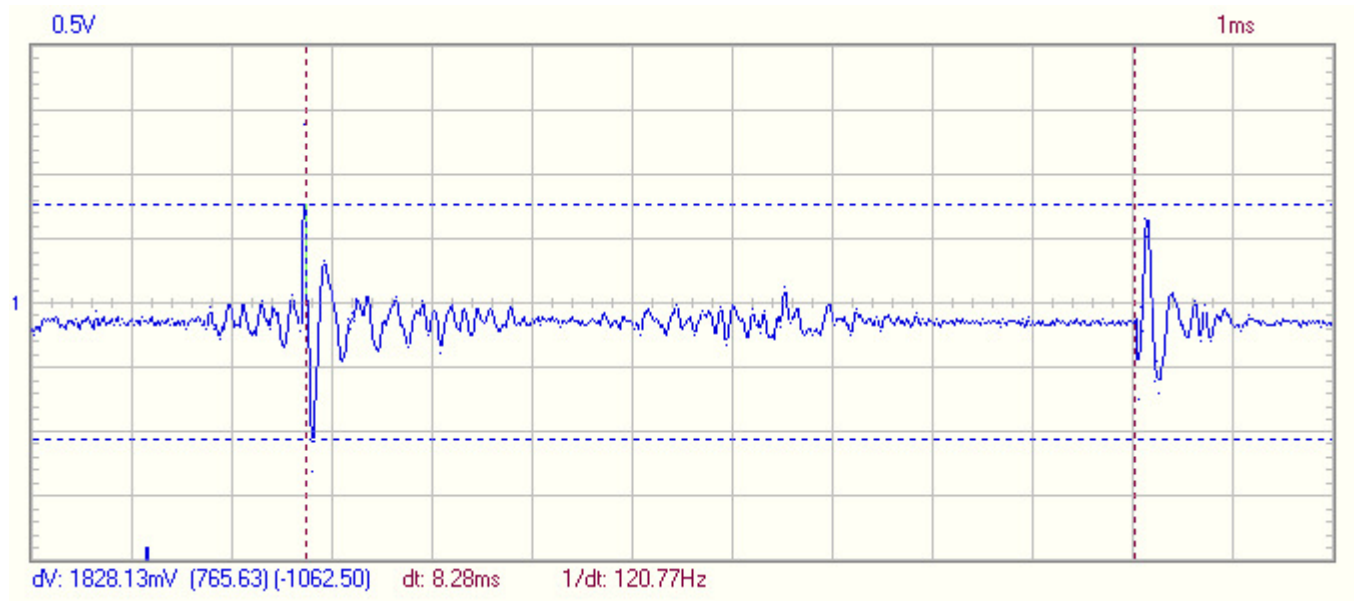
These harmonics occur on every peak of the 60 Hz sine wave, at +/-60 Hz (thus at 120 Hz). This is,

as Rob States observes, possibly indicative of a switched mode power supply (each division is 1 millisecond wide):

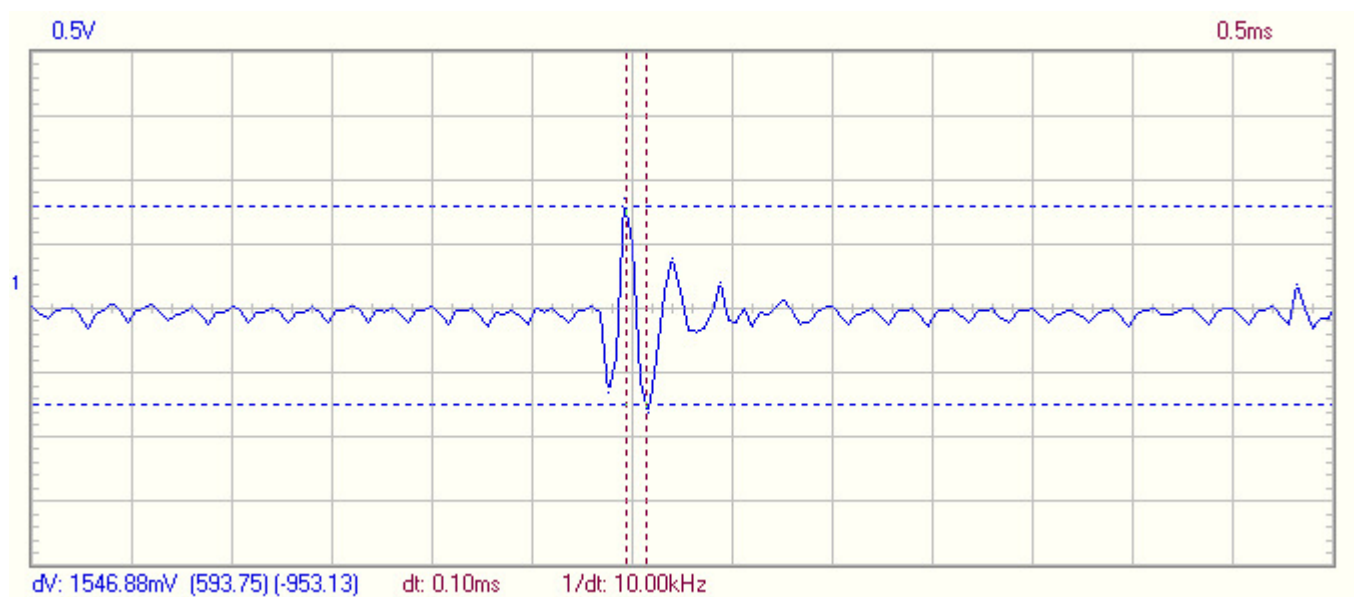
One image below shows these voltage harmonics to have a fundamental frequency of 5kHz. There is a transient of 1.5 Volts in 100 microseconds, for a slew of 15,000 Volts/second:

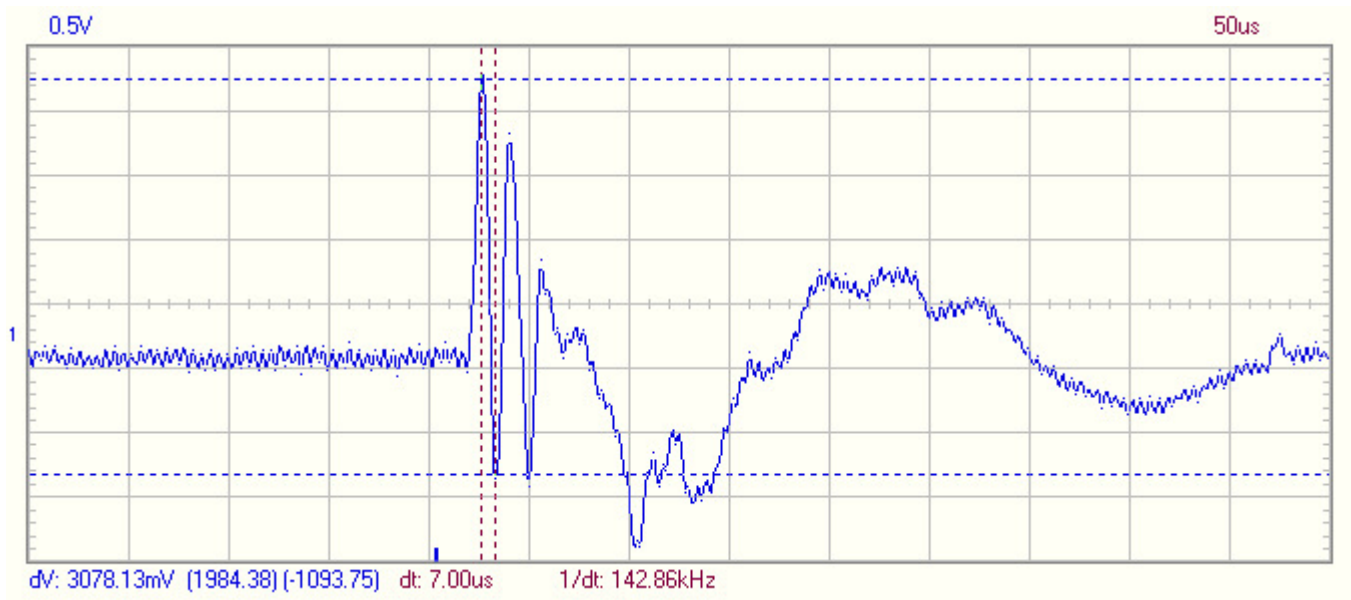
A second tracing shows voltage transients of 3.1 Volts in 7 microseconds, for a very high slew of 439,700 Volts/second. These waveforms showed the harmonics to have a fundamental frequency of 71kHz:

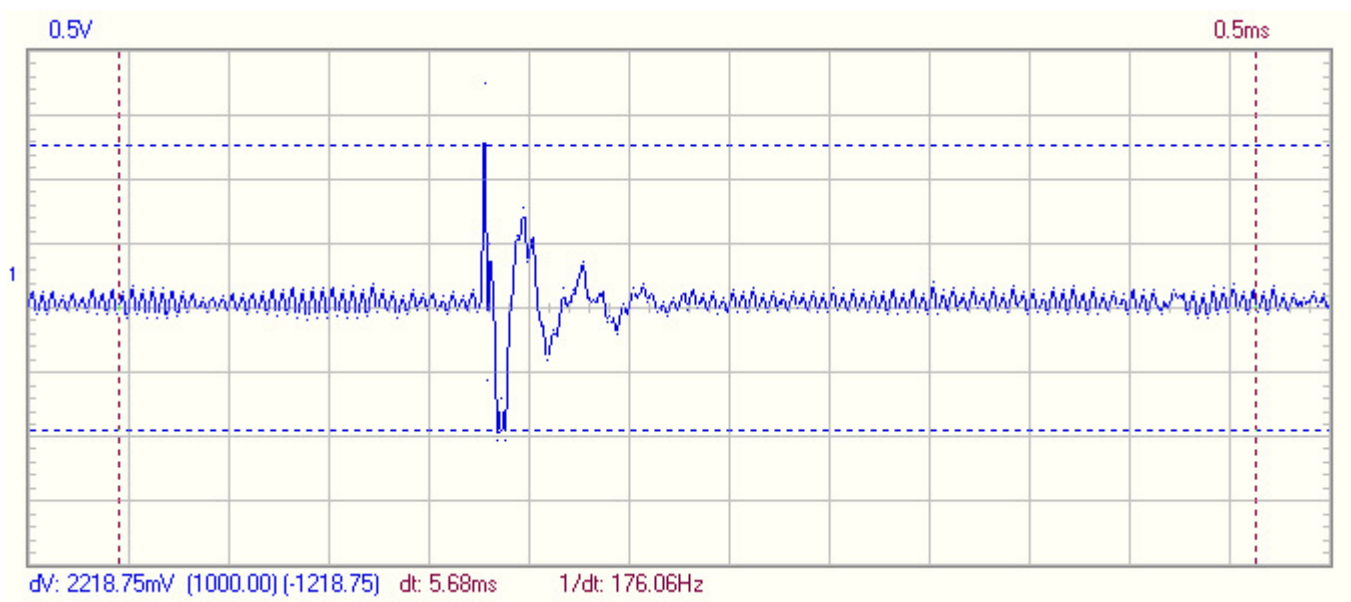
These voltage harmonics are attenuated by the insertion of a single Greenwave filter into the same outlet the Stetzer attenuator and probe were plugged into. Here is the tracing before insertion of the filter:

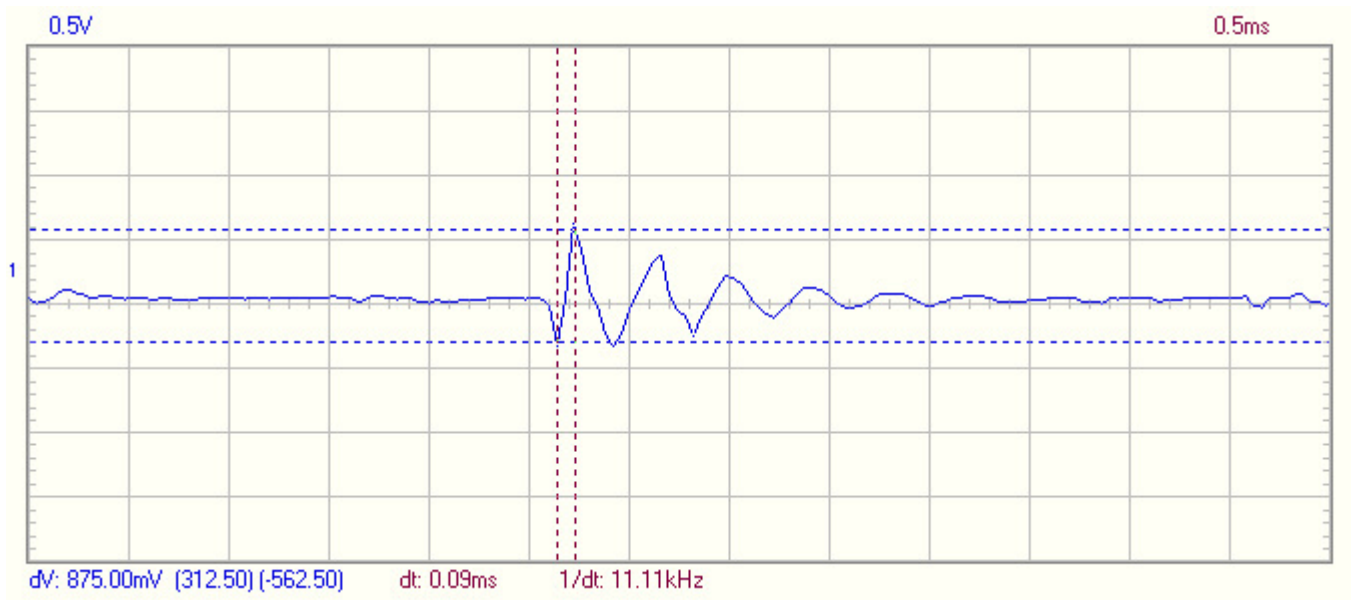
Here is the waveform after insertion of a single Greenwave filter, showing the attenuation, or lessening of the height of voltage harmonics from 2.2 down to 0.87 Volts, as well as a clearing of the low-level, background noise on the line:

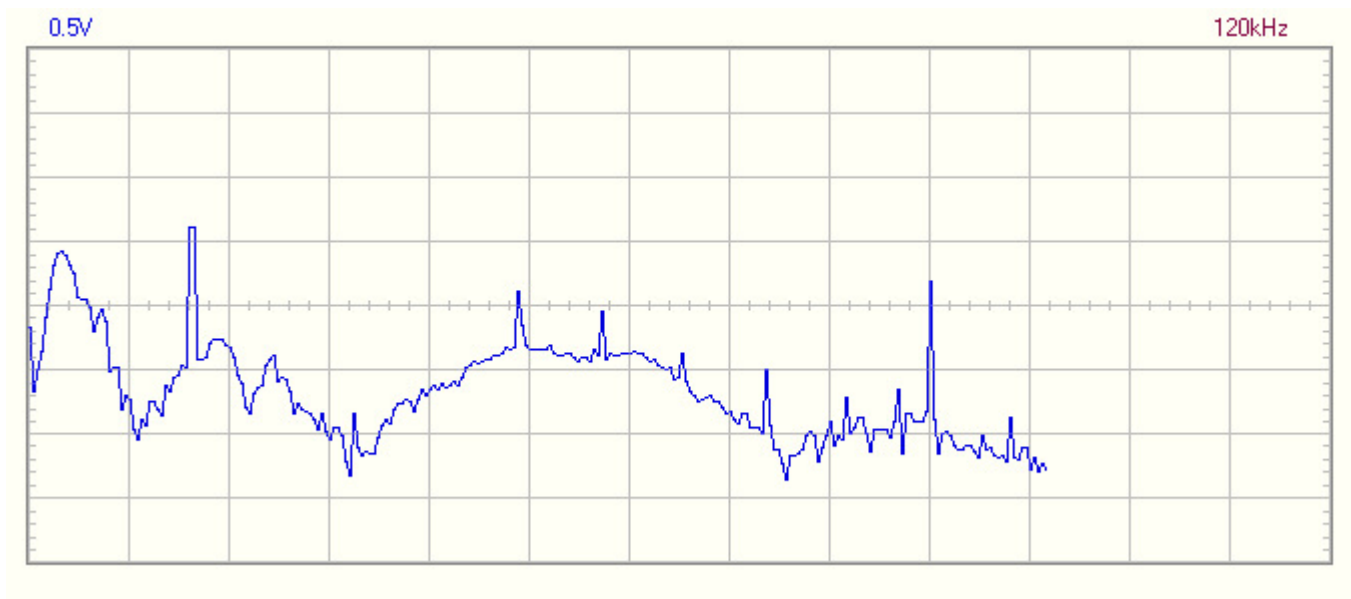
Below is a spectrum analysis of the waveform from the panel outlet from 0 to 120 kHz without a Greenwave filter (each division is 12kHz wide):

With the understanding from some engineers that spectrum analysis is the most valid way to identify voltage harmonics, I also obtained spectrum analysis of the voltage on the circuits, showing activity in the 120 kHz and 3 MHz range. This activity significantly lessens with insertion of a single Greenwave filter.

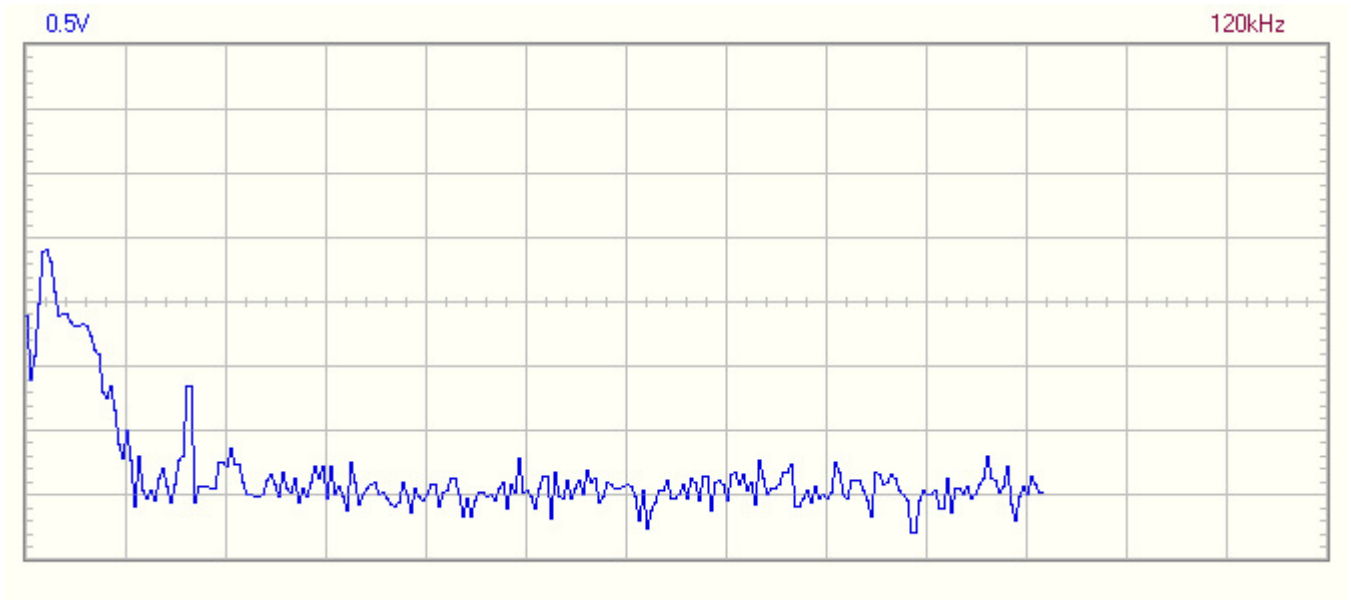
Here is the same analysis with a single Greenwave filter inserted, showing a clearing of the noise at many frequencies:

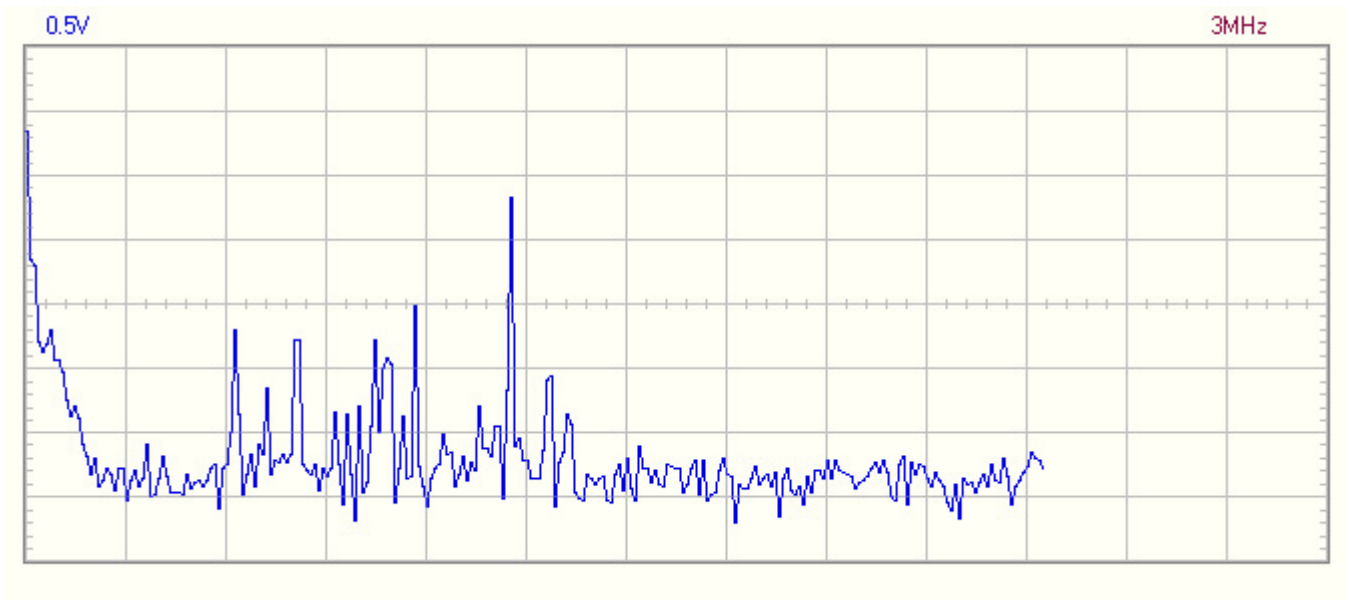
Here is the waveform from 0 to 3MHz without a Greenwave filter (each division is 300kHz wide):

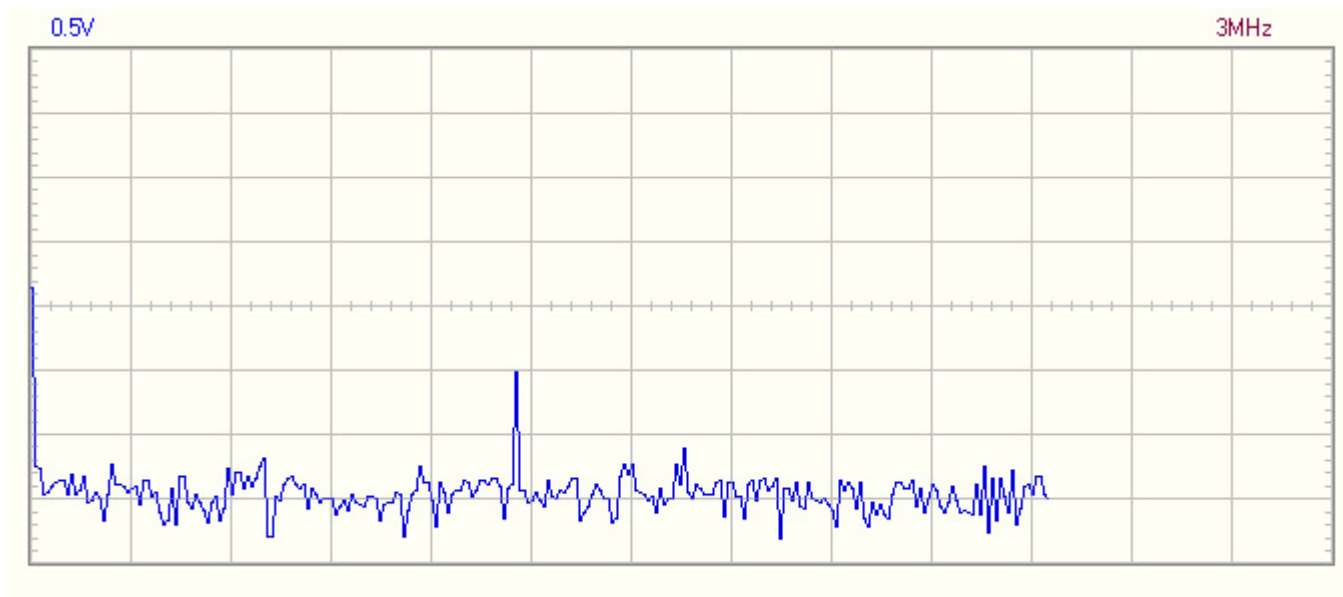
Here is the same analysis with a single Greenwave filter inserted, again showing significant clearing of most noise except for one spike at approximately 1.4MHz:
