# [Study to Determine the Presence of Dirty Electricity from Smart Electric Meters in Southern California](#)

written by Oram Miller | 3 June 2015

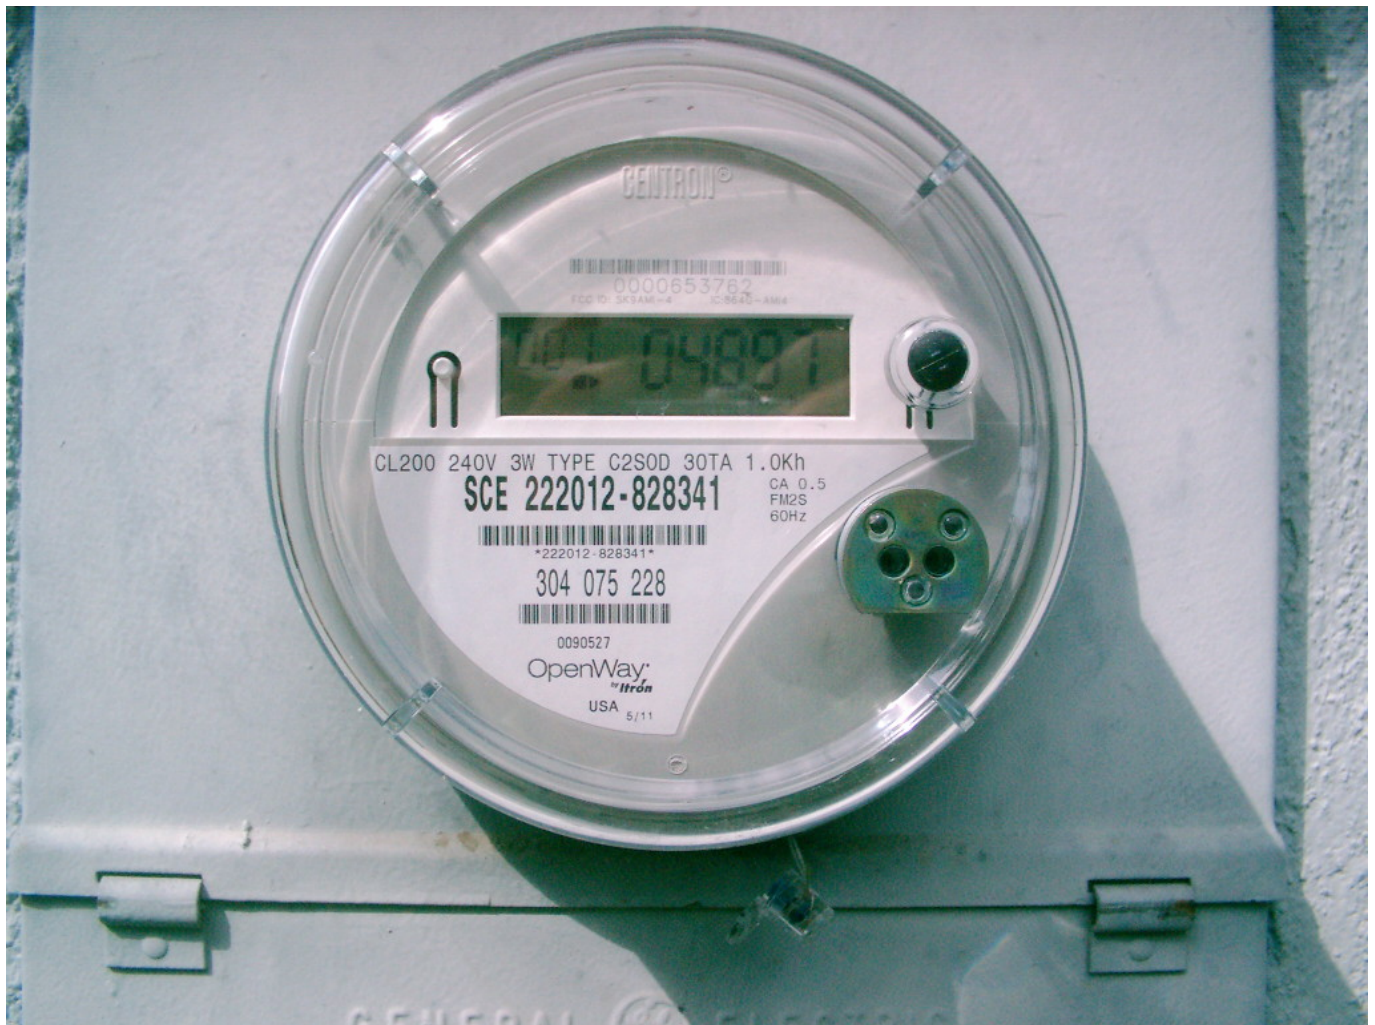
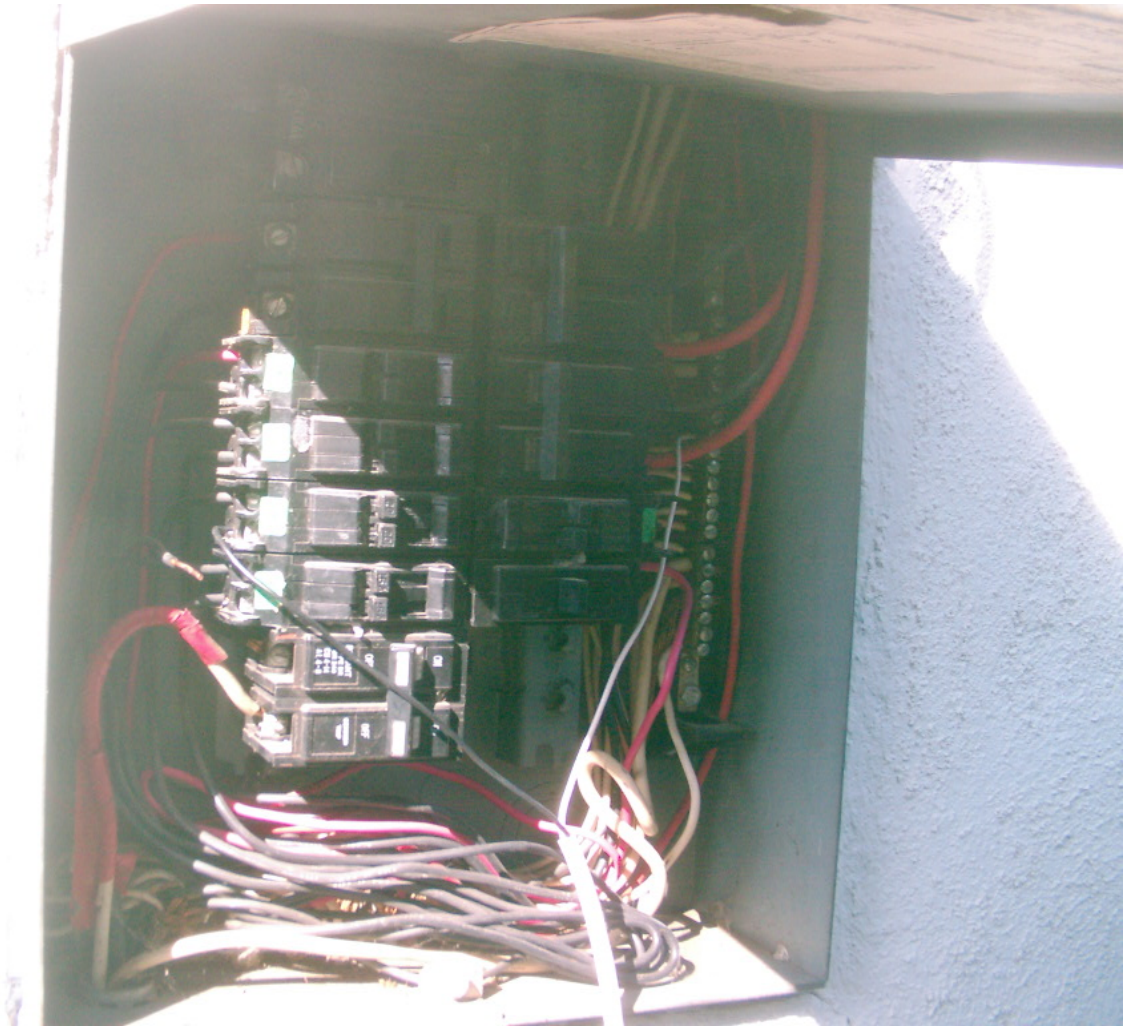
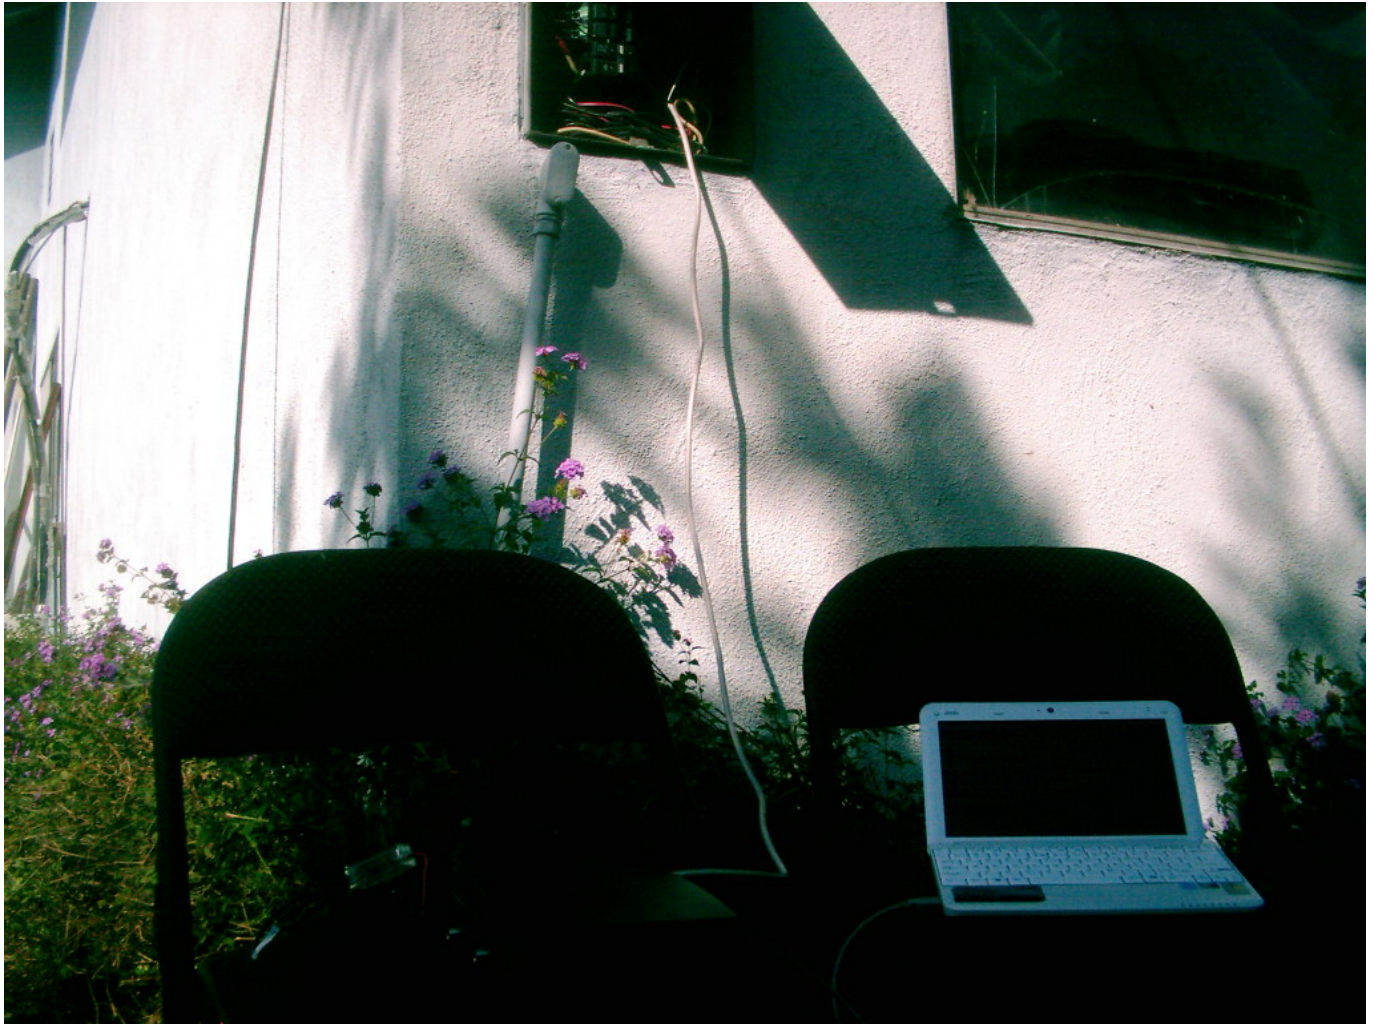
At the home in Tustin, in an effort to rule out artifacts from any other sources, I measured for

voltage harmonics at the breaker panel, shutting off every other circuit in the house. Here are photos of the test on phase A and phase B, with waveform tracings taken on wires coming directly out of the breaker panel, bypassing all circuits in the house:

Neither of these tracings shows any significant voltage harmonics in the path of incoming electric power right after the Itron smart meter.

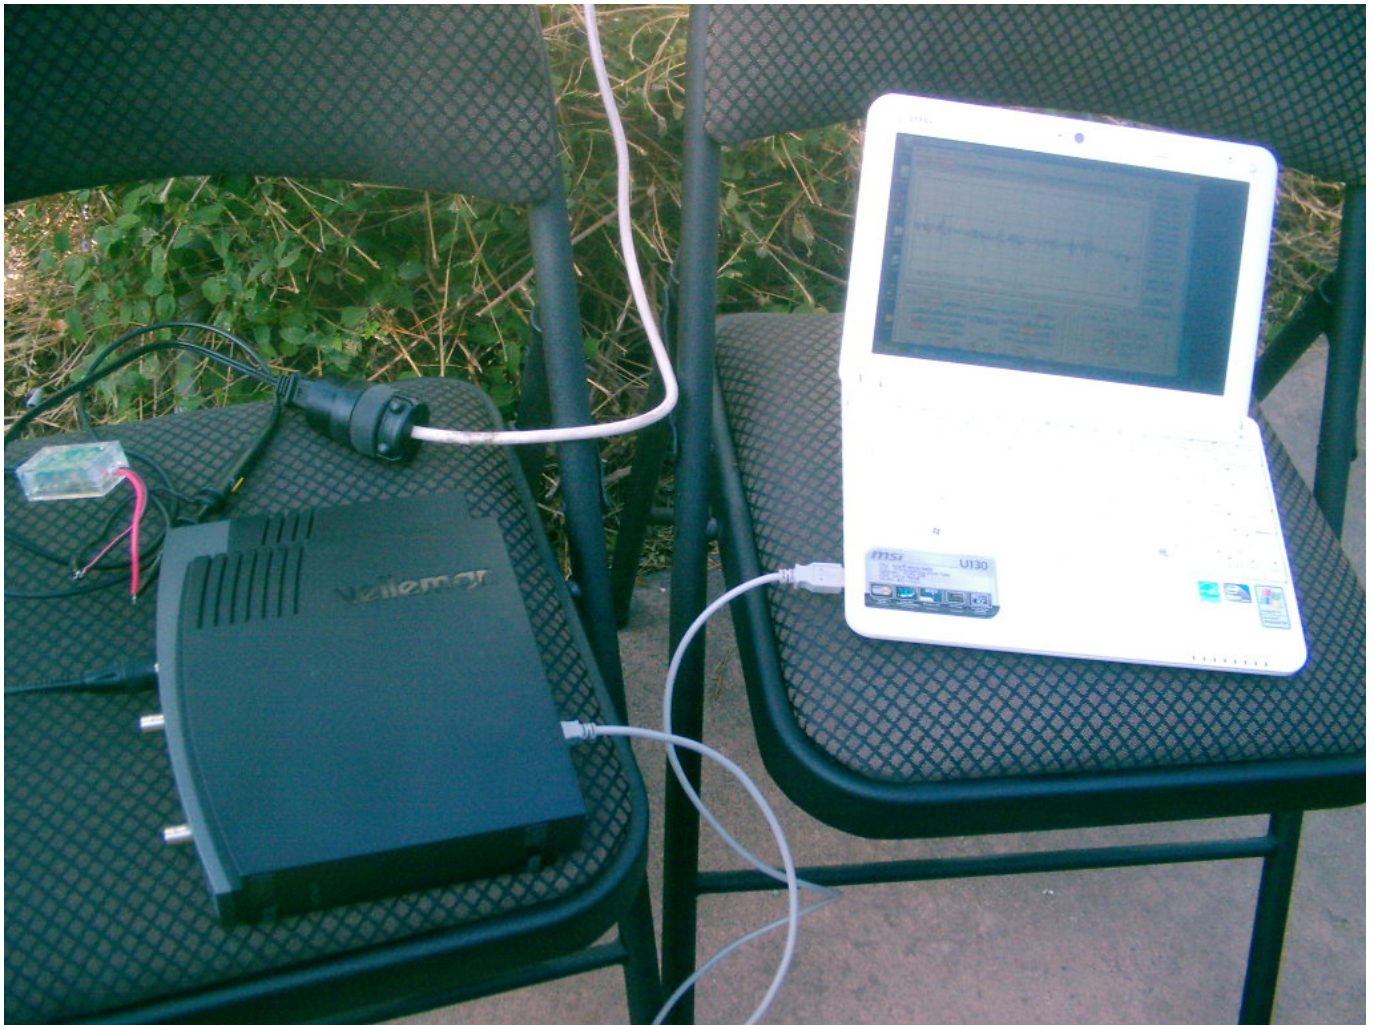
In this last photo, the oscilloscope and Stetzer attenuator are both on the left:

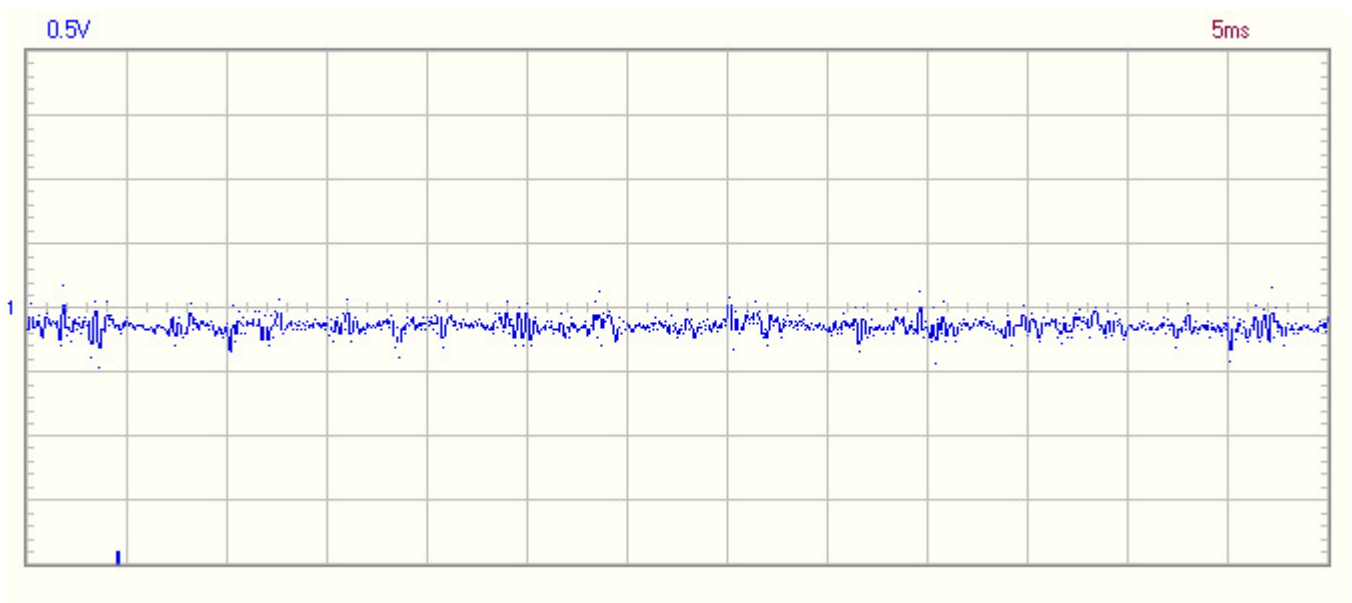
Below are images showing waveform tracings from both phases of the utility service drop measured at the panel. The first is from phase A:

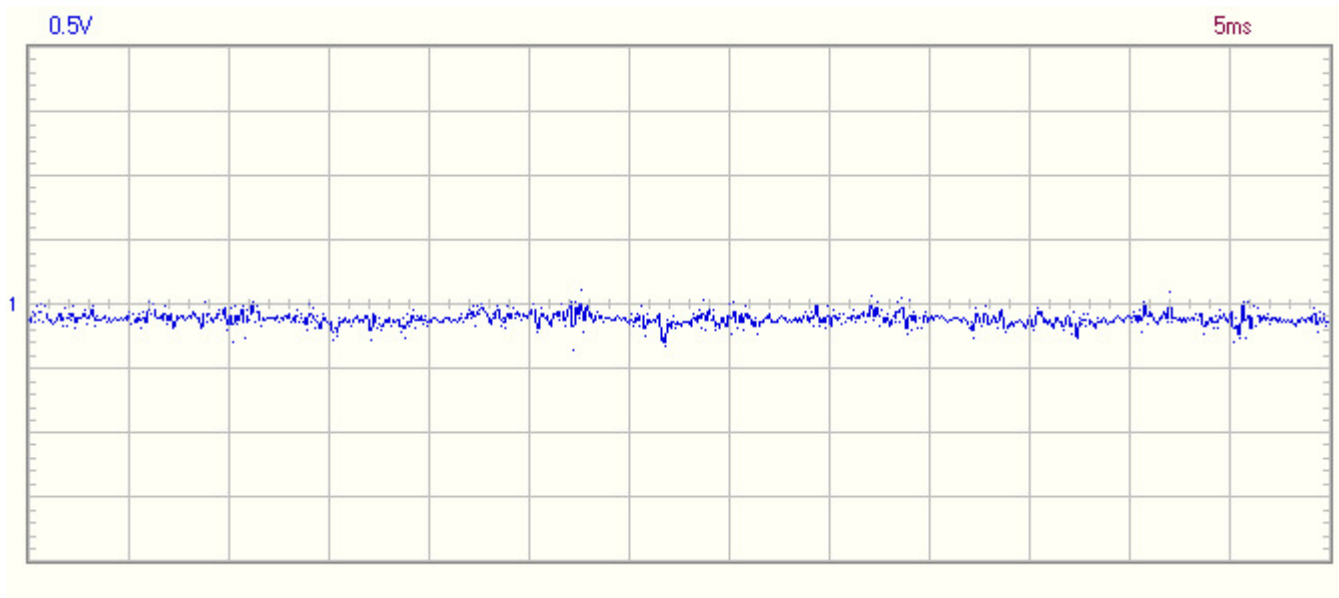
This next tracing is from phase B:

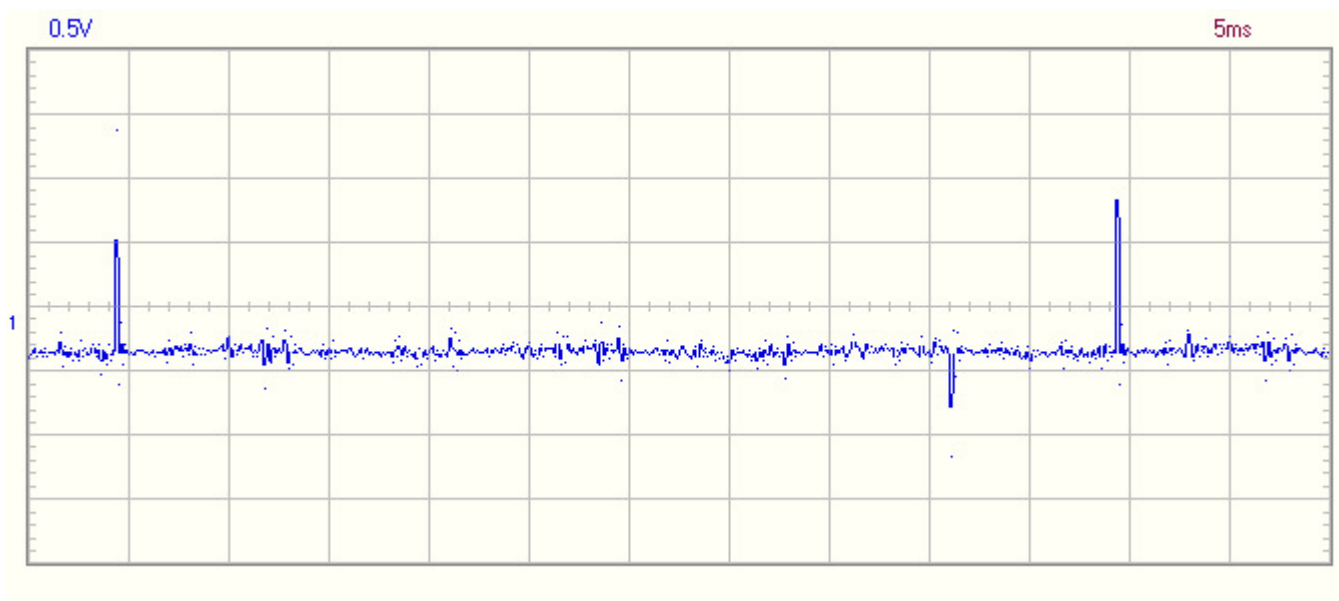
Here is a tracing taken one week earlier at the same home in Tustin on a circuit in the master bedroom, just inside where the smart meter is located, showing large harmonics that were initially thought to be from the Itron smart meter. However, it was later discovered that a touch lamp in another room was plugged into the same circuit and was on at the time of the tracing (each division is 5 milliseconds wide):

These harmonics had a primary frequency of 15.6kHz. The voltage transient was 2.72 Volts in 30 microseconds for a slew of 90,670 Volts/second. This had the same short duration, sharpness and similar frequency as the harmonics reported with the Landis Gyr meters in Northern California. A sample spike looked as follows:

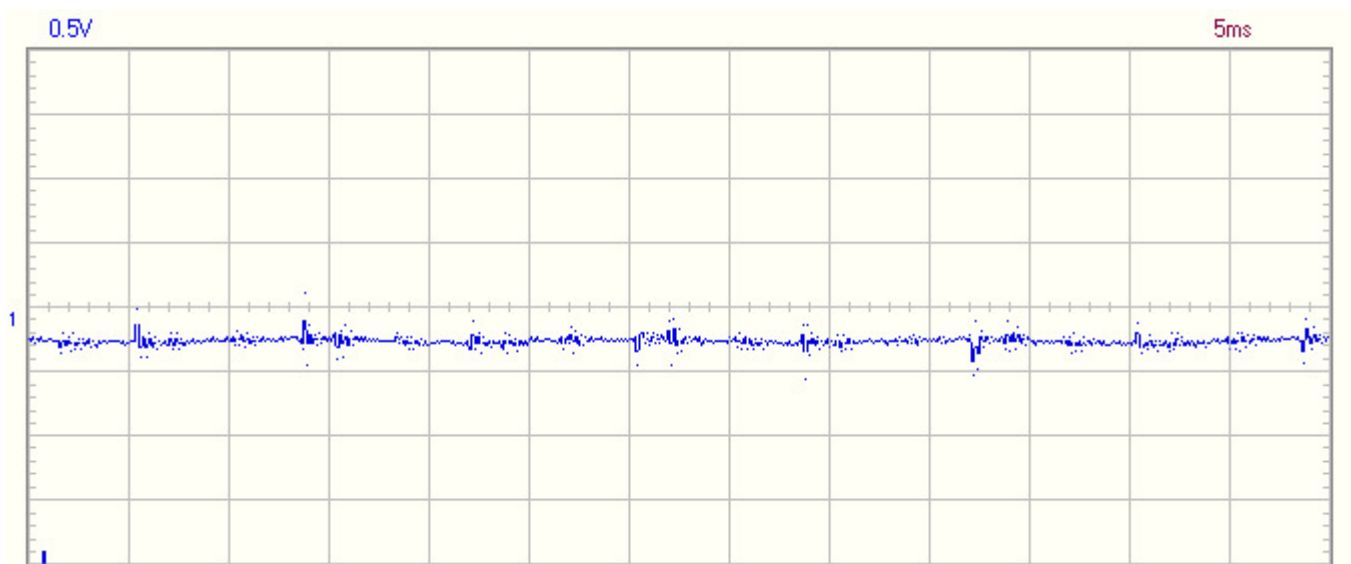
Here is a tracing taken at the same circuit back on May 25th again in the master bedroom, this time with the touch lamp turned off. Compare this to the tracing before the last one, where each division is 5 milliseconds wide and each division is 0.5 Volts high. The large harmonics have disappeared and are therefore not from the Itron smart meter:

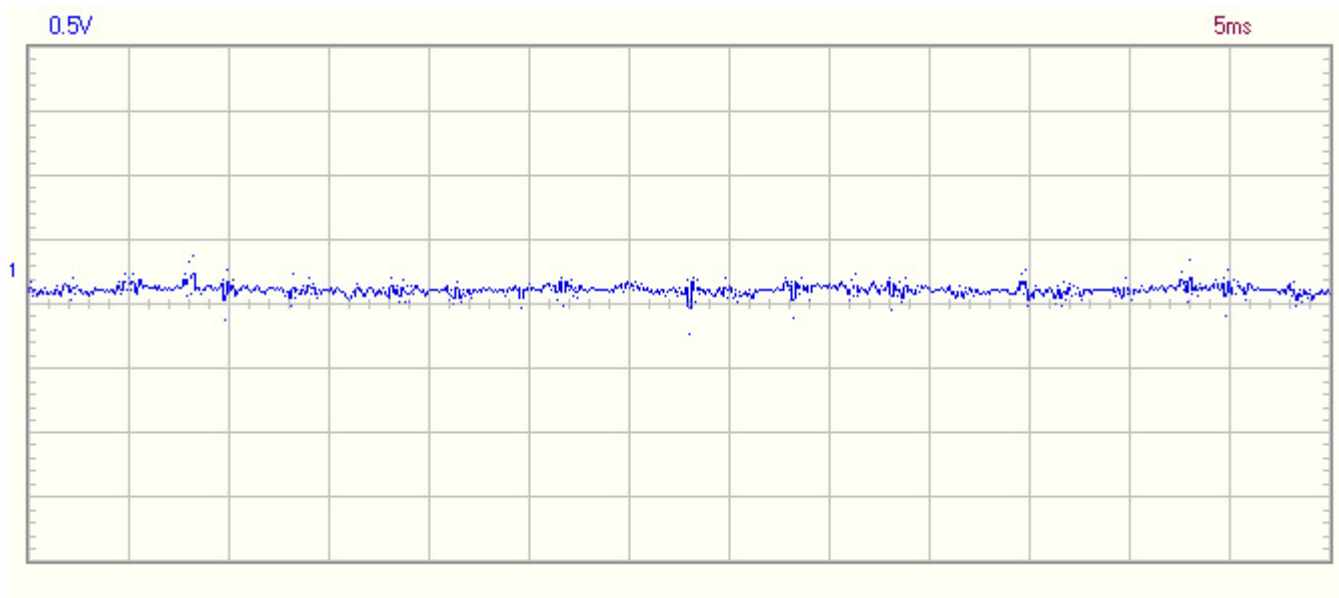
Here is a tracing taken at the same location with the touch lamp turned off but otherwise normal loads on in the house, again showing no harmonics of significance (each division is 5 milliseconds wide):

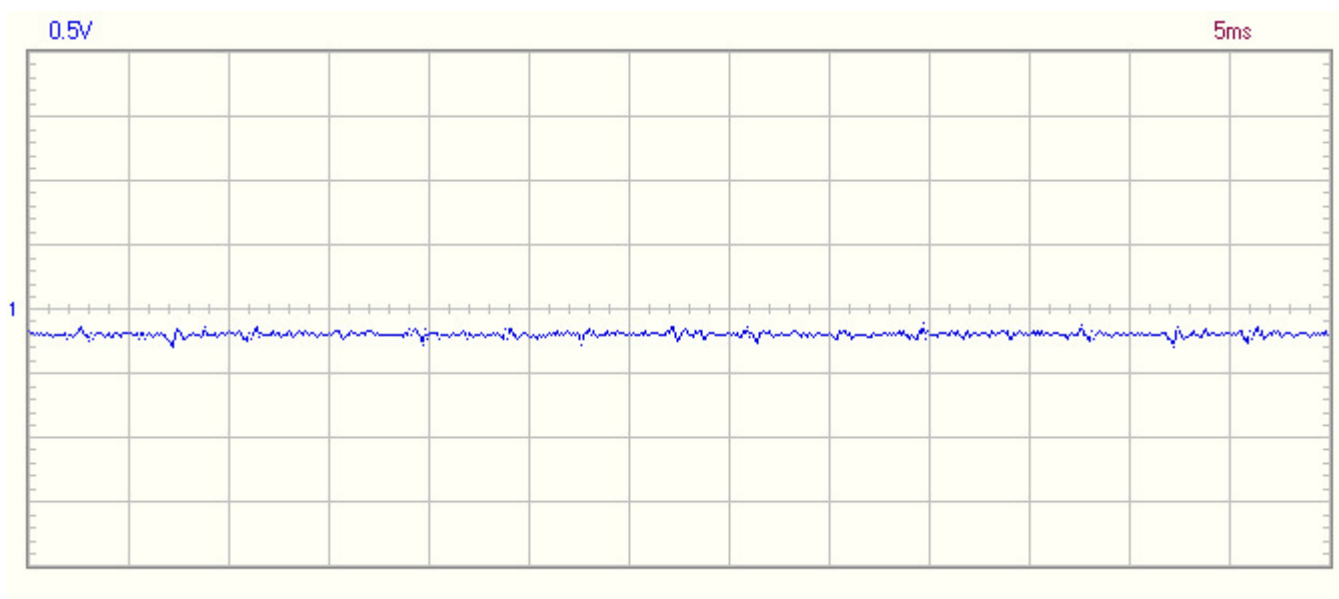
The next tracing was taken on May 29, 2012 at a home in Glendale in the Glendale Water and Power service area with an Itron Openway smart meter. All other circuits were left on. The homeowner is not symptomatic from EMF sources. There are no apparent voltage harmonics similar to those noted in Northern California (each division is 5 milliseconds wide):

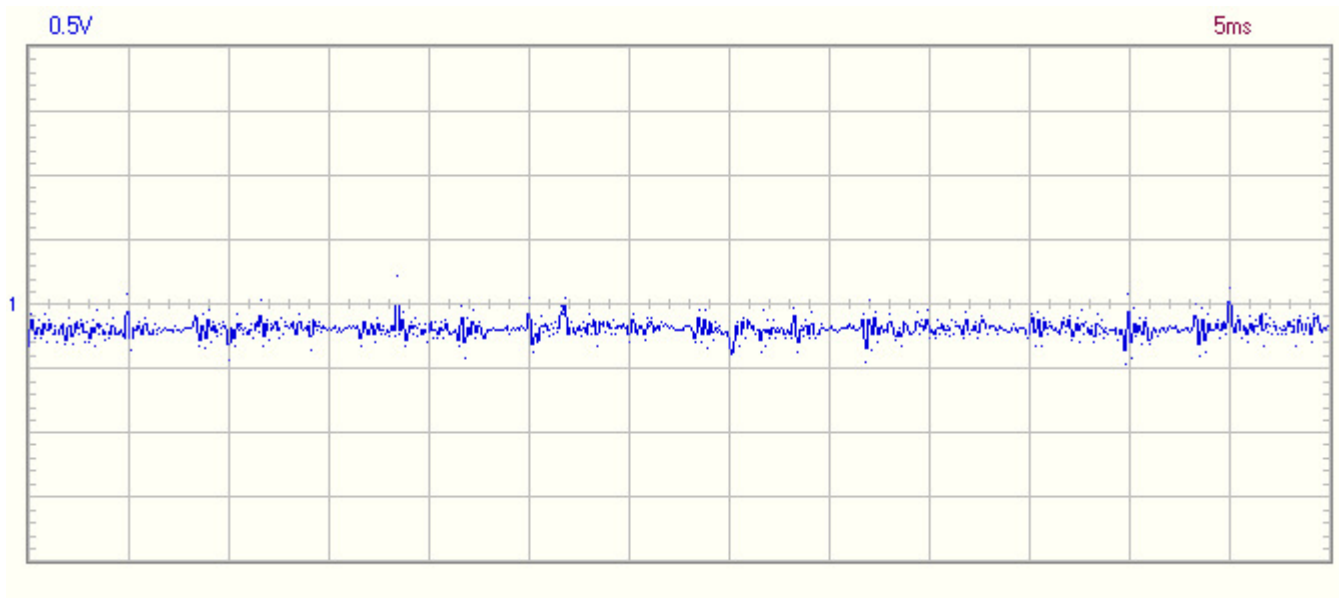
The next tracing was taken on May 22, 2012 at another home in Glendale in the Glendale Water and Power service area with an Itron Openway smart meter. All other circuits were left on. The homeowner is not symptomatic from EMF sources. Again, there are no apparent voltage harmonics similar to those noted in Northern California (each division is 5 milliseconds wide):

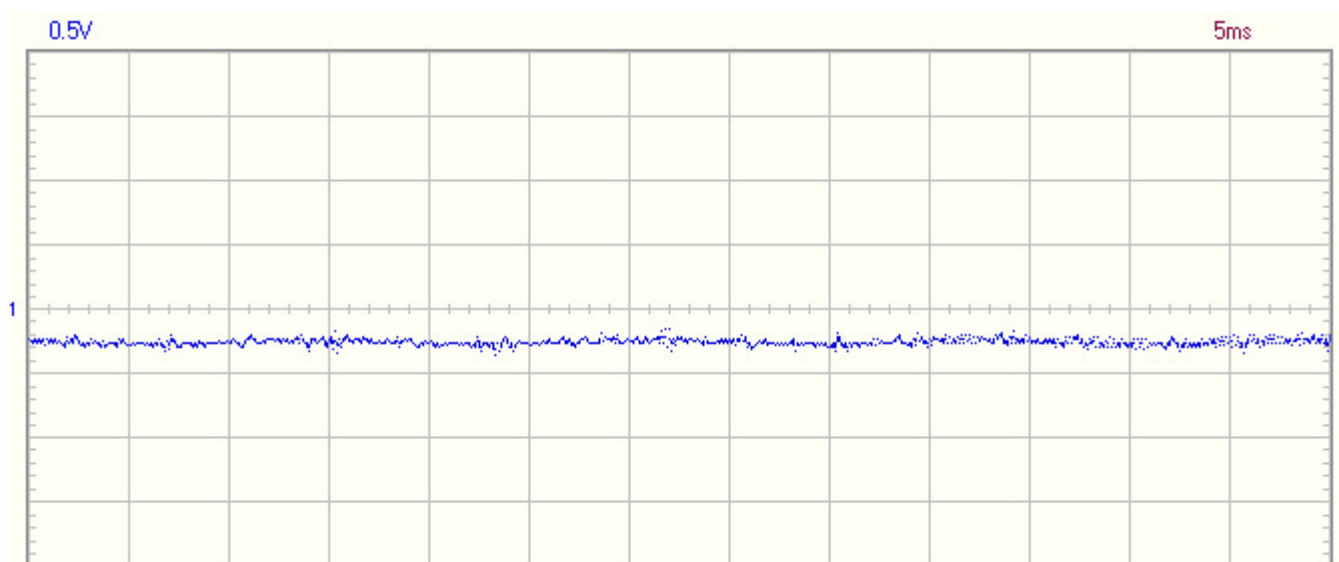
The next tracing was taken on May 29, 2012 at a third home in Glendale in the Glendale Water and Power service area with an Itron Openway smart meter. All other circuits were left on. The homeowner is not symptomatic from EMF sources. Again, there are no apparent voltage harmonics similar to those noted in Northern California (each division is 5 milliseconds wide):

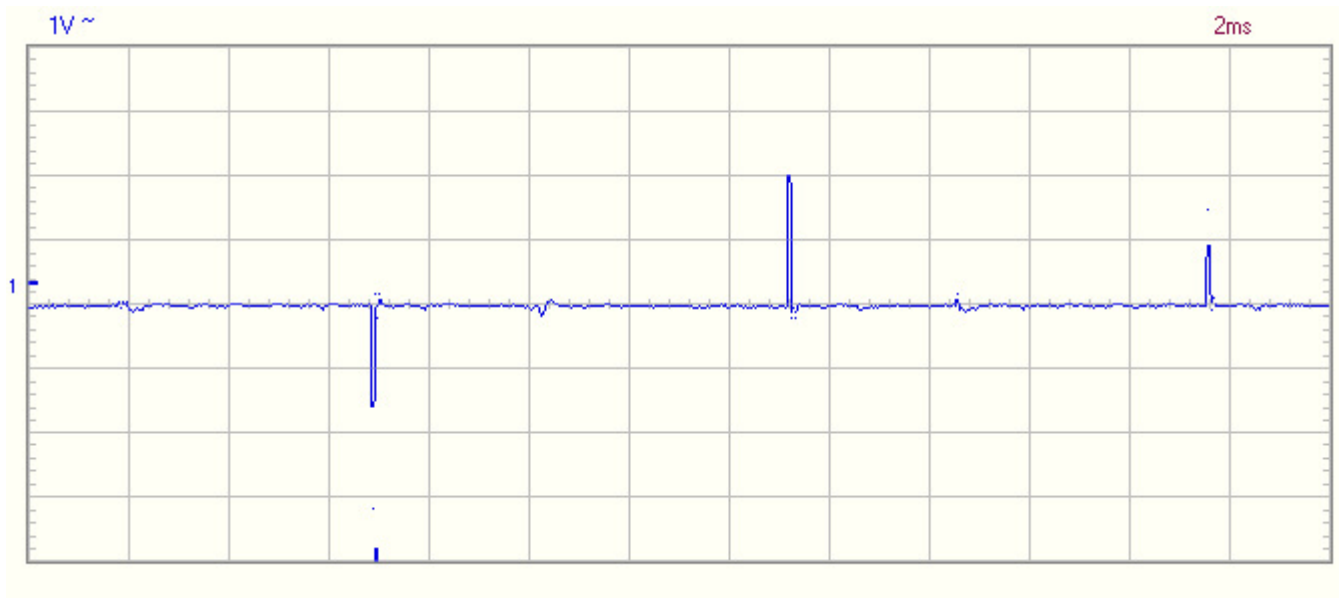
The next tracing was taken on May 17, 2012 at a home in Burbank in the Burbank Water and Power service area with a GE / Trilliant smart meter. All other circuits were left on. The homeowner is not symptomatic from EMF sources. Notice the voltage harmonics, as high as roughly 2 Volts, that I first thought were possibly produced by the Trilliant smart meter. What I did not know until the following week was that a dimmer switch was on in an adjacent room (each division is 2 milliseconds wide):

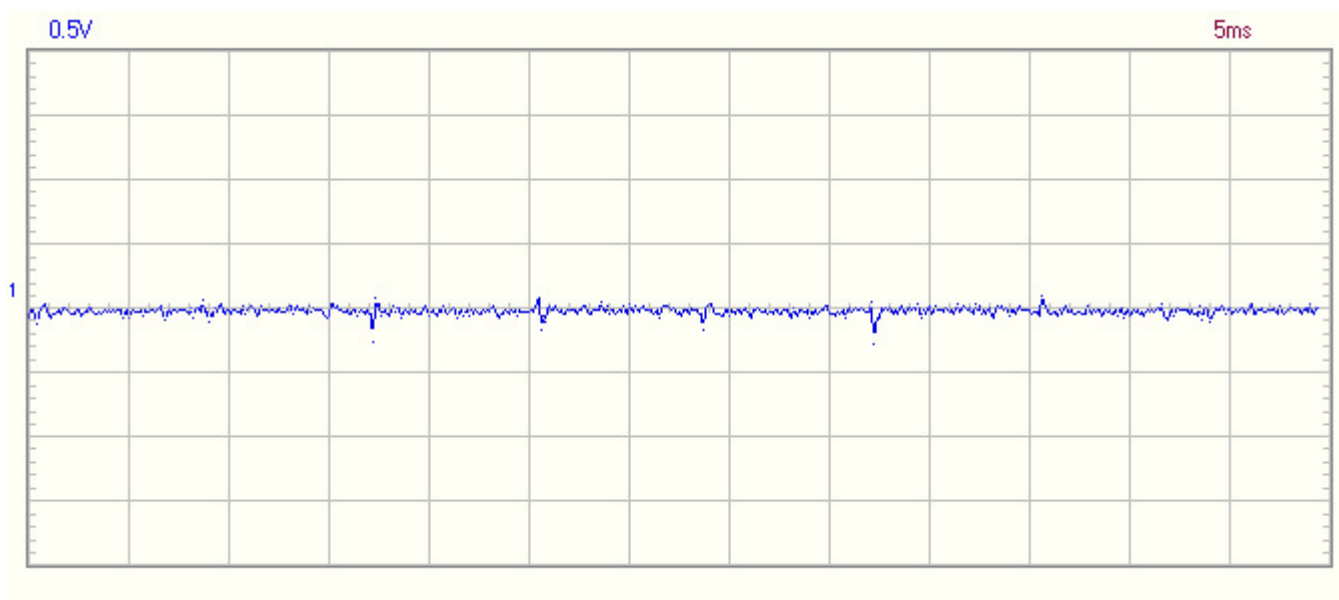
The next tracing was taken the following week at the same home in Burbank when I returned and discovered the dimmer switch. This tracing shows the disappearance of the voltage harmonics with the dimmer switch turned off (each division is 5 milliseconds wide):

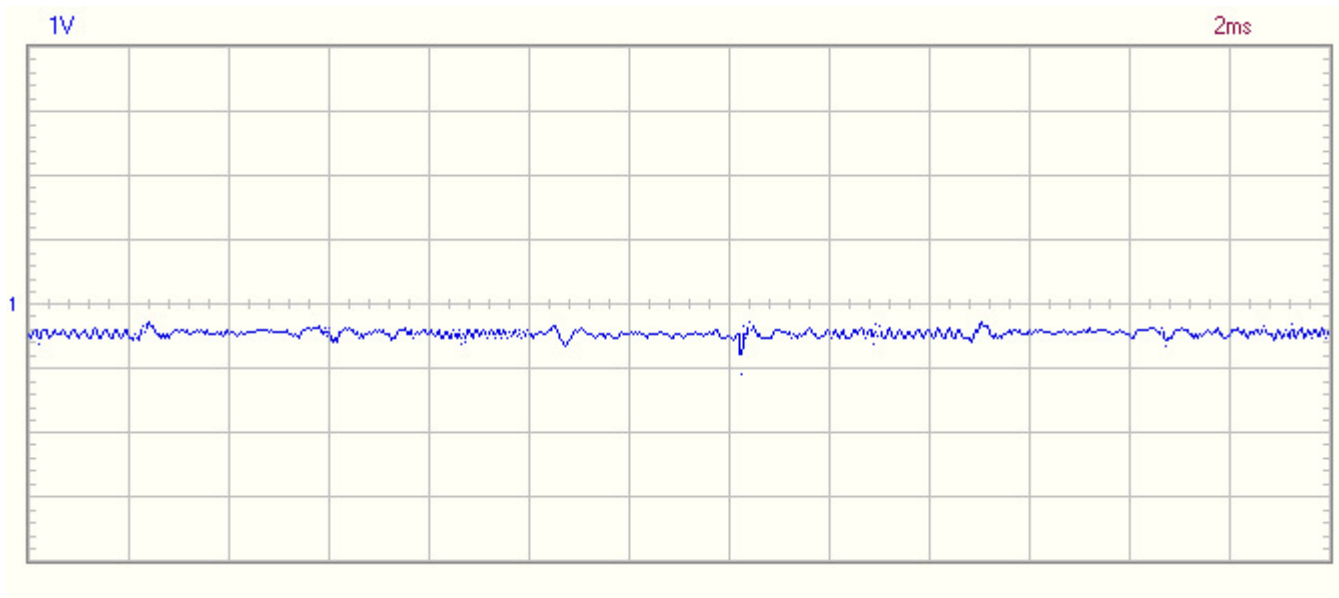
The next tracing was taken on May 17, 2012 at a second home in Burbank in the Burbank Water and Power service area with a Trilliant smart meter. All other circuits were left on. The homeowner is not symptomatic from EMF sources (each division is 2 milliseconds wide):

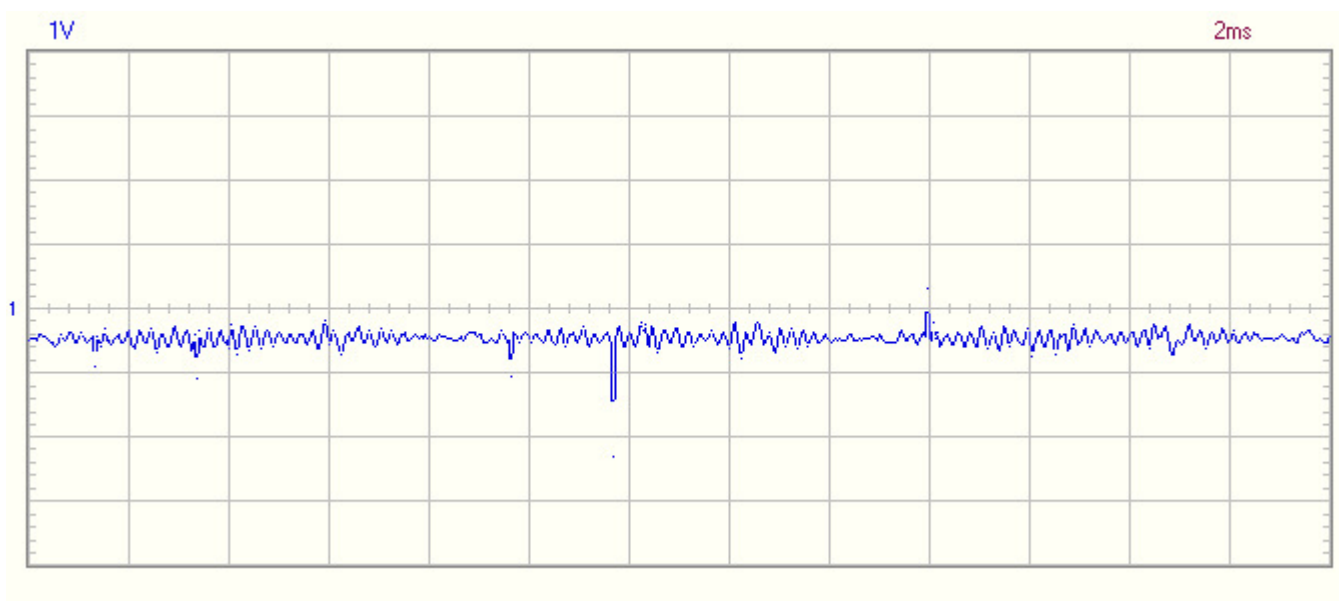
The second tracing was taken on May 17, 2012 at the same home in Burbank, however on a different circuit than the first one shown above. All other circuits were left on. You will notice the presence of one spike of roughly 1.6 Volts in height, however, it does not appear at the regular periodicity (once every 120 Hz) you would expect from a switched mode power supply. Also, at this house, I did not have the time to shut off circuits or fluorescent lights, or unplug appliances to try to isolate this effect:
