# [Spectrum Analysis and Oscilloscope Tracings of Harmonics from Photovoltaic \(PV\) Grid-Tied Inverters](#)

written by Oram Miller | 31 August 2014

## **Introduction**

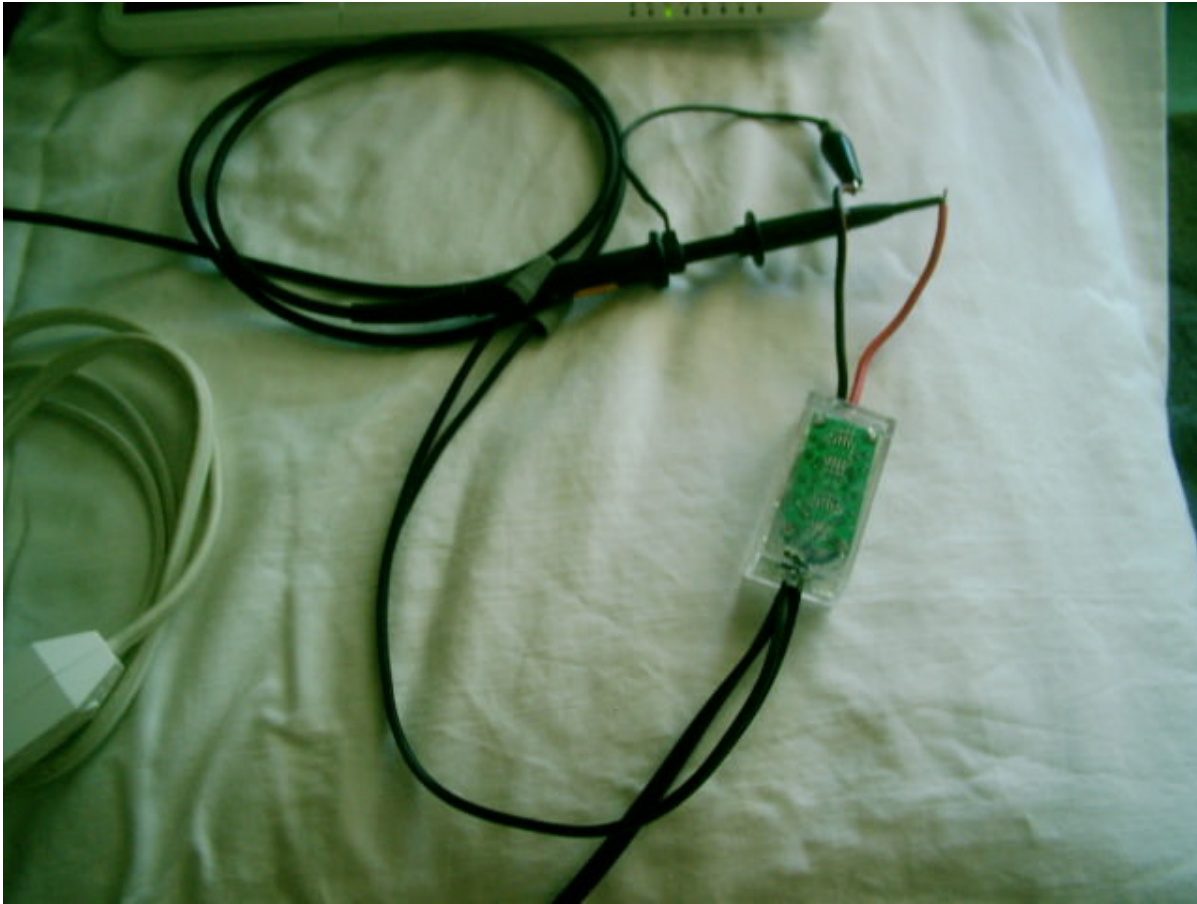
The tracings on the pages below are a spectrum analysis and oscilloscope tracings of a circuit close to the main breaker panel and inverter in each house. I used an attenuator plugged into an outlet, provided for \$50 by Stetzer Electric:

This allowed me to tap directly into an outlet without damaging the O-scope, which can only handle a maximum of 30 Volts input. The attenuator removed 60 Hz frequencies on the oscilloscope, allowing frequencies below and above 60 Hz to be shown on the tracing (however a whip antenna on a separate channel showed the typical 60 Hz sine wave configuration). The attenuator also reduced the input voltage to less than 1 Volt.

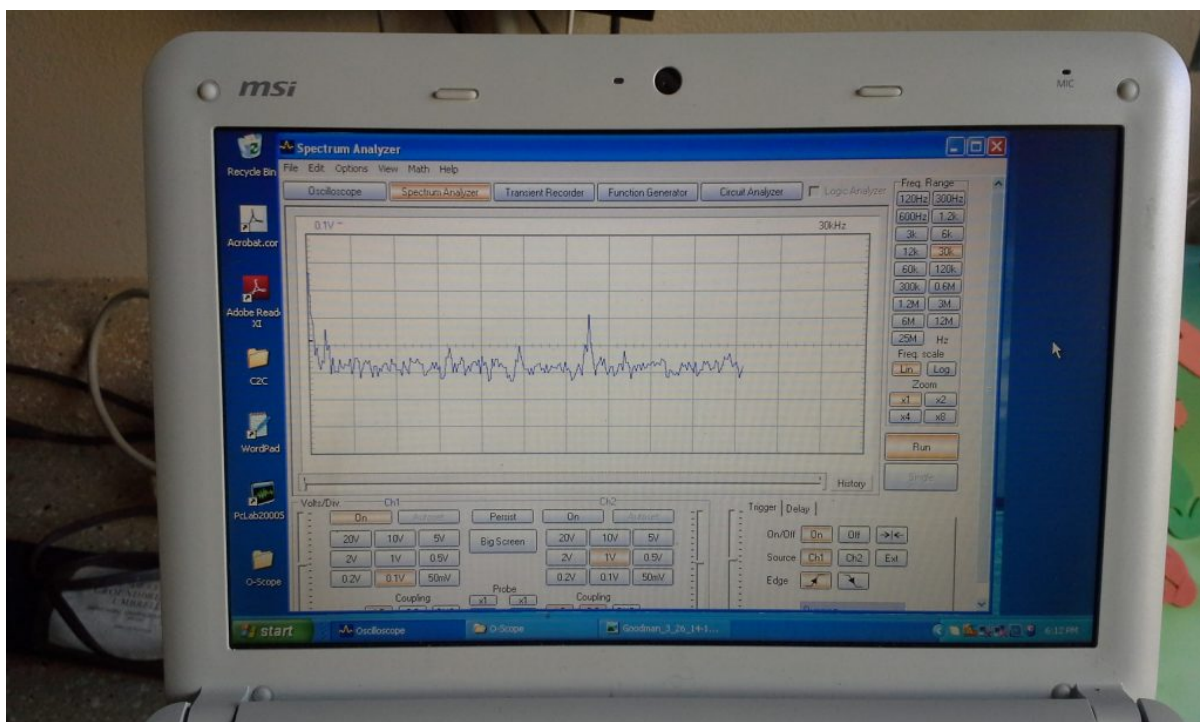
I used a [Velleman PCSU1000 Two-channel USB PC Oscilloscope](#) connected to a PC notebook for the display. The laptop was powered by its internal battery, not the inline transformer.

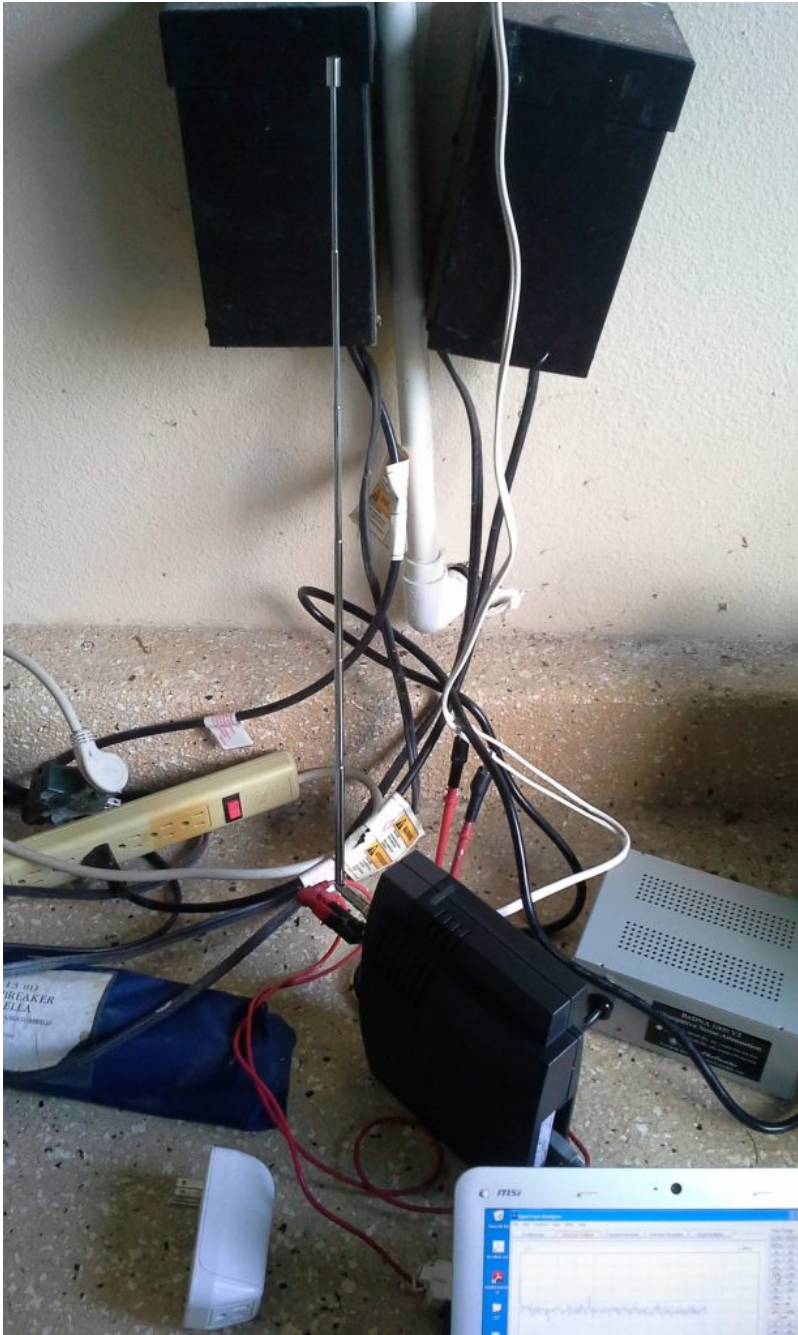
All tracings using a spectrum analyzer below show levels of DE measured in milliVolts (mV), on the vertical axis, relative to frequency, along the horizontal axis.

The frequency shown in the upper right corner of the image is the maximum value of the range being shown. For instance, the number 120 kHz is displayed in this case. That means the tracing shows all activity being measured on the circuit from 0 Hz on the left, to 120 kHz at the right end of the tracing on the display:

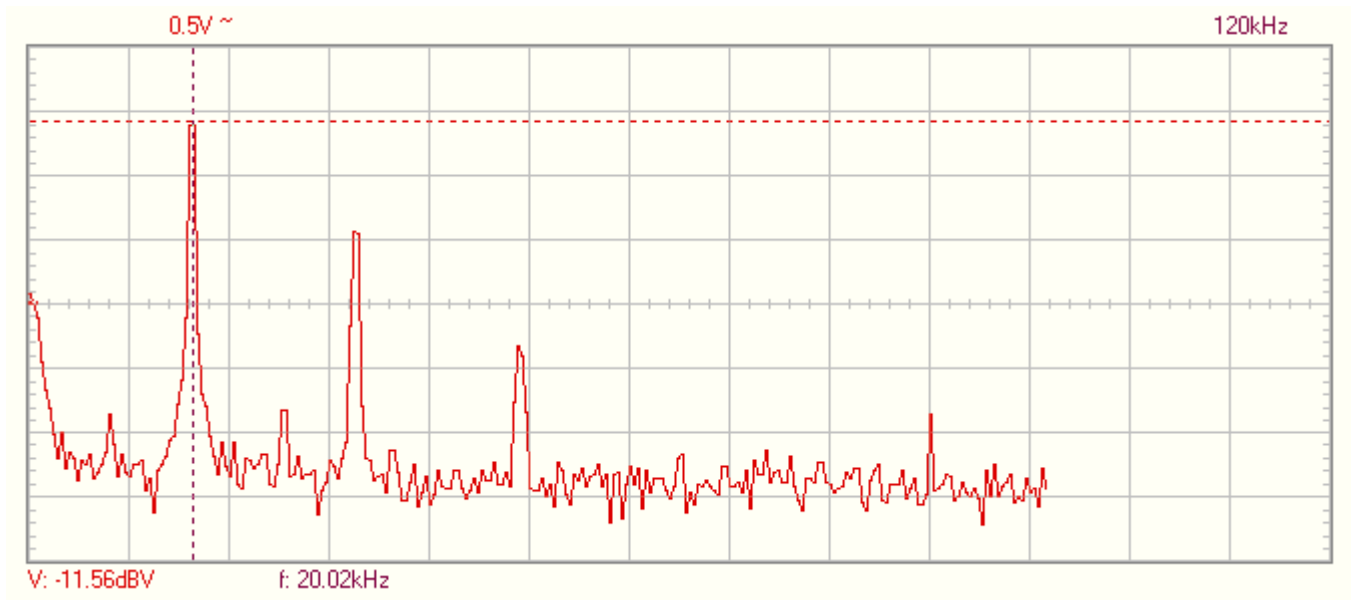
There are ten divisions along the horizontal axis from left to right, meaning each division measures 1/10th of the total range. Thus in this case, each division would display 12 kHz increments as you move from left to right.

You can thereby determine the frequency of any spike by counting the divisions from the left and multiplying that number by the frequencies per division. A spike of 20 kHz, which is the first large spike on the tracing above, would therefore be located just less than two divisions from the left margin in the case of a 0-120kHz range (1.7 divisions X 12 kHz per division), and just under four divisions in the 0-60 kHz range (as shown in a tracing below).

Using markers on the display, you can also determine the frequency by looking at the number that appears along the bottom of the tracing for the location that the dotted line is placed upon. In the tracing above, notice that the vertical marker is lined up with the first large spike on the left, corresponding with a frequency reading of 20.02 kHz displayed at the bottom of the tracing.

This first large spike is the fundamental frequency of a source of dirty electricity, which in this case, is the photovoltaic inverter. If you then count the divisions, you can see harmonics at the expected frequencies (multiples of the fundamental frequency), but with lower voltages (heights). These are at 40 kHz, 60 kHz, and so on.

The vertical axis, along the left margin of each tracing, shows the strength of each spike measured in Volts (V). The number at the top left shows the number of Volts per vertical division, which in all cases is 0.5V, or one-half of one Volt.

When I lined the vertical marker with the top of the first (fundamental frequency) spike, you see the strength or height of that spike recorded at the lower left margin in decibel Volts (dBV), which is -11.56 dBVolts in this case.

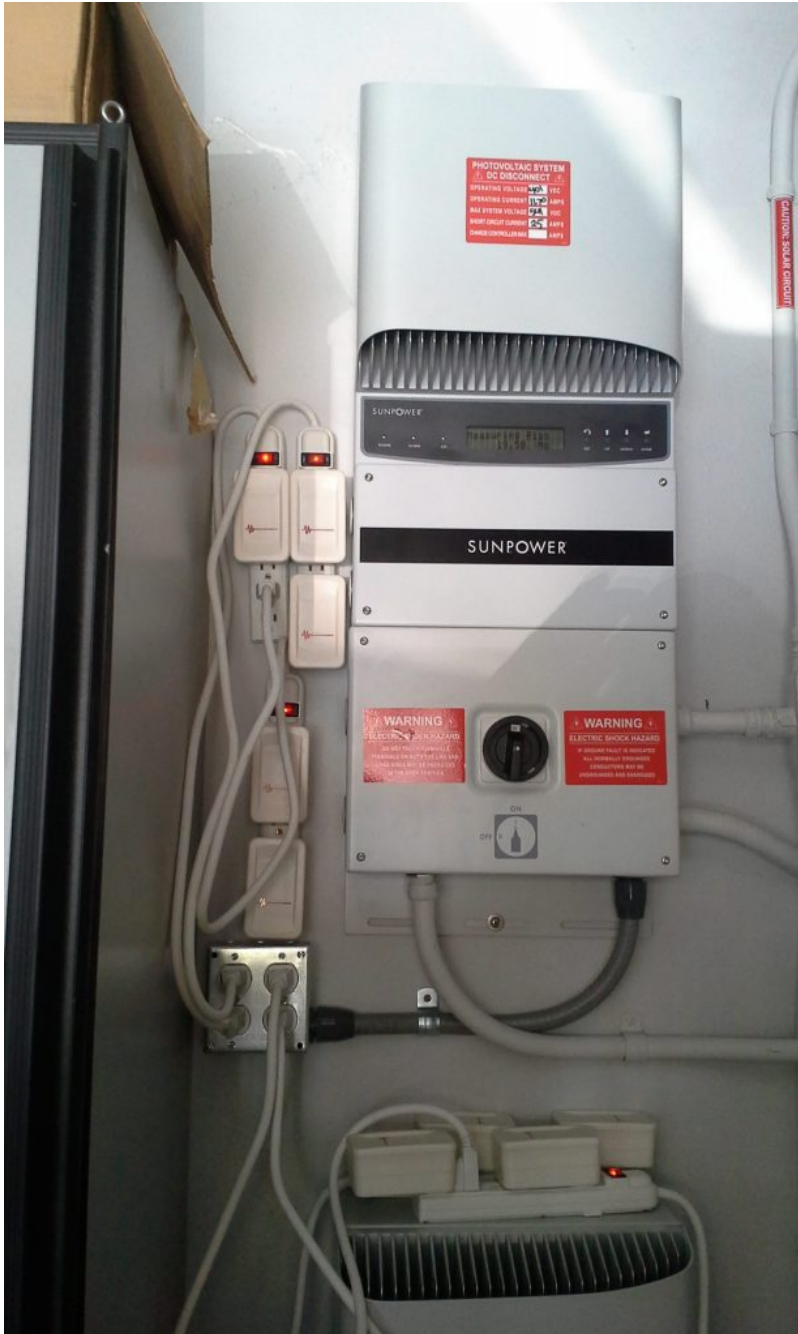
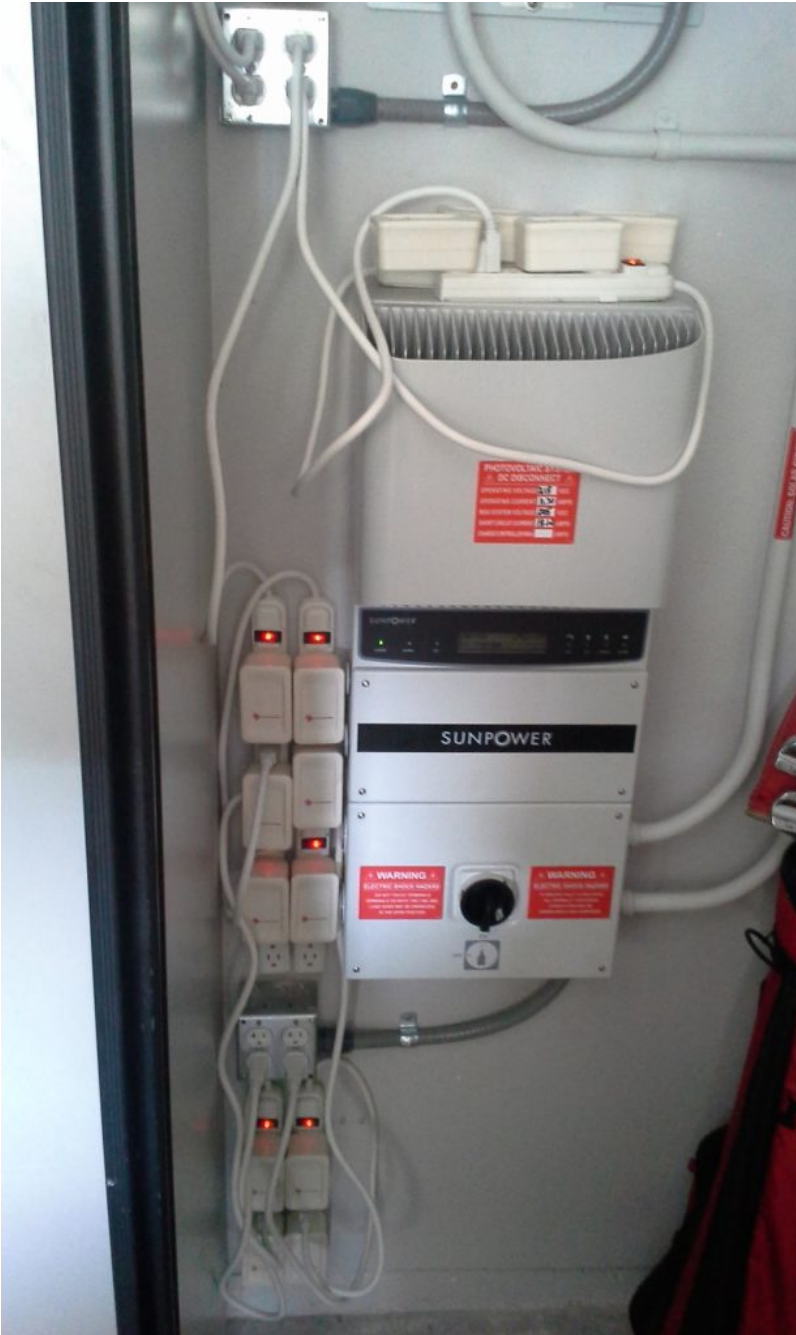
The first home was measured on 4/17/14. It has two Sunpower brand grid-tied inverters, mounted one above the other in the garage (and, yes, those are numerous Stetzer filters plugged in all around these inverters, in the homeowner's attempts to reduce the DE that bothers him to a great extent):

Stetzer microsurge meter readings with the inverters switched on were 1050 to 1350 Graham-Stetzer Units (GSU). With all the Stetzer filters plugged in that you see in the photos above, the reading dropped to 180-240 GSU.

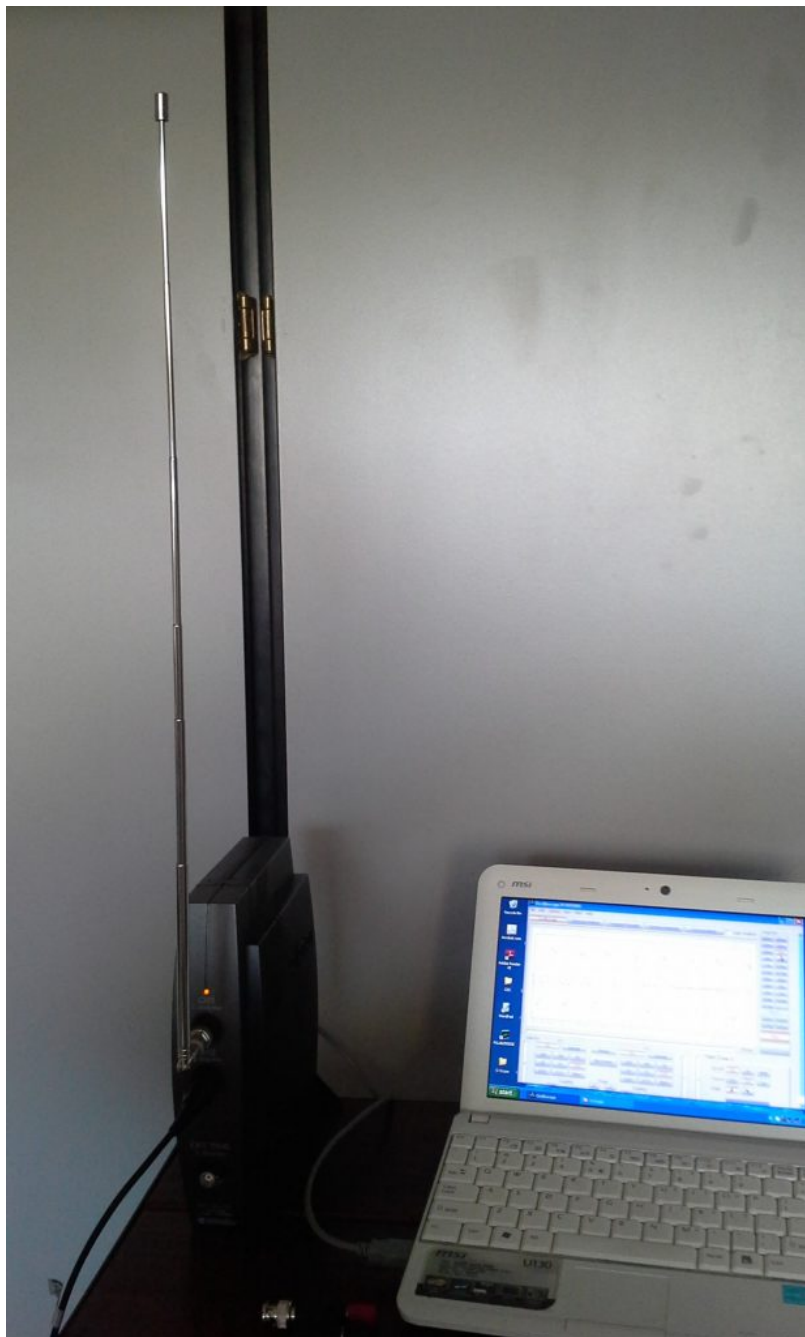
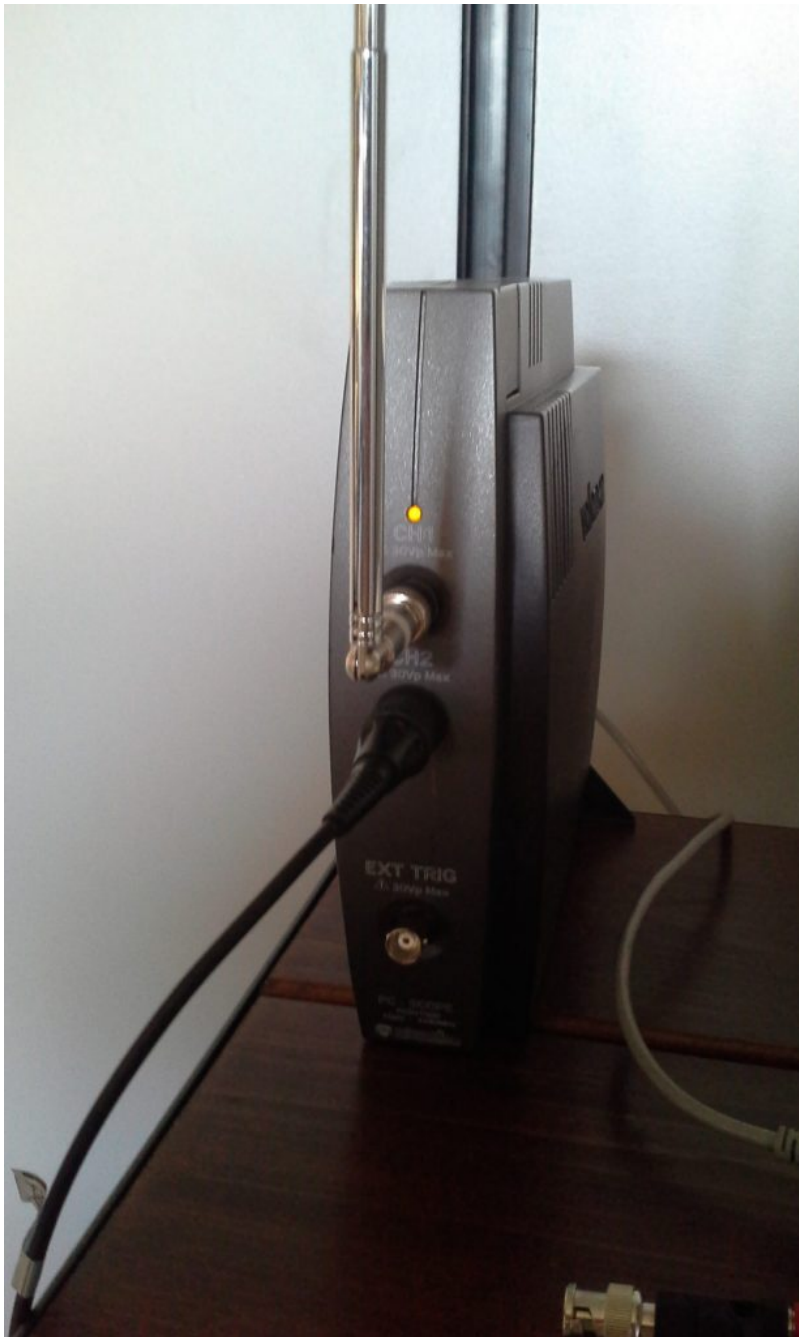
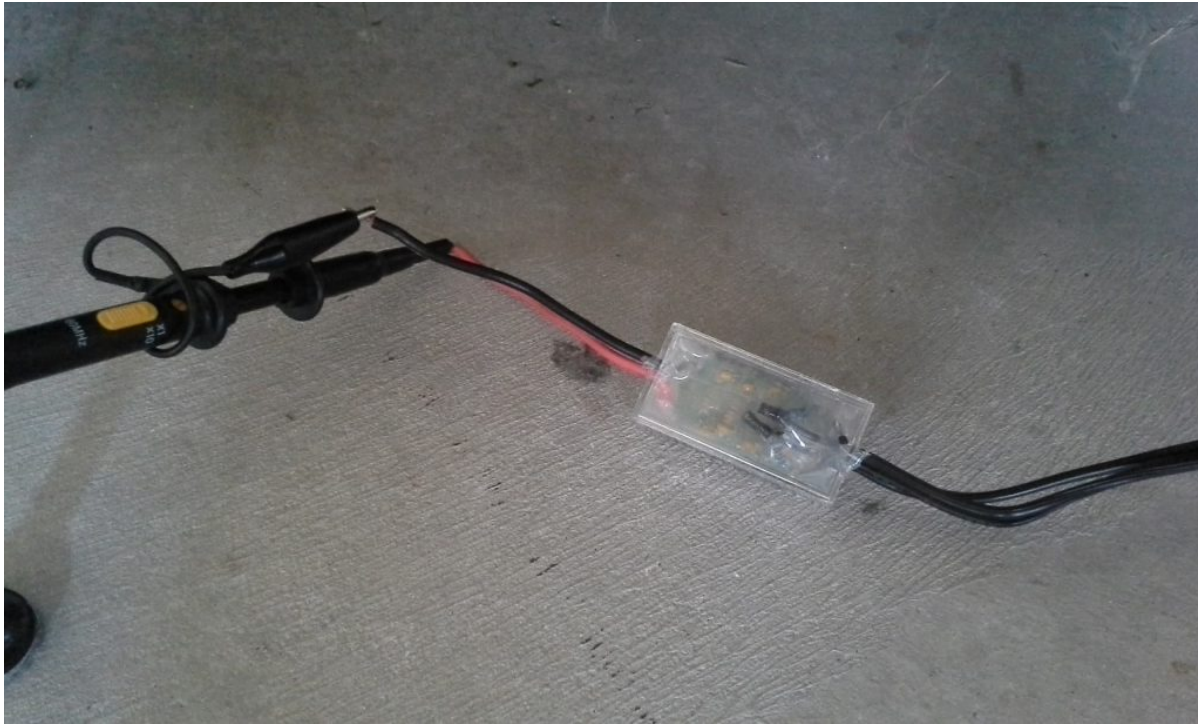
Here are photos of the oscilloscope set up. In the first photo, you see the Velleman scope with a whip antenna connected to channel A, while a wired lead from the circuit is connected to channel B. A close-up is shown in the second photo:

The wired lead is connected to the two wires of the Stetzer attenuator, which is plugged into an outlet:

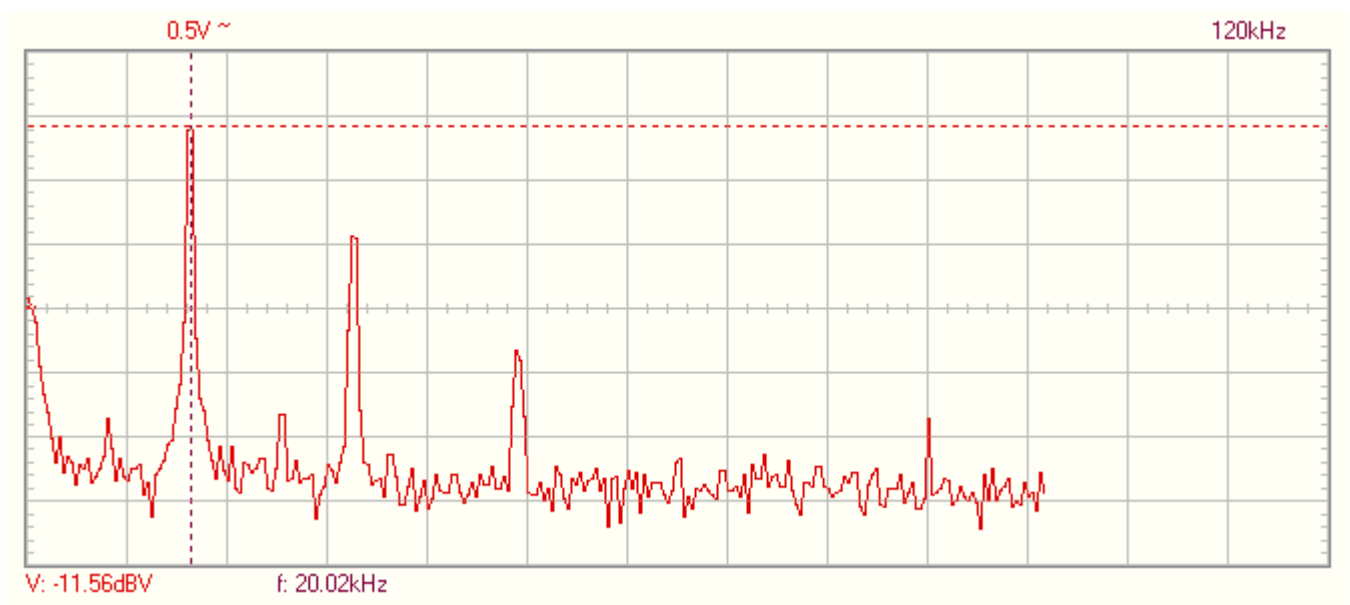
In the first tracing below, you see a fundamental frequency at 20 kHz with a height of -11.56 dB. You can count the height of the spike above the baseline by noting that each vertical division is 0.5 Volts and the peak is roughly 5.5 divisions above the baseline. Thus 0.5 Volts/division X 5.5 divisions correlates with roughly 2.75 Volts of height, equal to -11.56 dBV.

Notice also the harmonics at 40 kHz and 60 kHz to the right, each one with diminishing intensity or strength (height):

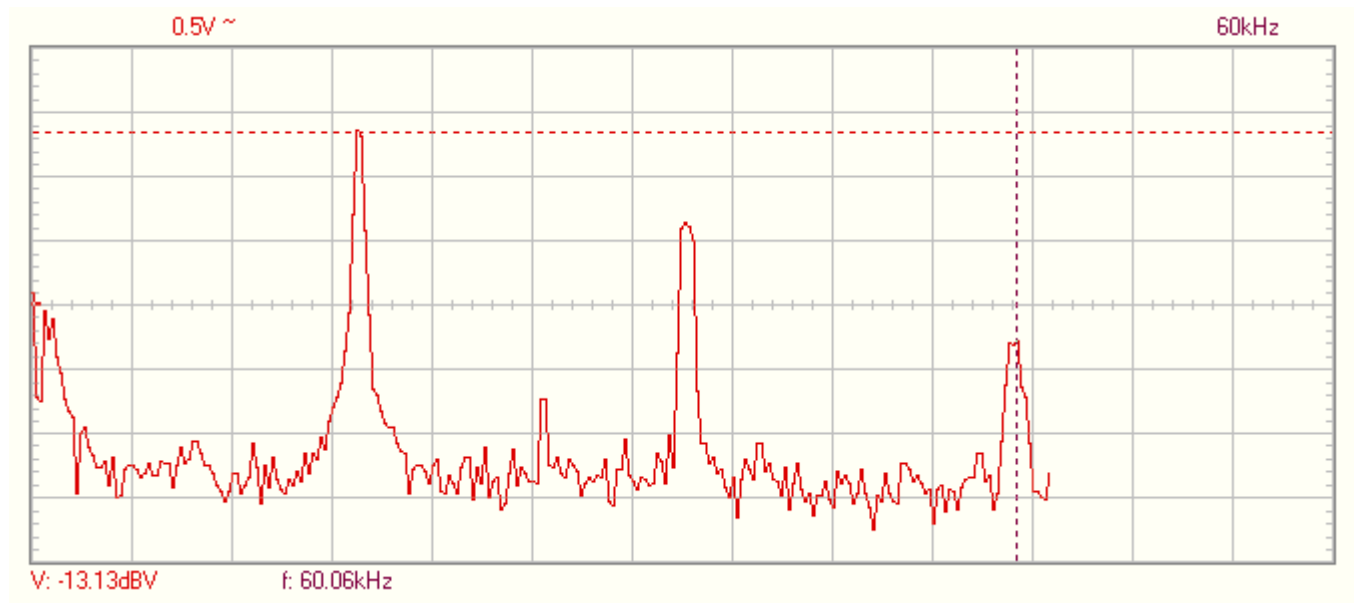
Below you will see the reading at closer range (0-60 kHz), meaning the range from left to right is from 0 to 60 kHz rather than from 0 to 120 kHz, and each division measures 6 kHz in width instead of 12 kHz.

I happen to have placed the marker over the third harmonic, which registers at the bottom as

60kHz. The height of the fundamental frequency on the left at 20 kHz is roughly the same as in the tracing above (-13.1 dBV vs. -11.6 dBV):

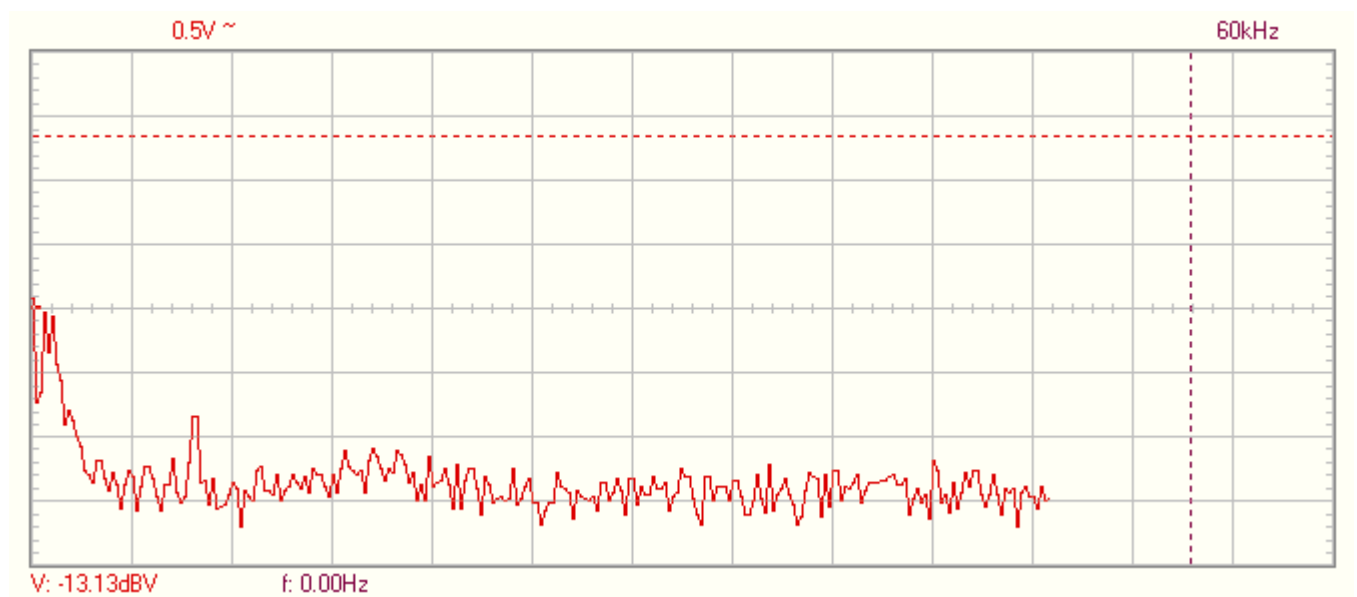
Now I show you a tracing at the same range of 0-60 kHz but with the PV system inverter turned off. Notice that the fundamental frequency and its harmonics are completely gone:

When the inverters were switched off and Stetzer filters were also switched off, the DE reading dropped to only 63 GSU. That is the baseline dirty electricity level at this house.

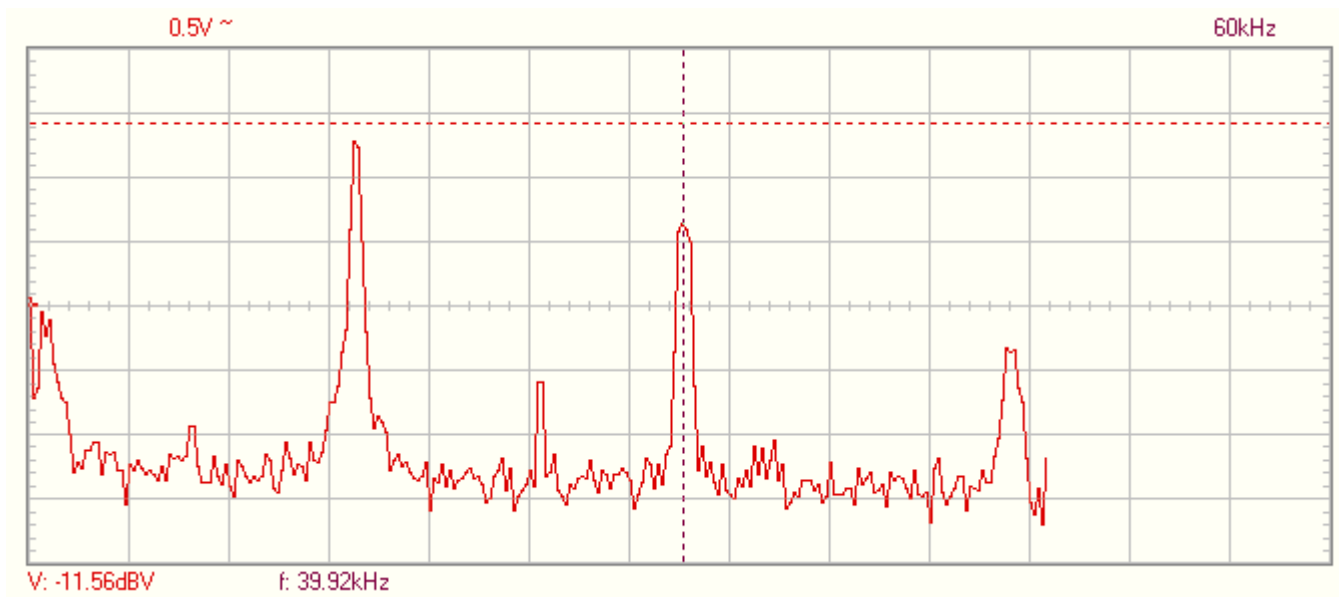
Next is a depiction of the reduction of DE with the inverter on but with all the Stetzer filters shown in the photos above in place. I first show a tracing with the surge protectors into which the Stetzer filters are plugged switched off, as a baseline. Notice, again, the height of the fundamental frequency (at 20 kHz) is -13.13 dBV, shown in the lower left margin (5.5 divisions above the baseline, corresponding to 2.75 V high):

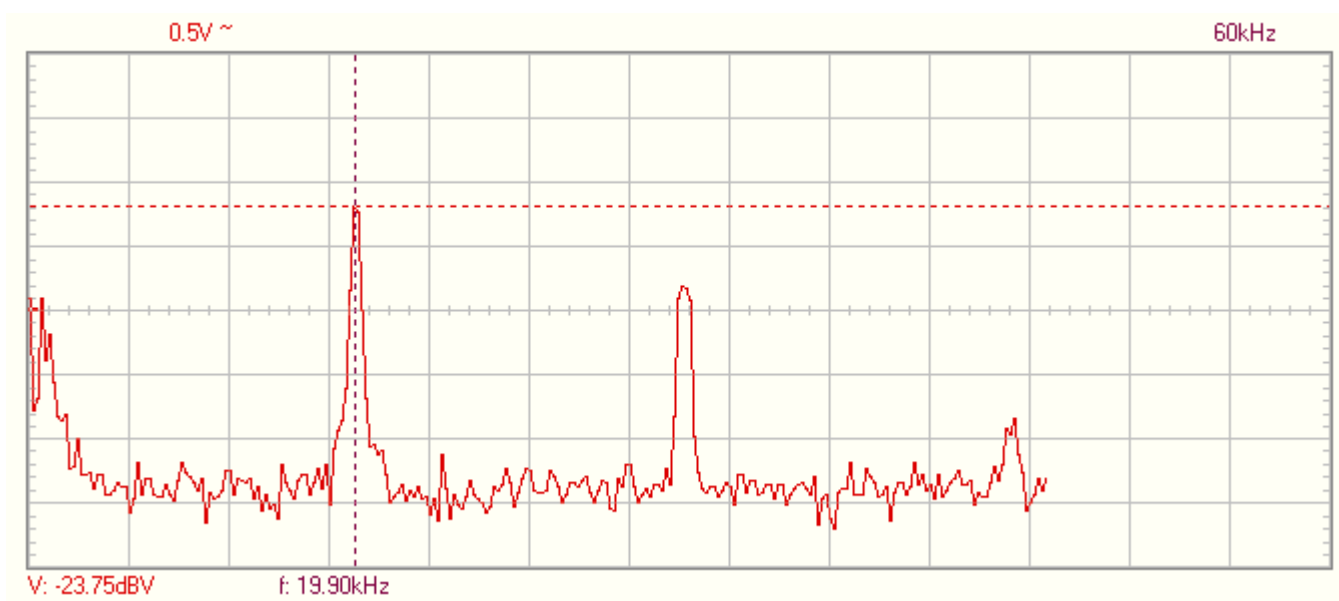
Next is a tracing with the surge protectors switched on, powering the Stetzer filters. Notice that the height of the fundamental frequency at 20 kHz has dropped from -13.1 dBV to -23.75 dBV (the more negative the dBV value, the lower the Voltage or height of the spike). This is shown in the lower left margin. With Stetzer filters on, the new height is 4.2 divisions above baseline, or 2.1 V, compared to 5.5 divisions above baseline with Stetzers off, at 2.75 V.

This represents a 25% reduction. The spikes for the first and second harmonics are also smaller than in the tracing above:

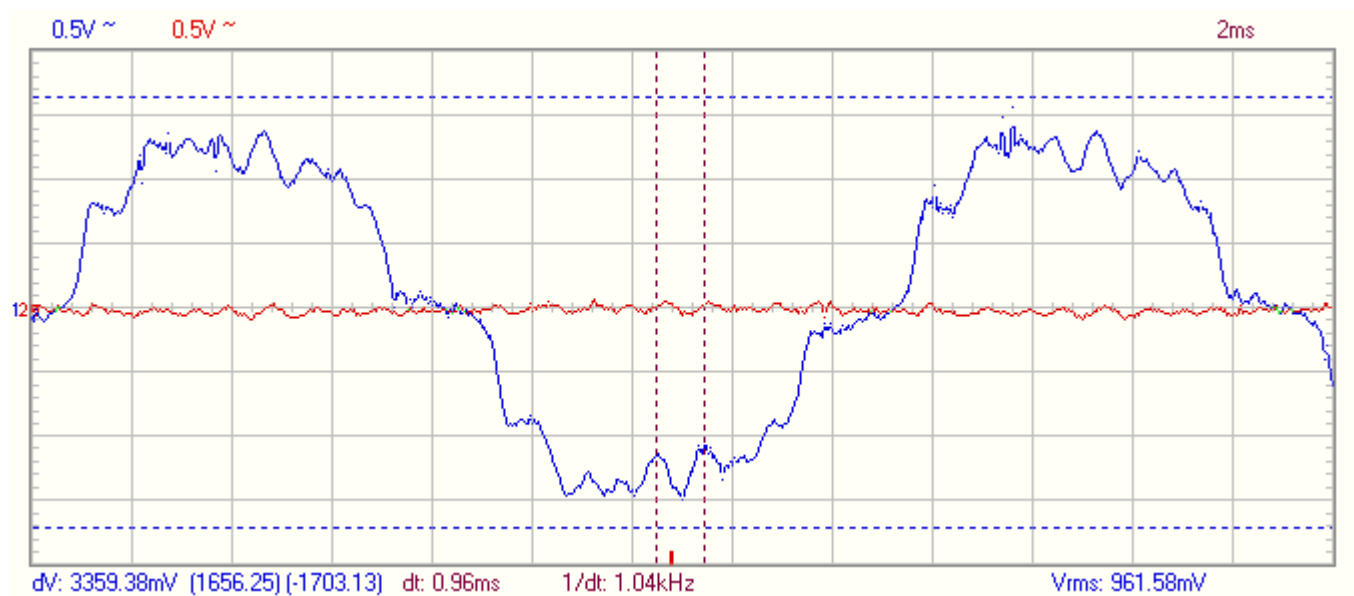
The first oscilloscope tracing below is with the inverters shut off. The red tracing (channel B) is taken directly from the circuit, as are the spectrum analyzer tracings shown above (remember, the Stetzer attenuator cuts out the 60 Hz sine wave, resulting in a flat oscilloscope tracing if no higher frequencies are present).

The blue tracing (channel A) is from a whip antenna, which measures any DE in the air (and shows a

true 60 Hz sine wave because there is no attenuator on the lead from the whip antenna, only on the lead from the electric circuit). There is some amount of harmonic frequencies (DE) in the air (at 1.06 kHz), which is not from the inverter (remember, it was turned off at this point). The blue sine wave is not completely clean, but this particular amount of DE, from some other source, is not of a significant amount:

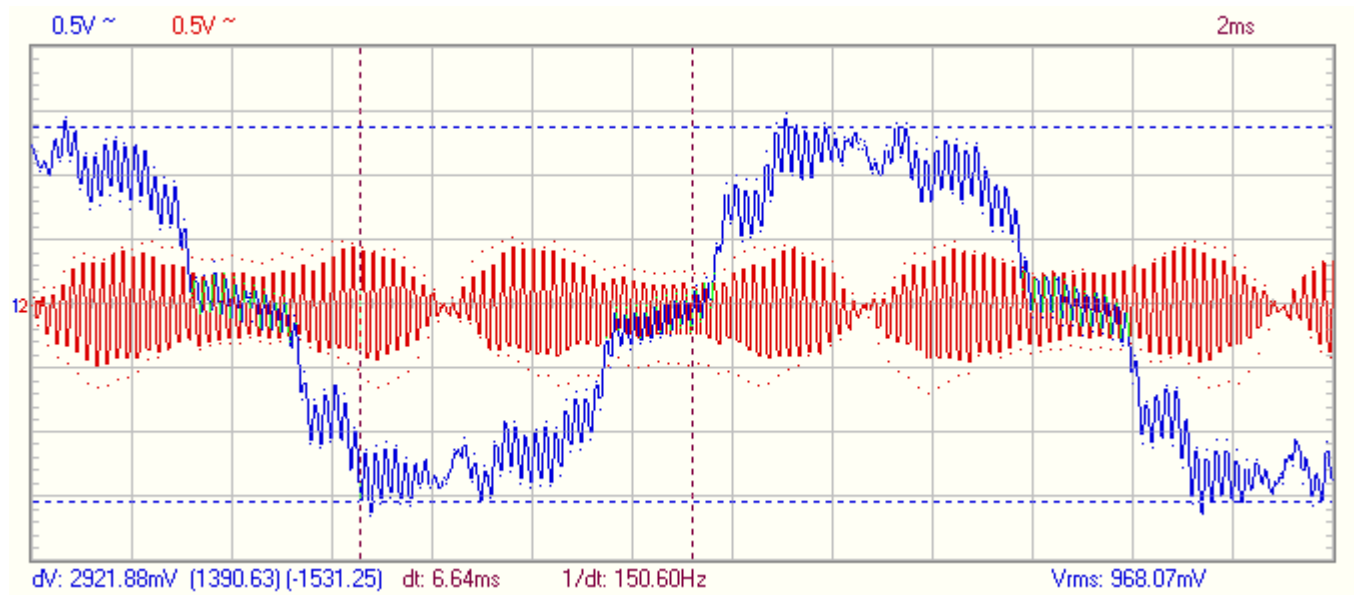
Compare this relatively clean oscilloscope tracing to the tracing below, this time with the inverters turned on. A higher frequency is superimposed upon the 60 Hz sine wave, as seen on both channel B connected to the circuit (red) and on channel A connected to the whip antenna in the air (blue):

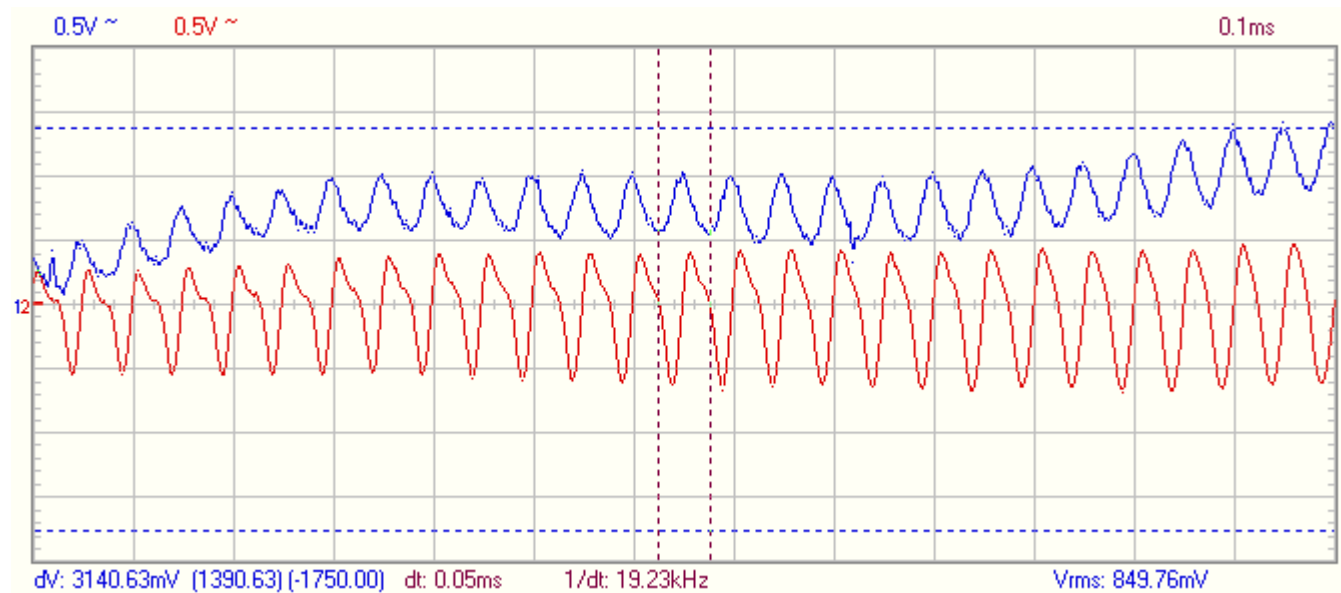
Here is a close up of the same tracing with the horizontal divisions now at 0.1 milliseconds (ms) rather than 2 ms, as in the tracings above. We know that this higher frequency superimposed upon the 60 Hz sine wave is from the inverter and that it has a frequency of 20 kHz. You can actually determine this on the oscilloscope by placing the markers at the beginning and end points of any one cycle. The markers below are placed on roughly the zero point of the red tracing (an imaginary horizontal line running through the sine waves). They can be placed anywhere on two sequential oscillations as long as they are on the same point in each cycle.

In the case below, the markers measure 0.05 milliseconds of time (listed at the bottom of the graph

as dt, or “delta time,” at 0.05ms). This represents the wavelength, shown as a red number at the bottom margin. You can then calculate the frequency based upon the wavelength, because frequency is inversely related to wavelength, or 1 over delta time (1/dt). The frequency is shown in red on the bottom margin as well. It reads 19.23 kHz, matching the fundamental frequency of roughly 20 kHz seen on the spectrum analysis tracings shown above. Thus you can determine any harmonic frequency of DE using either the spectrum analyzer or the oscilloscope.

Here is the oscilloscope tracing showing the wavelength and frequency of the higher (20 kHz) frequency superimposed upon the 60 Hz sine wave of utility electricity:

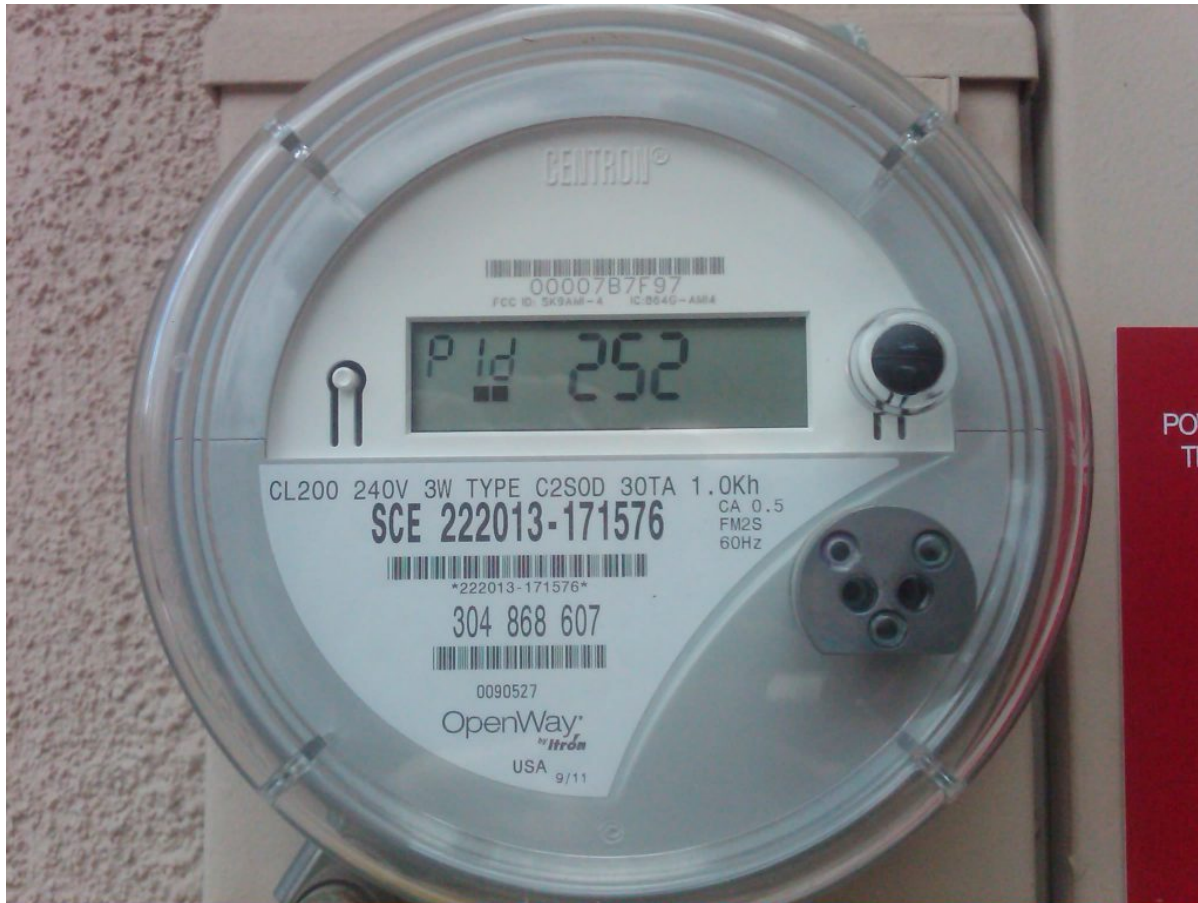
This house has a Southern California Edison Itron brand smart electric meter, as seen in this photo taken by the homeowner (at the bottom of the smart meter are the words, “OpenWay by Itron” and the letters “SCE” stand for Southern California Edison):

The fact that the spectrum analyzer at this house showed an absence of 20kHz dirty electricity when the inverters were switched off has implications in terms of the question of whether Itron brand smart meters generate dirty electricity or not. That is a separate question from this discussion on dirty electricity and solar panel inverters, but important nonetheless.

As you can see above, our measurements on the spectrum analyzer and oscilloscope show that there is no DE when the device that does produce DE, the Sunpower inverter, is switched off. Yet, we have an Itron smart meter in place. Where is the dirty electricity that this smart meter is supposed to produce? It does not appear to be present, at least not with this particular brand.

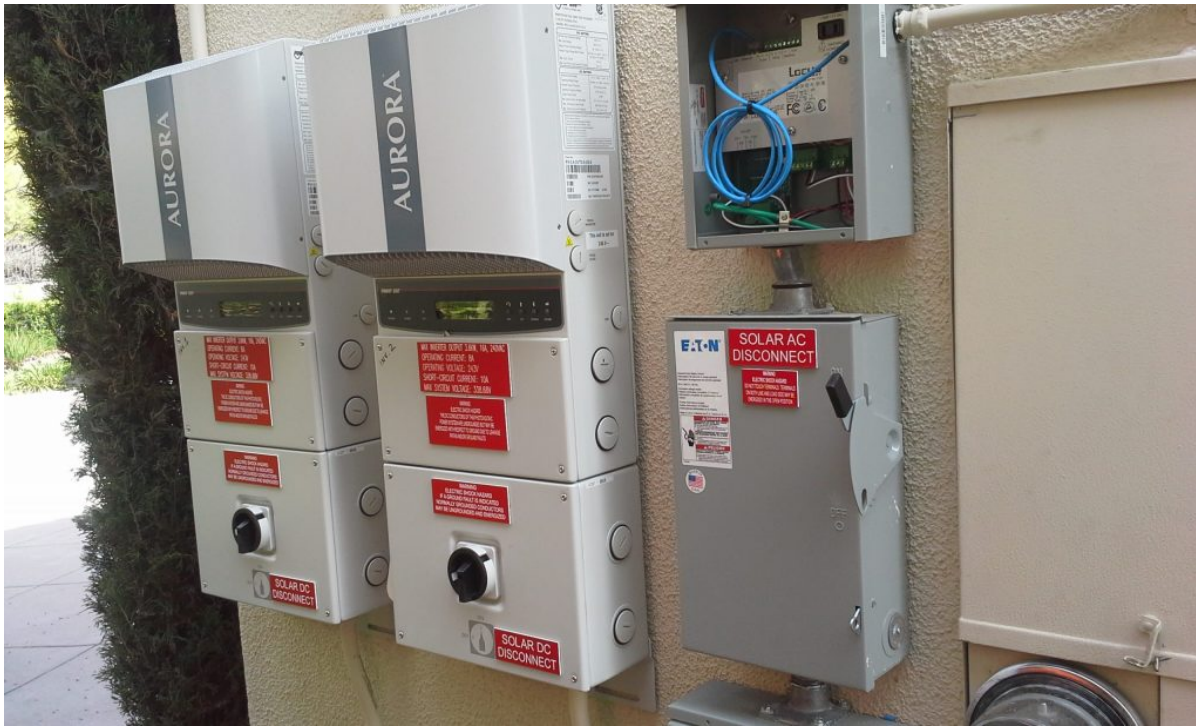
We measured DE at a home on 3/26/14 that also has PV solar panels and two Aurora Power One photovoltaic grid-tied inverters, leased from Verango:

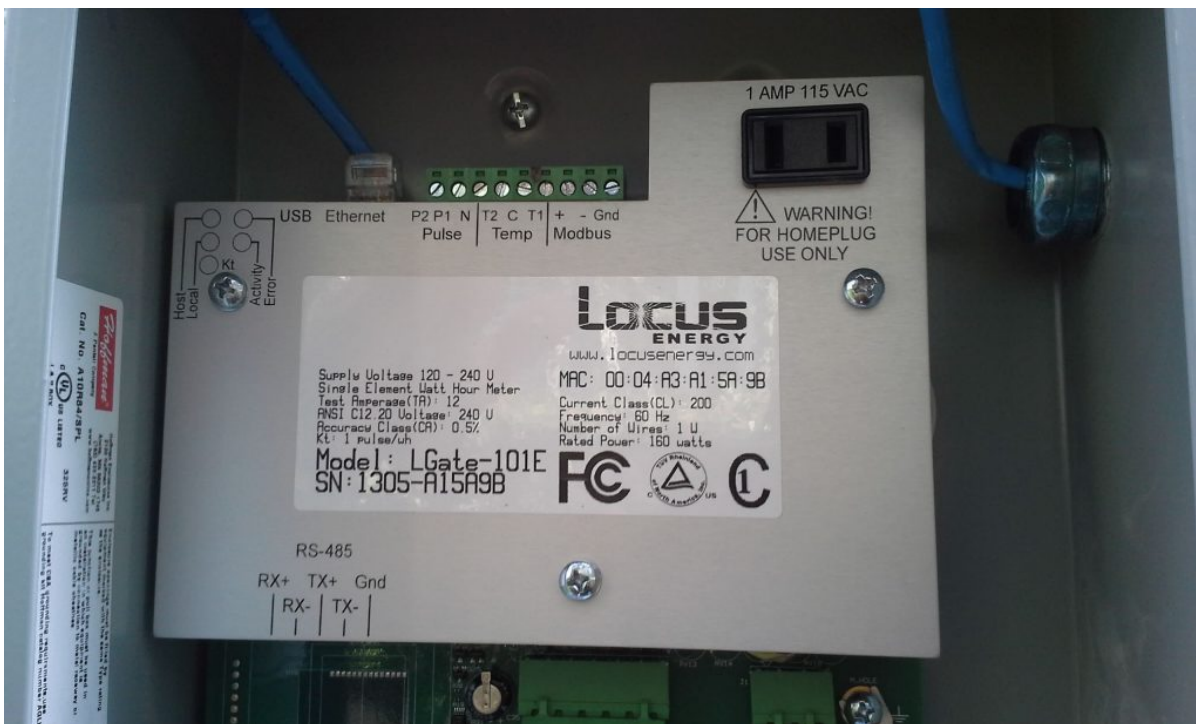
Here is a photo of the L-Gate non-wireless electric meter used by Verango:

Verango is also willing to use the L-Gate 100 electric meter for customers who do not want a wireless electric meter.

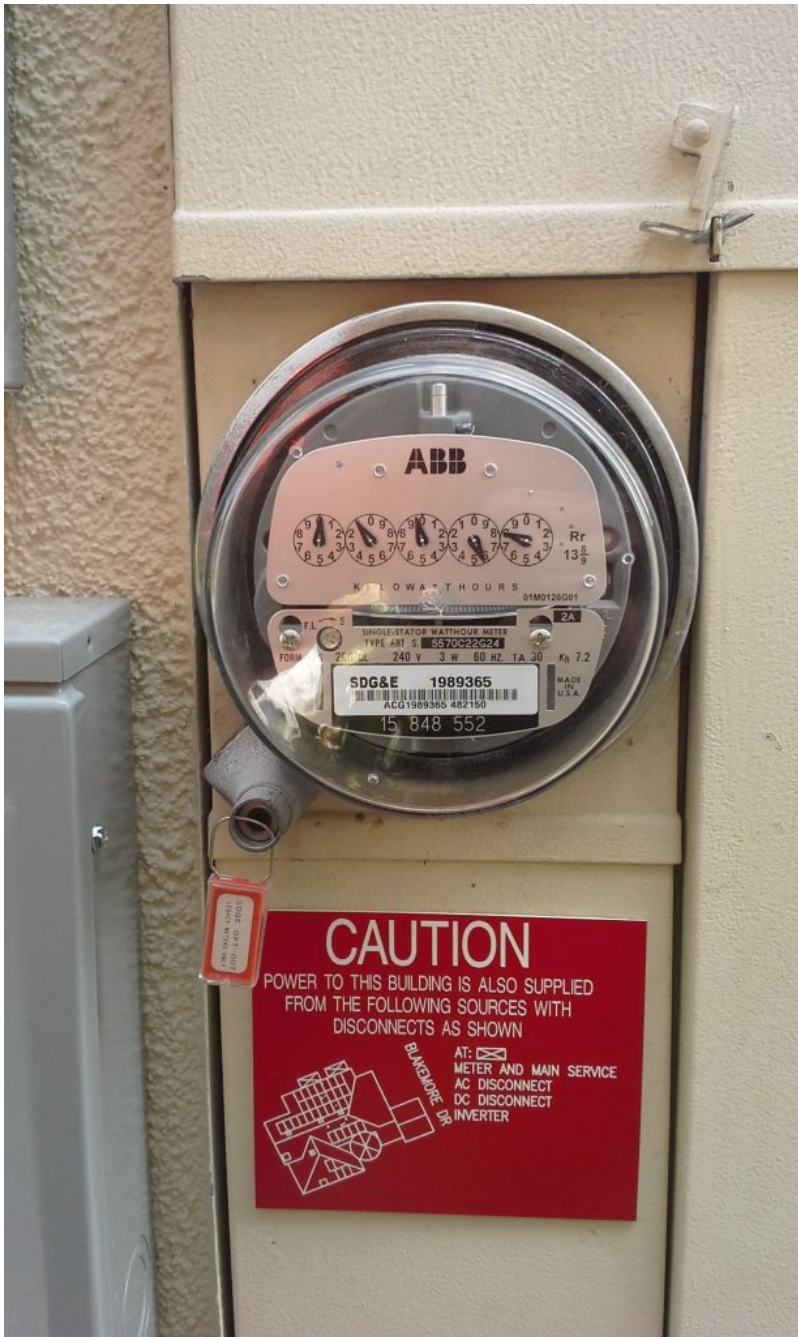
This client had opted out of San Diego Gas & Electric's smart meter program and instead had an opt-out analog meter. This resulted in a solar panel set up that was devoid of any wireless

transmissions from either Verango's meter nor from SDG&E's electric meter:
