# [Spectrum Analysis and Oscilloscope Tracings of Harmonics from Photovoltaic \(PV\) Grid-Tied Inverters](#)

written by Oram Miller | 31 August 2014

## **Introduction**

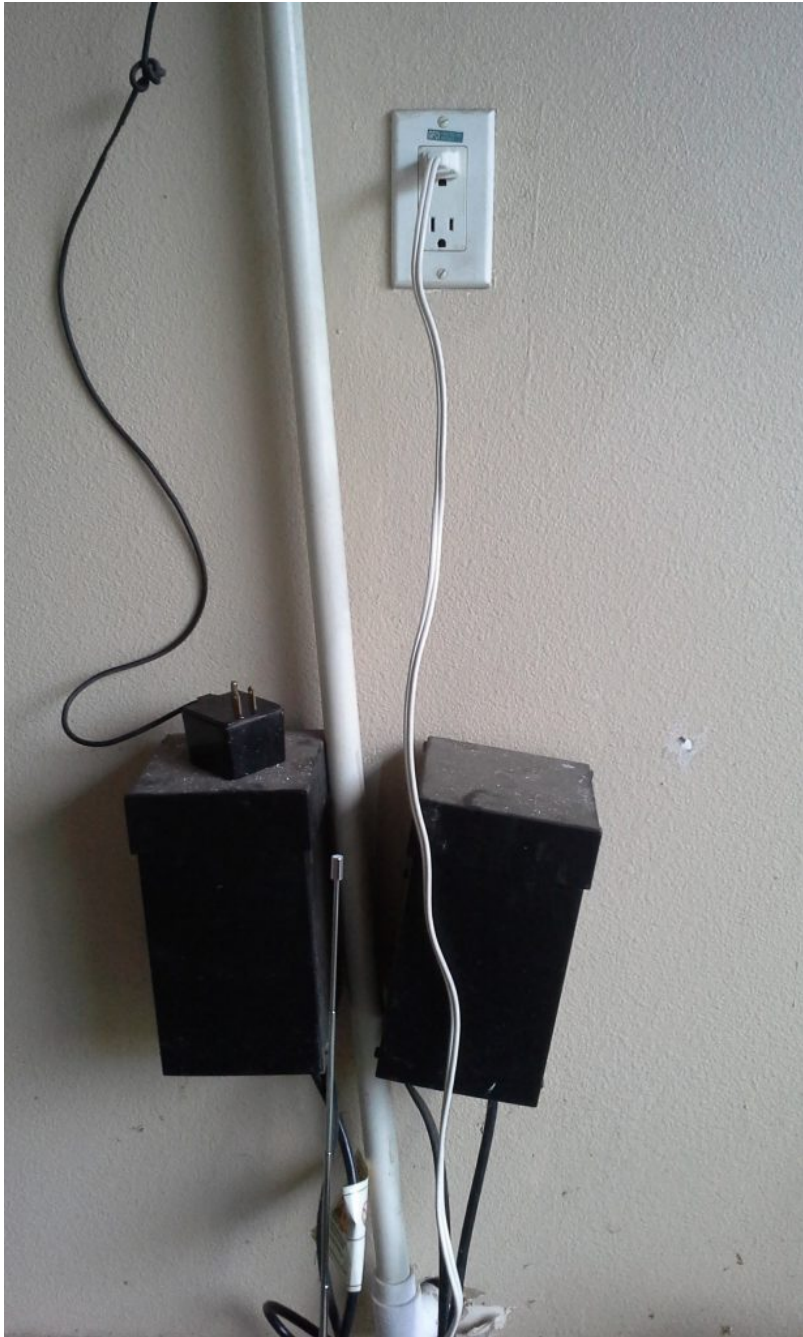
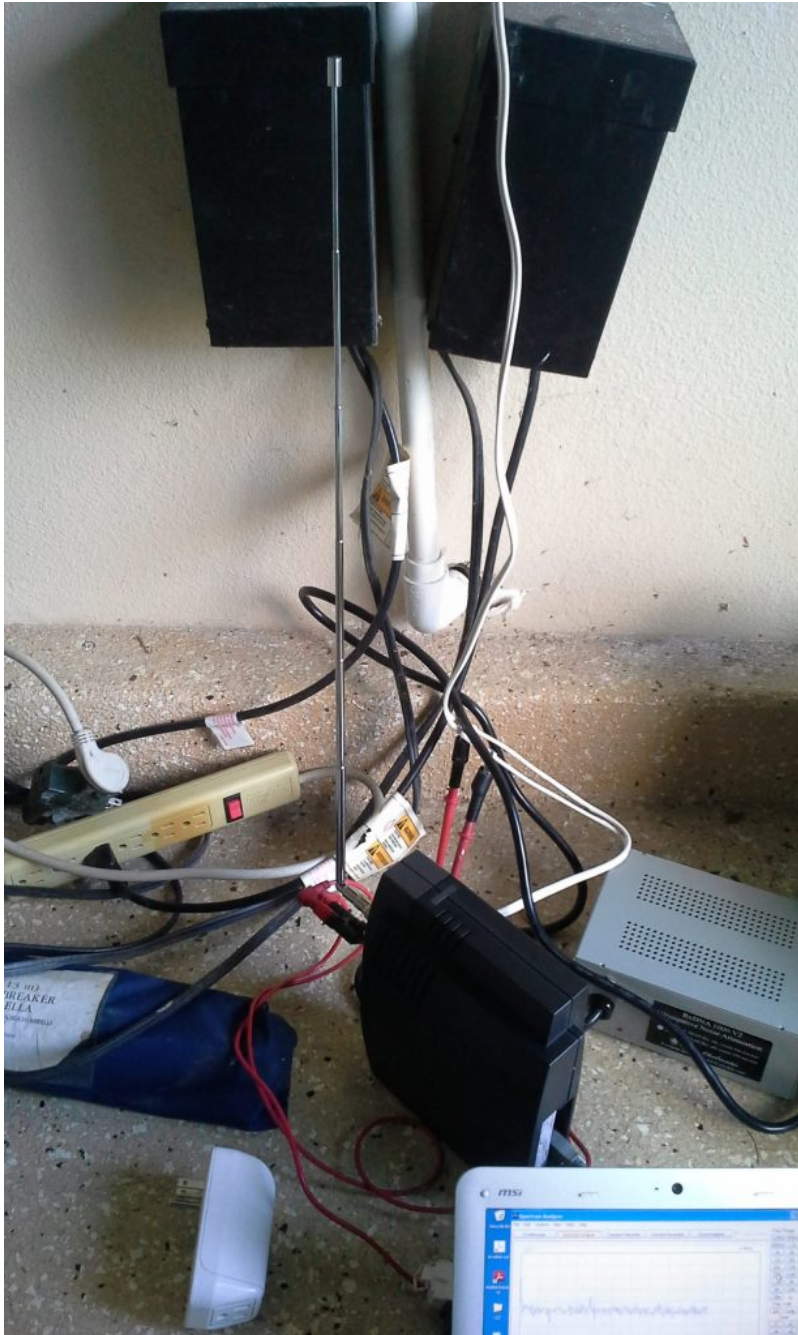
Once again, here is the oscilloscope set up at the home in Ladera Ranch. The Velleman scope was plugged into an outlet in the garage on the opposite side of the wall from the inverters, allowing DE measurements straight off the circuit into channel B. I also had a whip antenna connected to channel A. The power supplies for the two irrigation timer motors in the black boxes mounted on the wall were removed, as they produced extraneous DE, which would have been an artifact on our tracings had I left them plugged in:

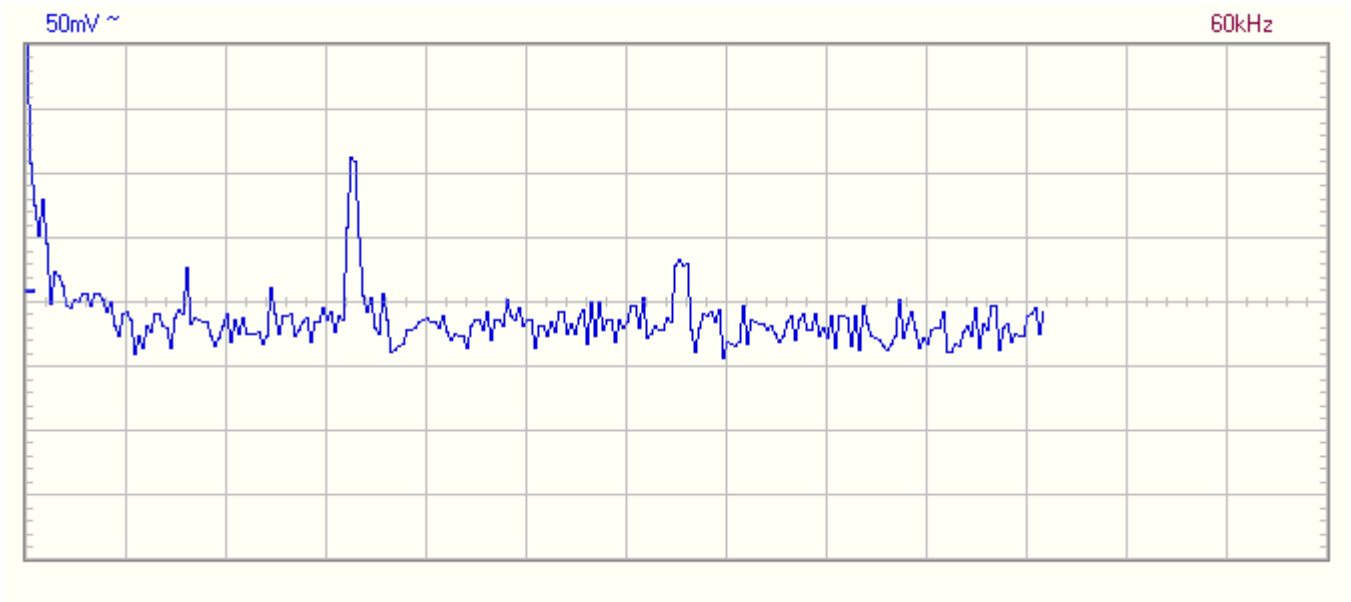
Tracings of the spectrum analysis of this circuit are shown below. The first image shows a spike 3.3 divisions from the left in the 0-60 kHz range. Since each division is 6 kHz wide, 3.3 divisions would equal roughly 20 kHz. Just as with the house in Trabuco Canyon with the Sunpower inverter, this fundamental frequency is also at 20 kHz:

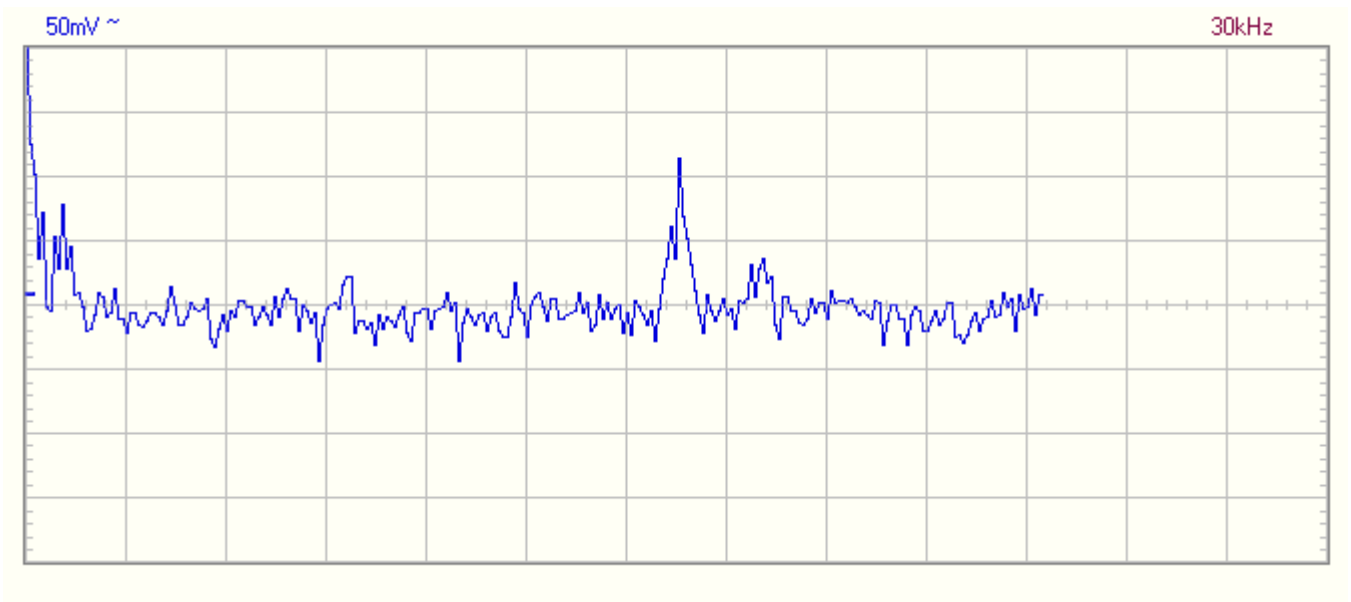
Here the 20 kHz spike is seen again, this time at 6.6 divisions from the left on a tracing with a 0-30 kHz range:

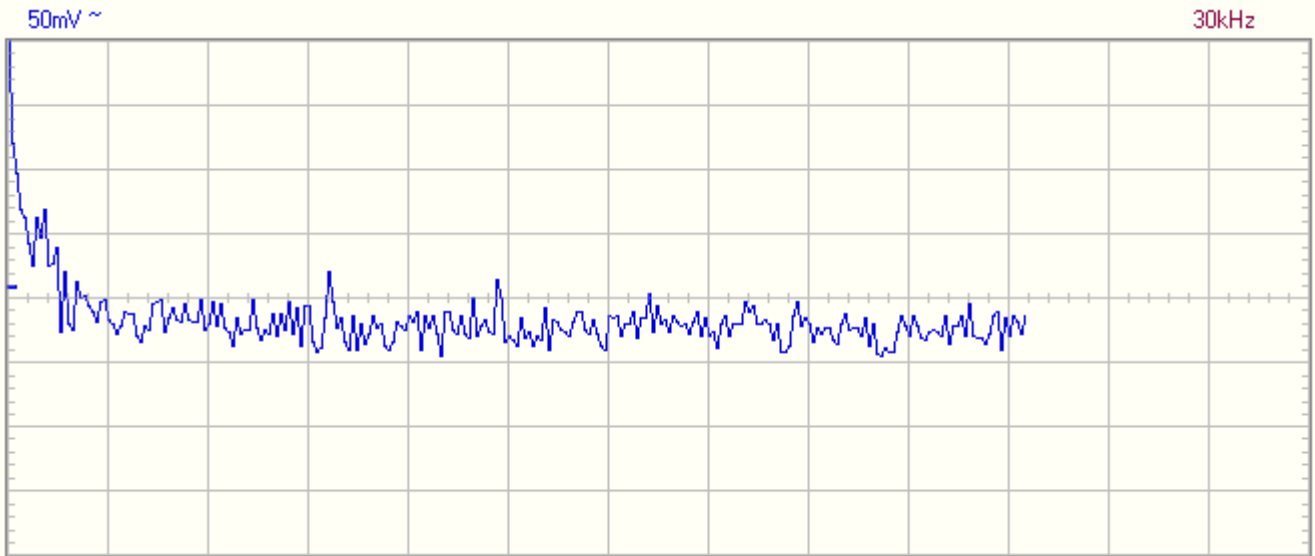
Now see the same tracing but with the inverters switched off. As at the previous house, the spikes are now completely gone:

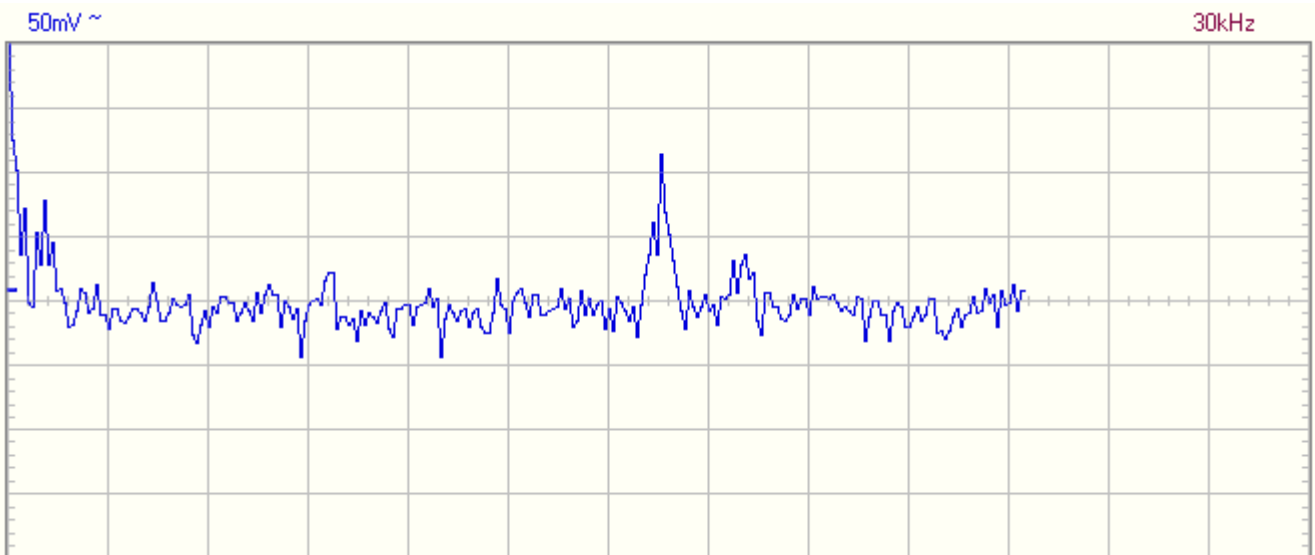
The following tracings show the reduction of DE using DE-reducing devices. First we show you a tracing without devices in place, showing the spike from the Aurora inverters. The spike measures 125mV (2.5 divisions) high:

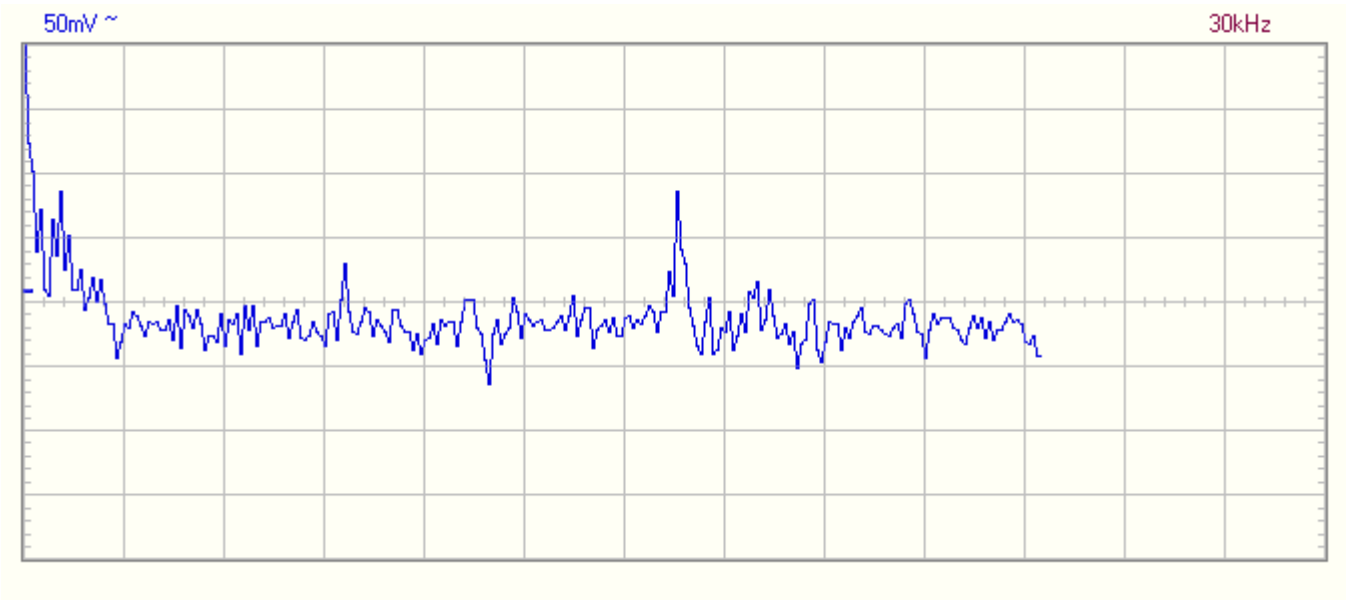
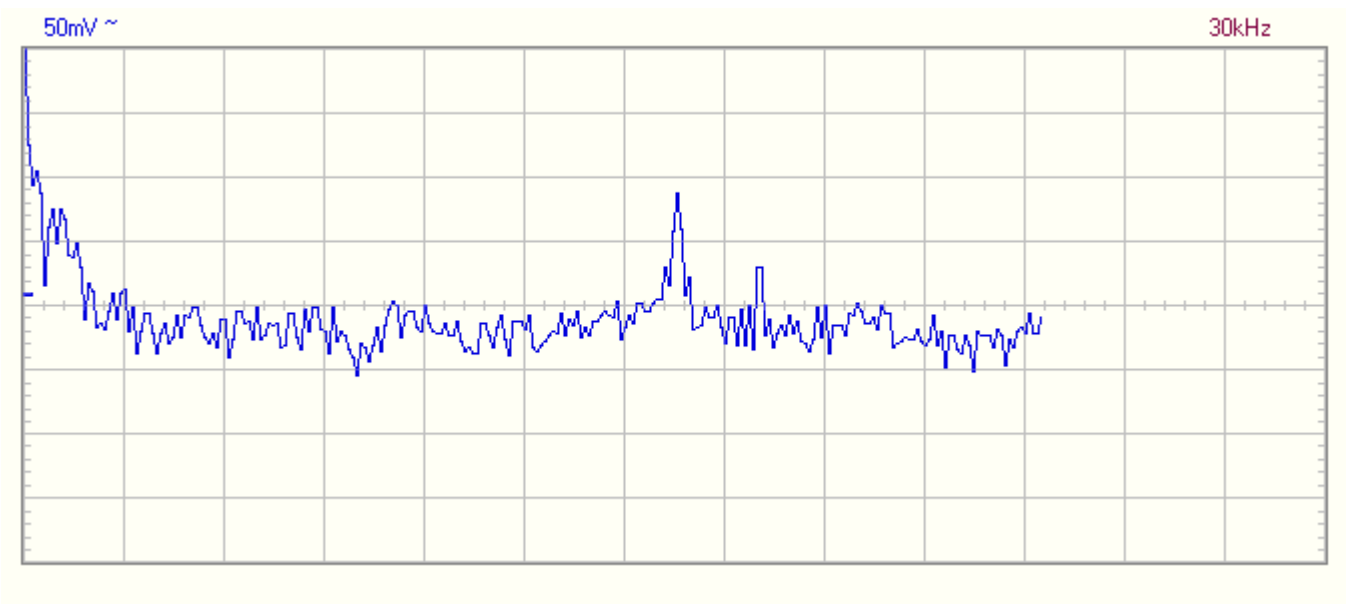
The first photo below shows a Greenwave filter in use. Below that an RxDNA device is in use. In both cases, spikes are 100 mV (2 divisions) high, not 125 mV (2.5 divisions) high, representing a 20% reduction:

Dirty electricity readings on the Stetzer microsurge meter at this house were 1000-1800 GSU with the inverters on but without filters or DE-reducing devices in place. Separately inserting a Greenwave filter and the RxDNA both reduced the DE levels to 300-400 GSU. When the inverters were turned off, the DE level dropped to only 68 GSU.

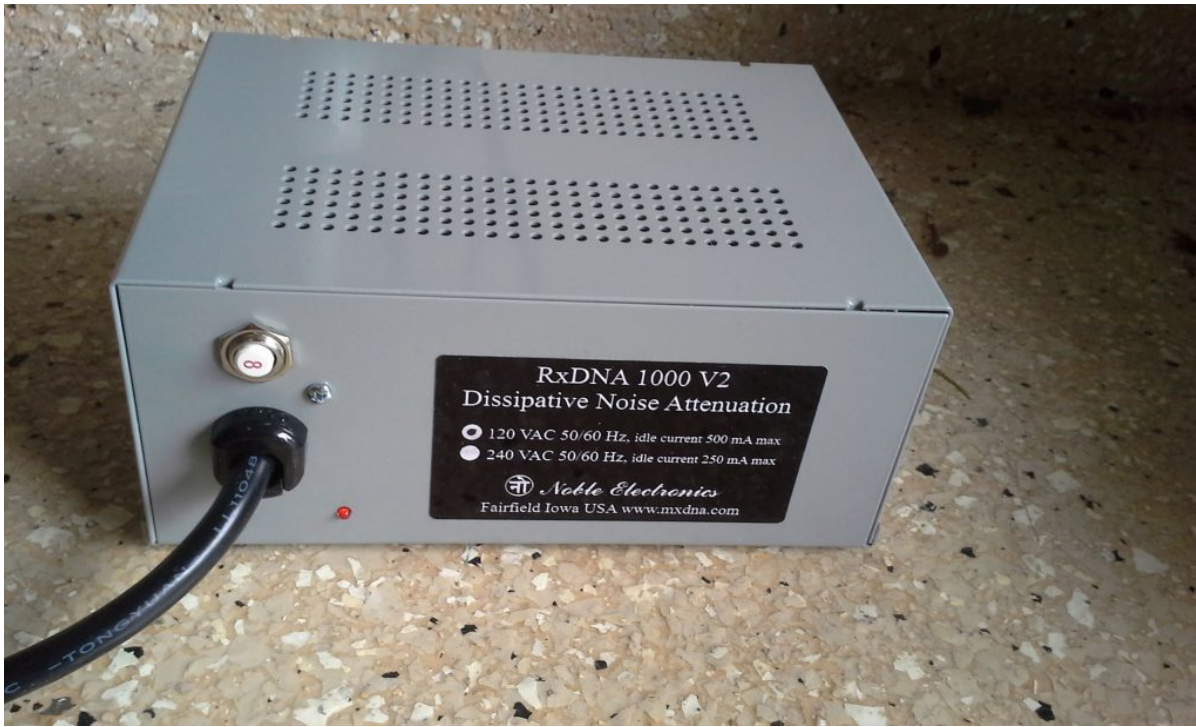
Here is a photo of the RxDNA dissipative noise attenuation device:

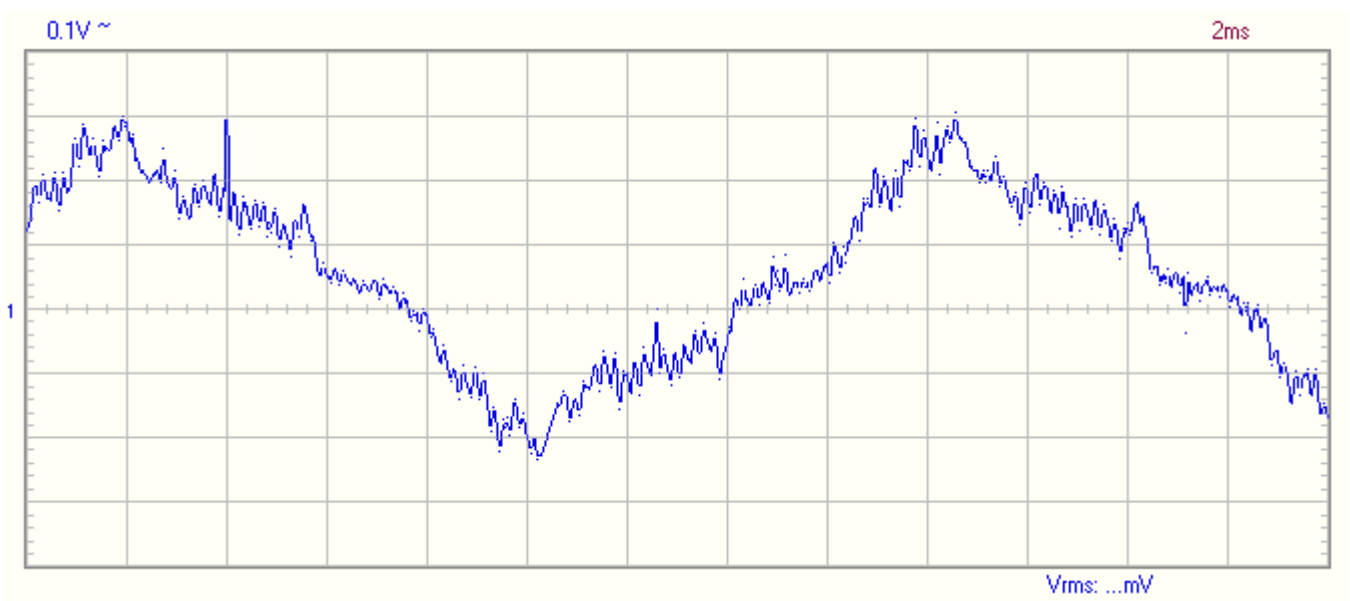
Below you see an oscilloscope tracing of the 60 Hz sine wave captured in the air with a whip antenna comparing inverters switched on versus switching them off.

The first tracing shows a sine wave with the inverters switched on. You will notice a high frequency pattern (20 kHz) superimposed upon the 60 Hz sine wave, appearing as a tiny saw-toothed oscillation overlaid onto the sine wave. Both tracings are at 2ms per horizontal division and 0.1V per vertical division.

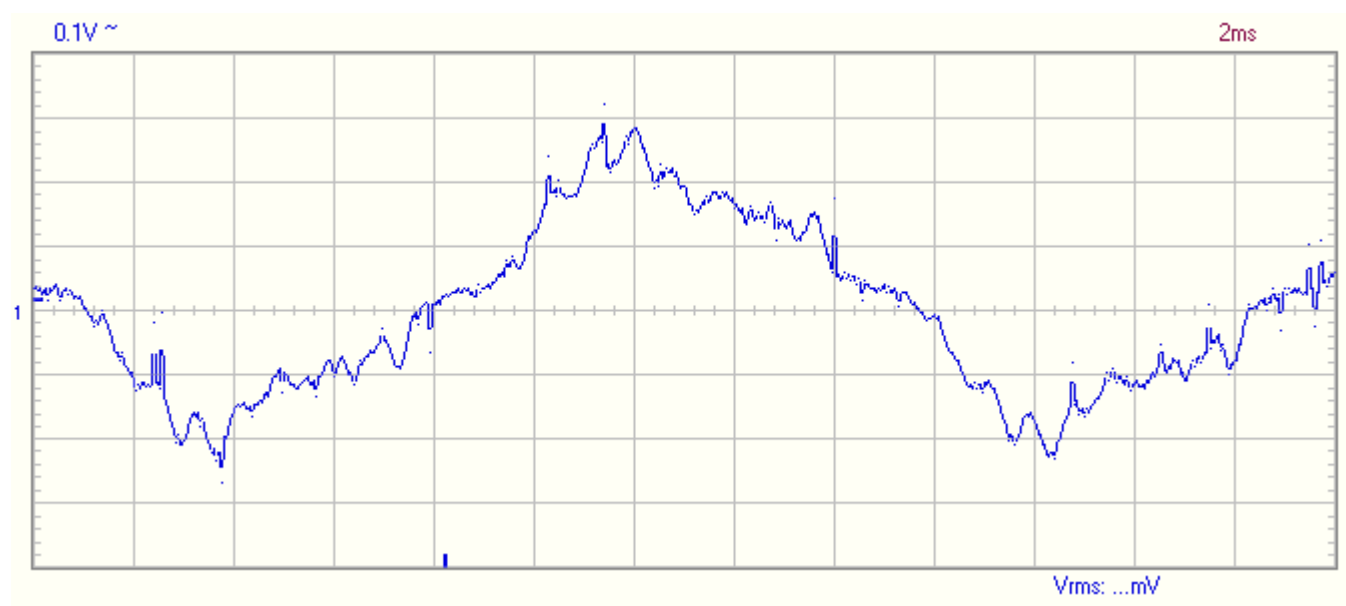
Here is the oscilloscope tracing with the inverter switched off. Notice how much smoother the tracing is, devoid of the saw-toothed higher frequency superimposed upon the 60 Hz sine wave above:
