[Spectrum Analysis and Oscilloscope Tracings of Harmonics from Photovoltaic \(PV\) Grid-Tied Inverters](#)

written by Oram Miller | 31 August 2014

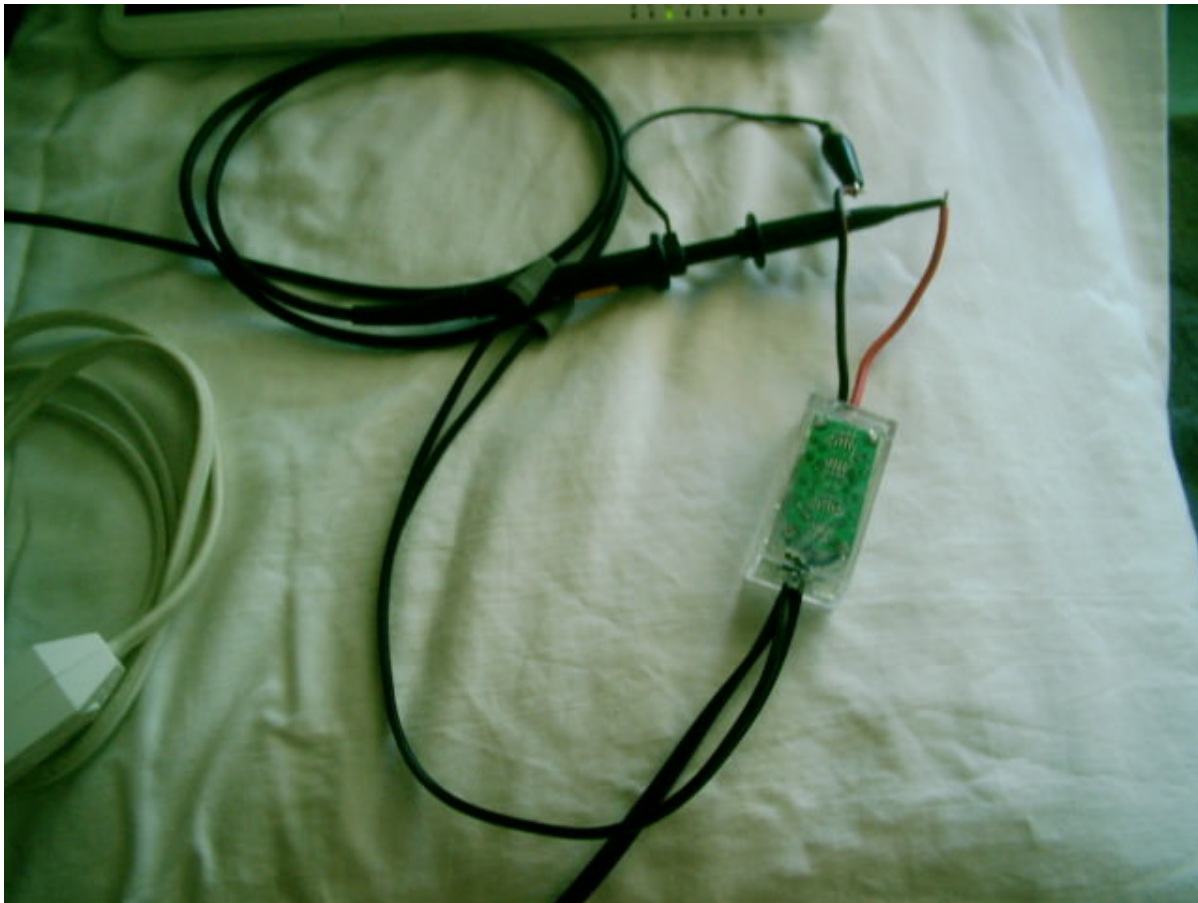
The tracings on the pages below are a spectrum analysis and oscilloscope tracings of a circuit close to the main breaker panel and inverter in each house. I used an attenuator plugged into an outlet, provided for \$50 by Stetzer Electric:

This allowed me to tap directly into an outlet without damaging the O-scope, which can only handle a maximum of 30 Volts input. The attenuator removed 60 Hz frequencies on the oscilloscope, allowing frequencies below and above 60 Hz to be shown on the tracing (however a whip antenna on a separate channel showed the typical 60 Hz sine wave configuration). The attenuator also reduced the input voltage to less than 1 Volt.

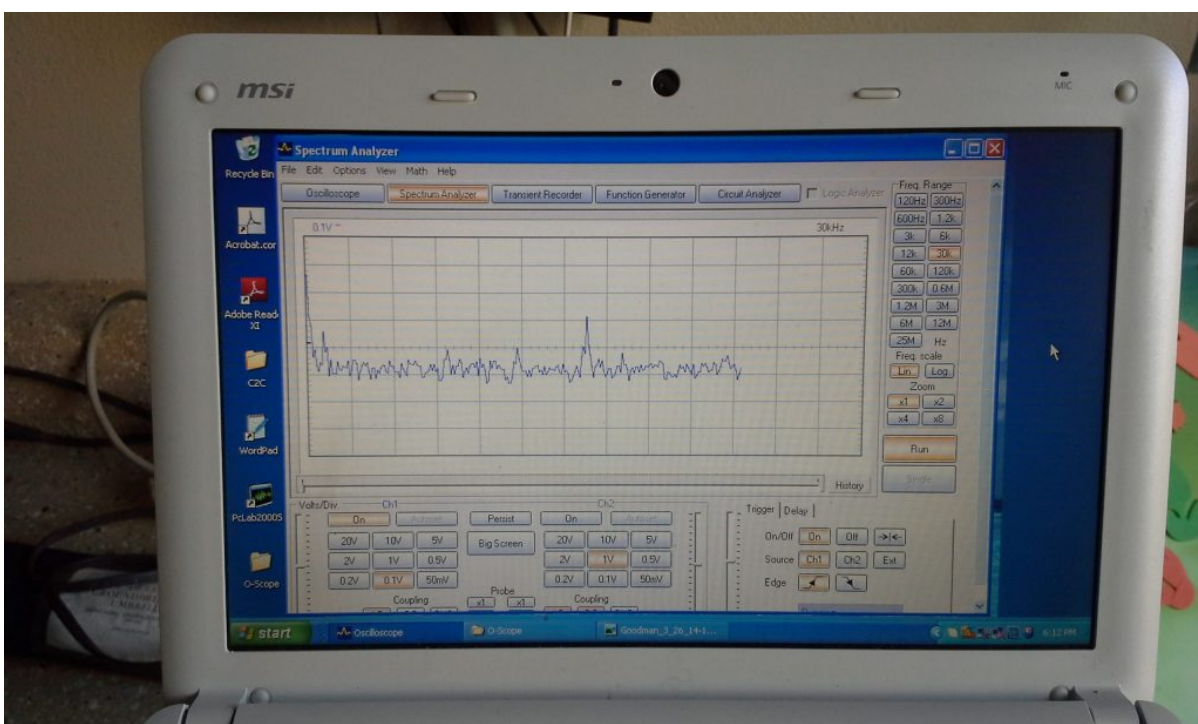
I used a [Velleman PCSU1000 Two-channel USB PC Oscilloscope](#) connected to a PC notebook for the display. The laptop was powered by its internal battery, not the inline transformer.

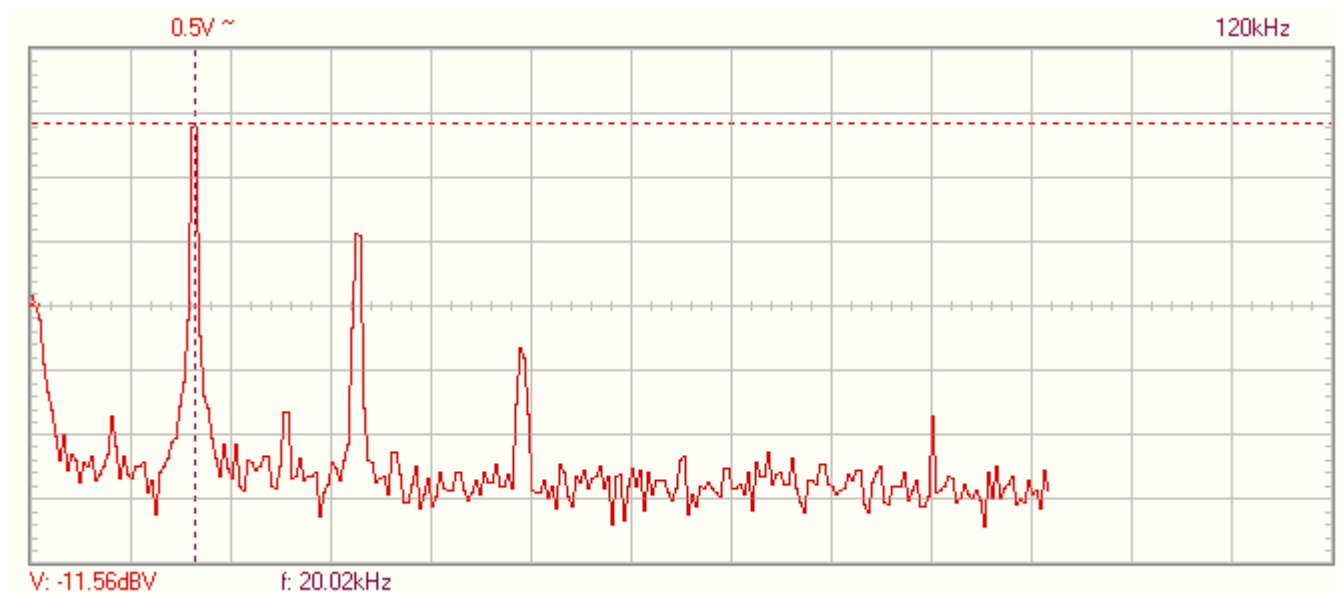
The frequency shown in the upper right corner of the image is the maximum value of the range being shown. For instance, the number 120 kHz is displayed in this case. That means the tracing shows all activity being measured on the circuit from 0 Hz on the left, to 120 kHz at the right end of the tracing on the display:

There are ten divisions along the horizontal axis from left to right, meaning each division measures 1/10th of the total range. Thus in this case, each division would display 12 kHz increments as you move from left to right.

You can thereby determine the frequency of any spike by counting the divisions from the left and multiplying that number by the frequencies per division. A spike of 20 kHz, which is the first large spike on the tracing above, would therefore be located just less than two divisions from the left margin in the case of a 0-120kHz range (1.7 divisions X 12 kHz per division), and just under four divisions in the 0-60 kHz range (as shown in a tracing below).

Using markers on the display, you can also determine the frequency by looking at the number that appears along the bottom of the tracing for the location that the dotted line is placed upon. In the tracing above, notice that the vertical marker is lined up with the first large spike on the left, corresponding with a frequency reading of 20.02 kHz displayed at the bottom of the tracing.

This first large spike is the fundamental frequency of a source of dirty electricity, which in this case, is the photovoltaic inverter. If you then count the divisions, you can see harmonics at the expected frequencies (multiples of the fundamental frequency), but with lower voltages (heights). These are at 40 kHz, 60 kHz, and so on.

The vertical axis, along the left margin of each tracing, shows the strength of each spike measured in Volts (V). The number at the top left shows the number of Volts per vertical division, which in all cases is 0.5V, or one-half of one Volt.

When I lined the vertical marker with the top of the first (fundamental frequency) spike, you see the strength or height of that spike recorded at the lower left margin in decibel Volts (dBV), which is -11.56 dBVolts in this case.

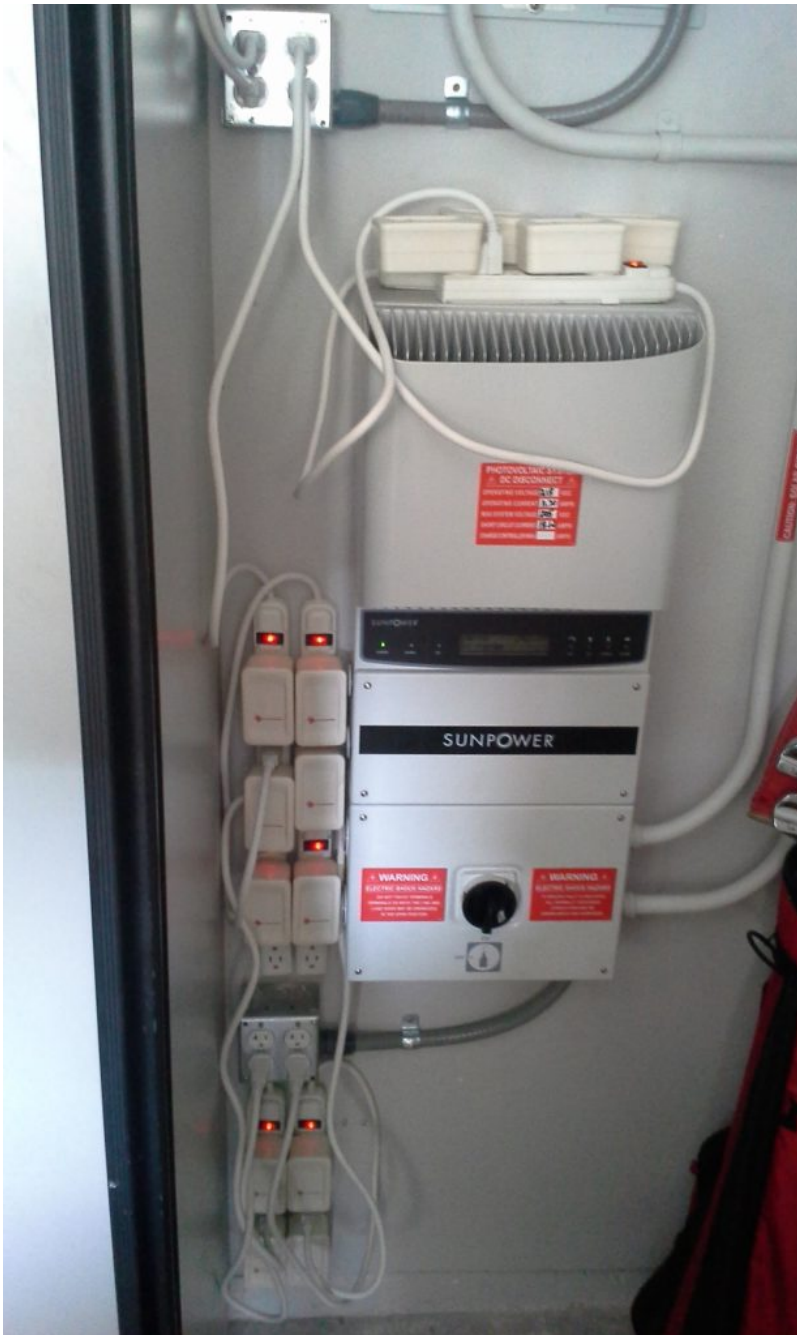
The first home was measured on 4/17/14. It has two Sunpower brand grid-tied inverters, mounted one above the other in the garage (and, yes, those are numerous Stetzer filters plugged in all around these inverters, in the homeowner's attempts to reduce the DE that bothers him to a great extent):

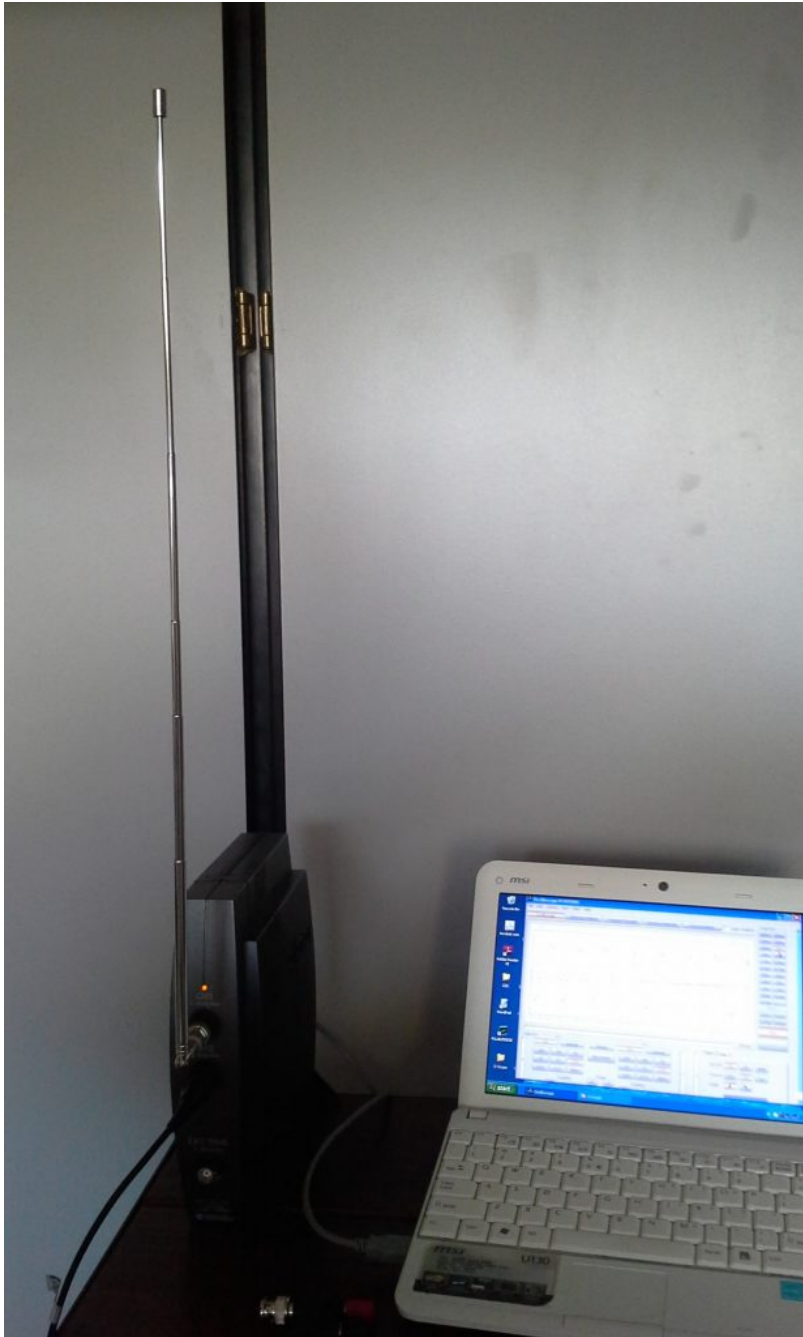
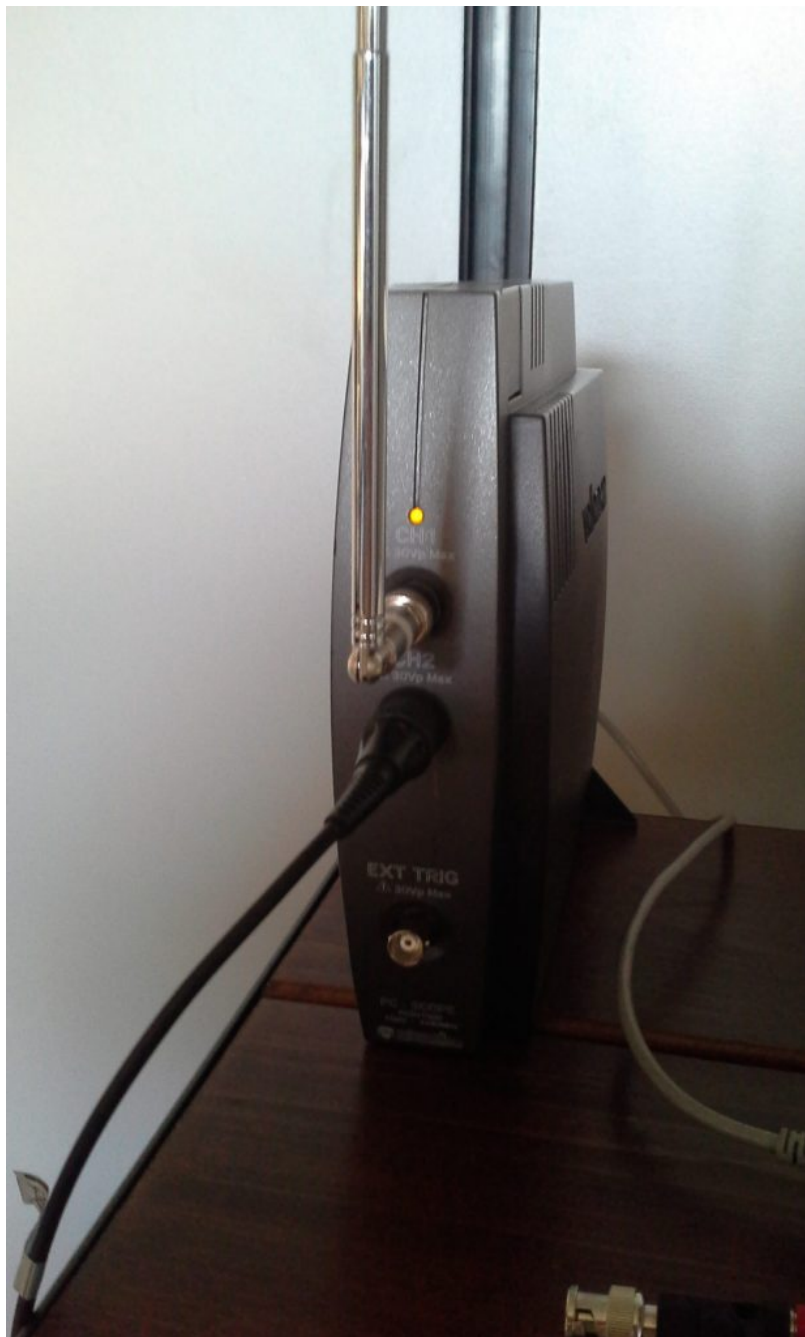
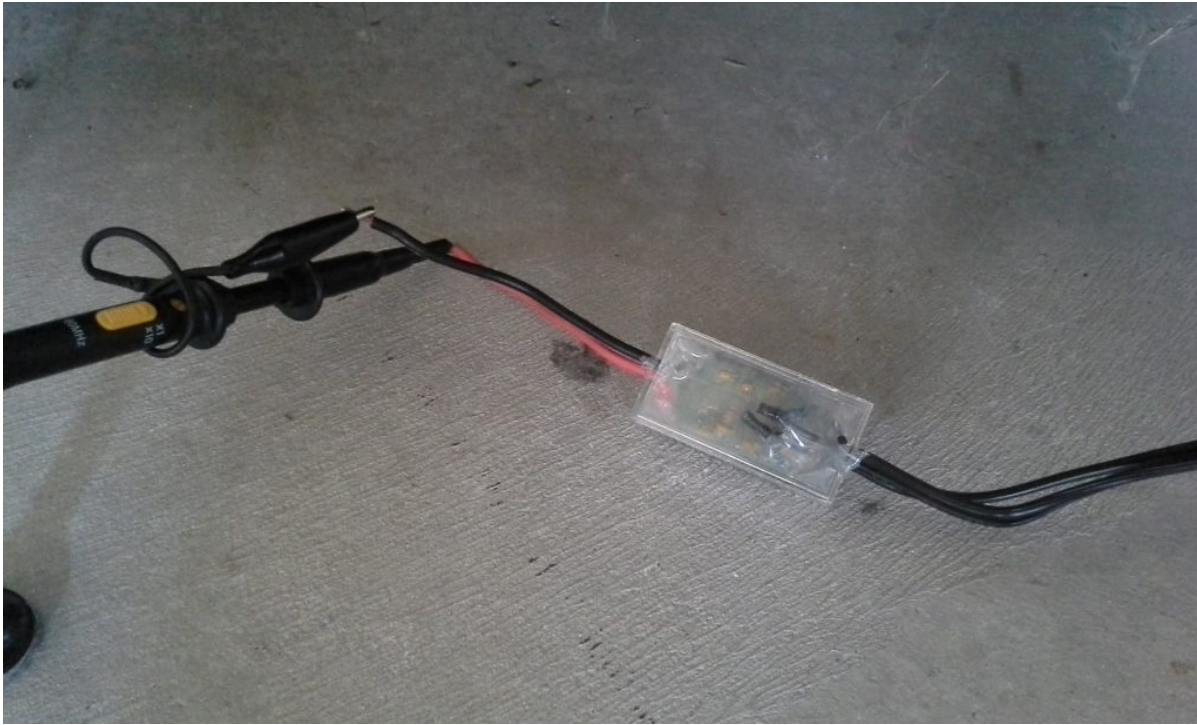
Here are photos of the oscilloscope set up. In the first photo, you see the Velleman scope with a whip antenna connected to channel A, while a wired lead from the circuit is connected to channel B. A close-up is shown in the second photo:

The wired lead is connected to the two wires of the Stetzer attenuator, which is plugged into an outlet:

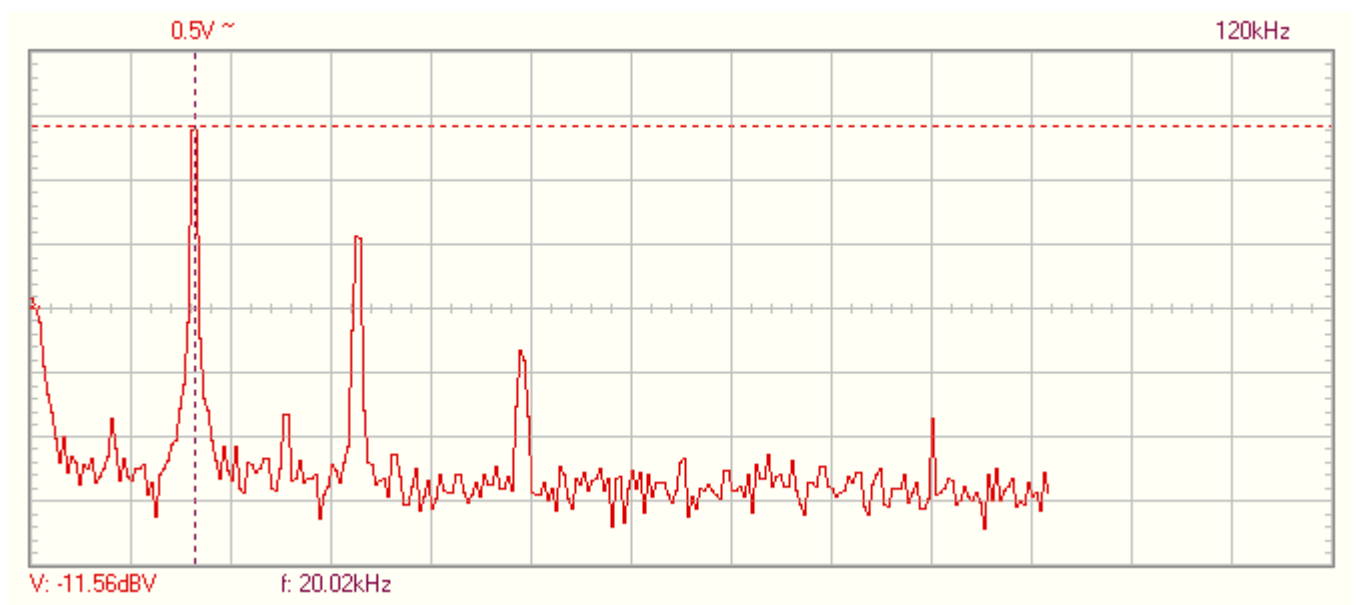
In the first tracing below, you see a fundamental frequency at 20 kHz with a height of -11.56 dB. You can count the height of the spike above the baseline by noting that each vertical division is 0.5 Volts and the peak is roughly 5.5 divisions above the baseline. Thus 0.5 Volts/division X 5.5 divisions correlates with roughly 2.75 Volts of height, equal to -11.56 dBV.

Notice also the harmonics at 40 kHz and 60 kHz to the right, each one with diminishing intensity or strength (height):

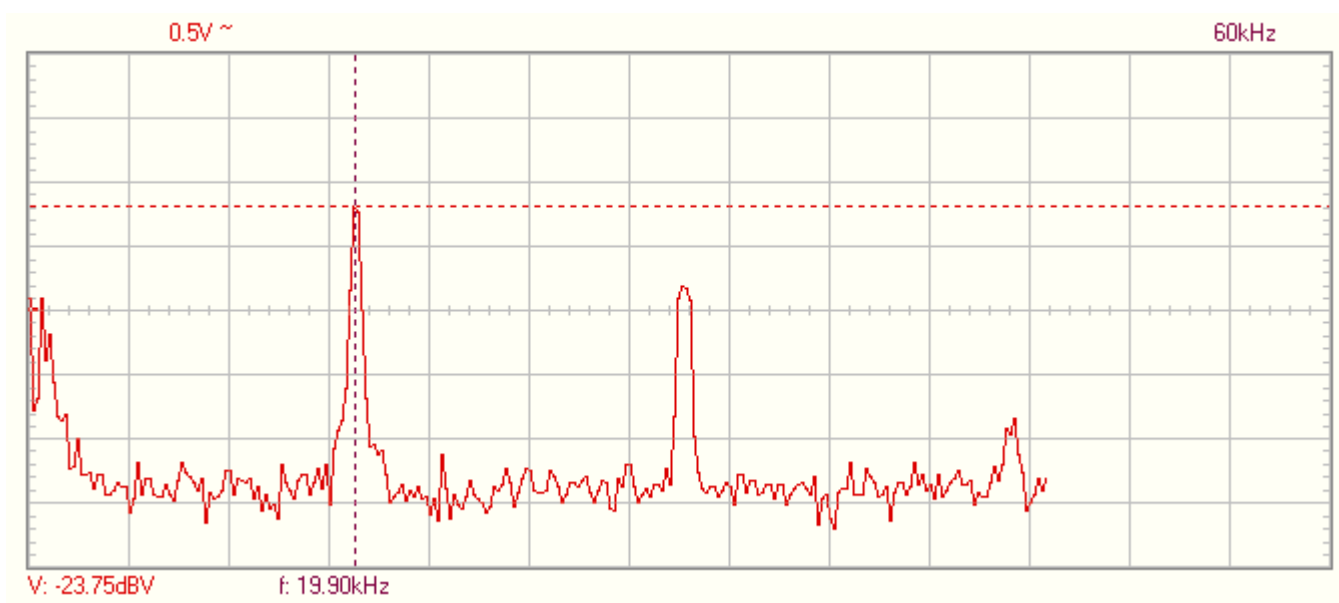
Next is a tracing with the surge protectors switched on, powering the Stetzer filters. Notice that the height of the fundamental frequency at 20 kHz has dropped from -13.1 dBV to -23.75 dBV (the more negative the dBV value, the lower the Voltage or height of the spike). This is shown in the lower left margin. With Stetzer filters on, the new height is 4.2 divisions above baseline, or 2.1 V, compared to 5.5 divisions above baseline with Stetzers off, at 2.75 V.

This represents a 25% reduction. The spikes for the first and second harmonics are also smaller than in the tracing above:

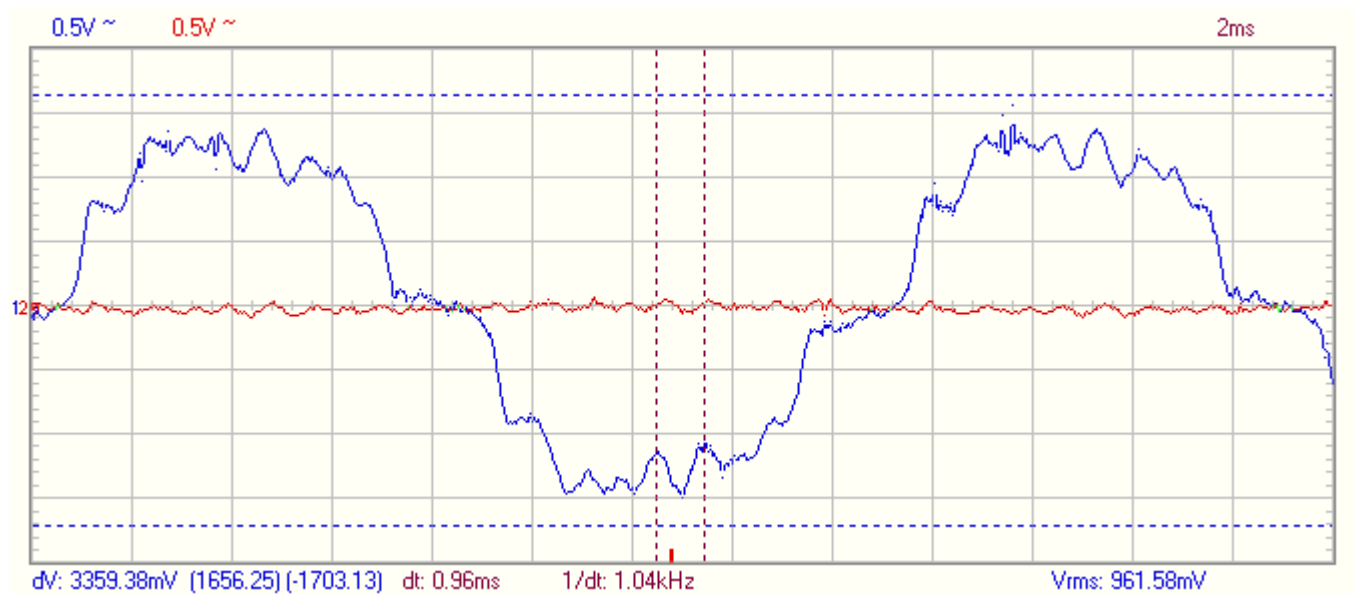
The first oscilloscope tracing below is with the inverters shut off. The red tracing (channel B) is taken directly from the circuit, as are the spectrum analyzer tracings shown above (remember, the Stetzer attenuator cuts out the 60 Hz sine wave, resulting in a flat oscilloscope tracing if no higher frequencies are present).

The blue tracing (channel A) is from a whip antenna, which measures any DE in the air (and shows a

true 60 Hz sine wave because there is no attenuator on the lead from the whip antenna, only on the lead from the electric circuit). There is some amount of harmonic frequencies (DE) in the air (at 1.06 kHz), which is not from the inverter (remember, it was turned off at this point). The blue sine wave is not completely clean, but this particular amount of DE, from some other source, is not of a significant amount:

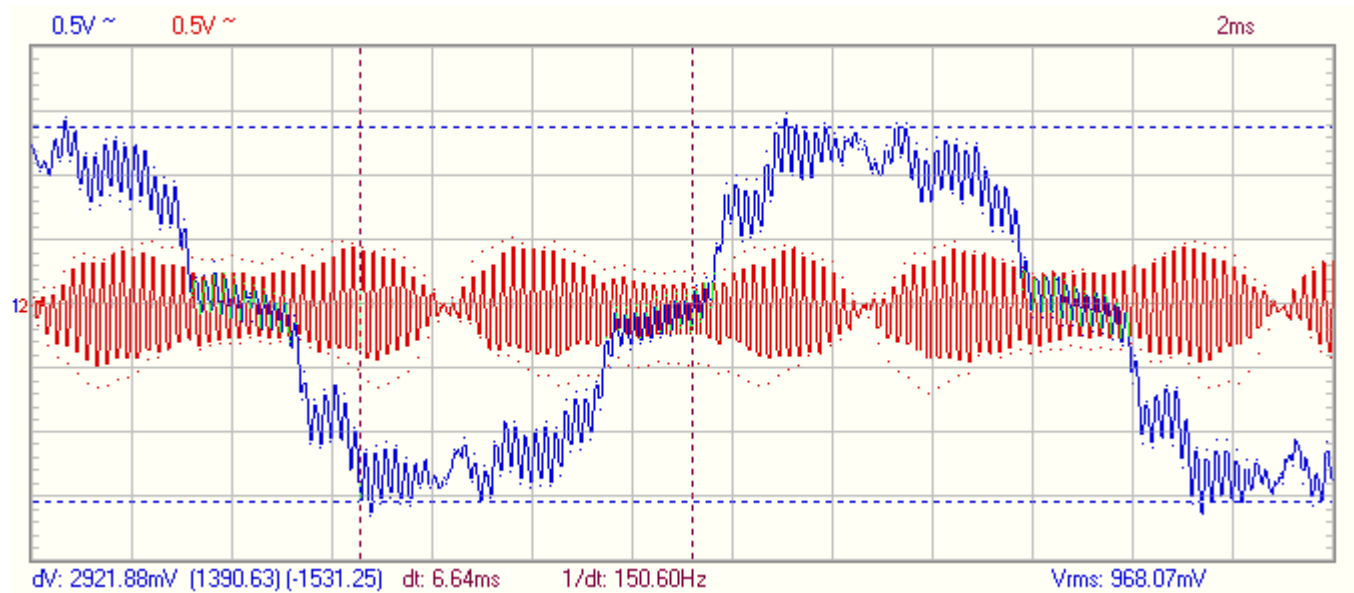
Compare this relatively clean oscilloscope tracing to the tracing below, this time with the inverters turned on. A higher frequency is superimposed upon the 60 Hz sine wave, as seen on both channel B connected to the circuit (red) and on channel A connected to the whip antenna in the air (blue):

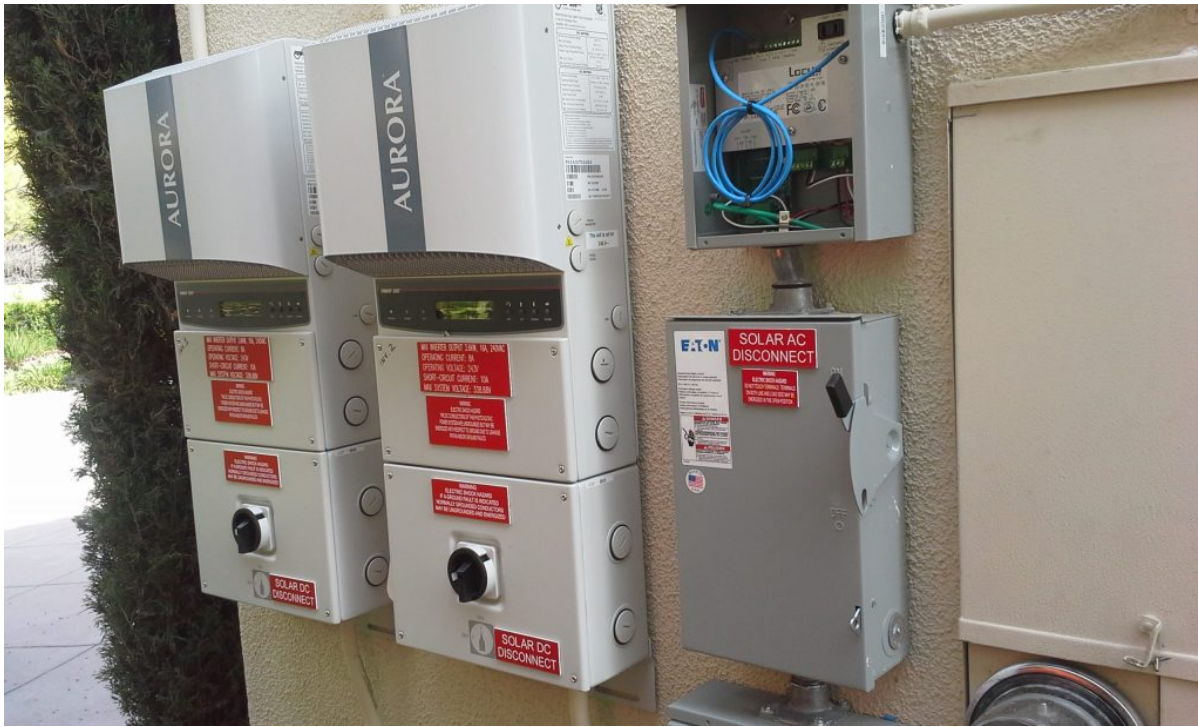
We measured DE at a home on 3/26/14 that also has PV solar panels and two Aurora Power One photovoltaic grid-tied inverters, leased from Verango:

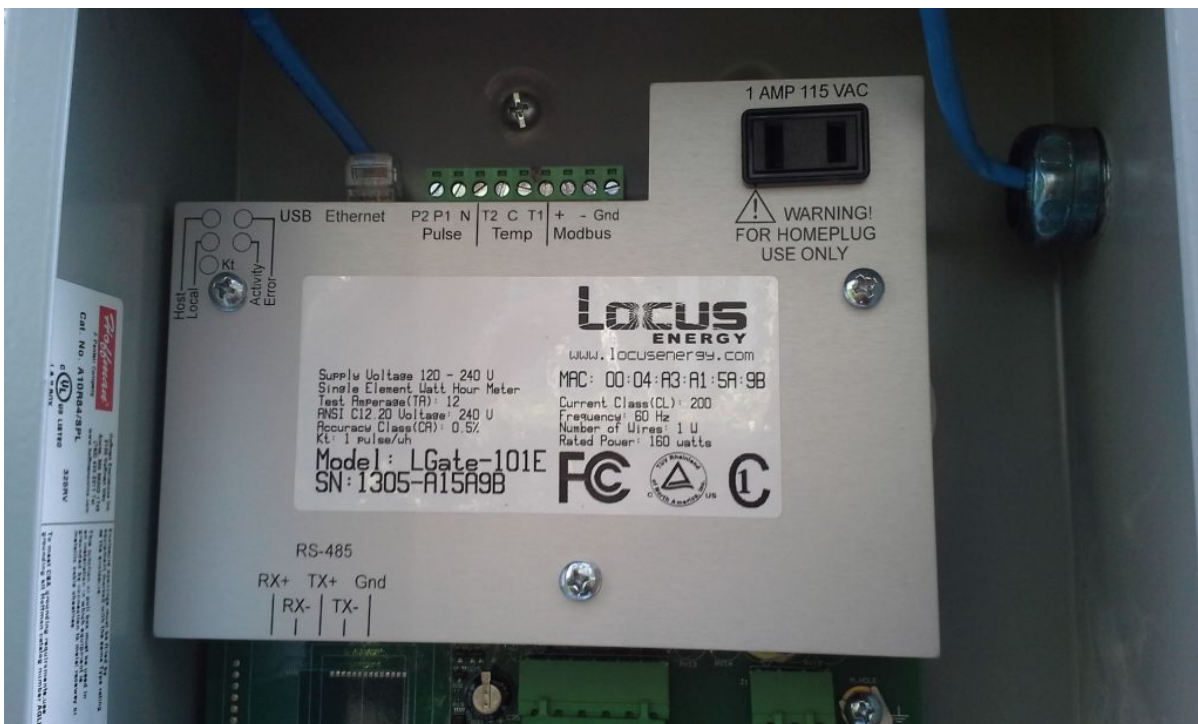
Here is a photo of the L-Gate non-wireless electric meter used by Verango:

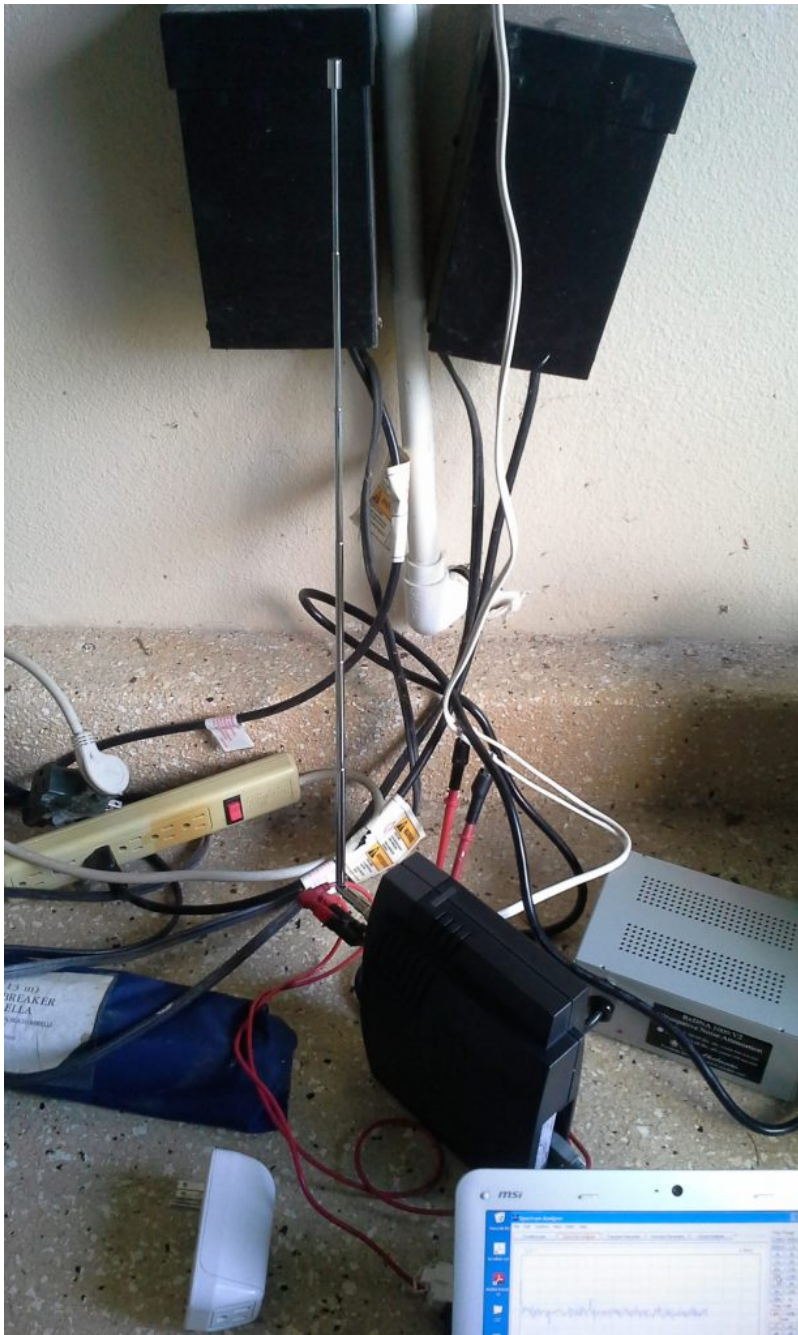
Once again, here is the oscilloscope set up at the home in Ladera Ranch. The Velleman scope was plugged into an outlet in the garage on the opposite side of the wall from the inverters, allowing DE measurements straight off the circuit into channel B. I also had a whip antenna connected to channel A. The power supplies for the two irrigation timer motors in the black boxes mounted on the wall were removed, as they produced extraneous DE, which would have been an artifact on our tracings had I left them plugged in:

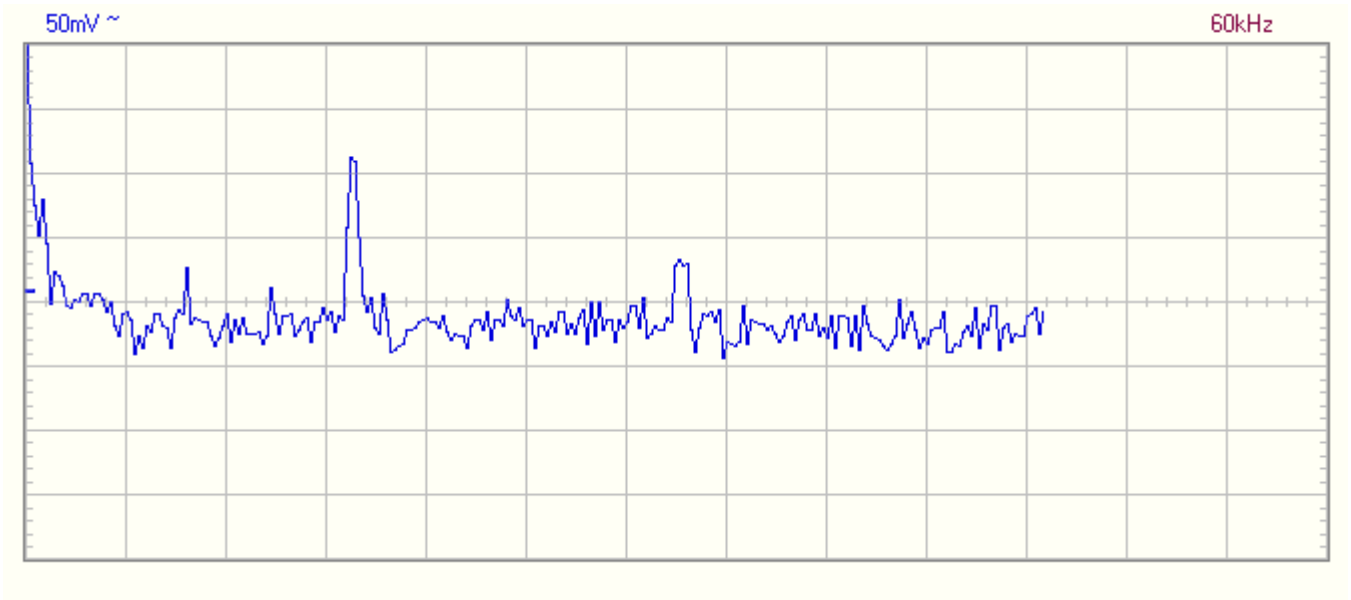
Tracings of the spectrum analysis of this circuit are shown below. The first image shows a spike 3.3 divisions from the left in the 0-60 kHz range. Since each division is 6 kHz wide, 3.3 divisions would equal roughly 20 kHz. Just as with the house in Trabuco Canyon with the Sunpower inverter, this fundamental frequency is also at 20 kHz:

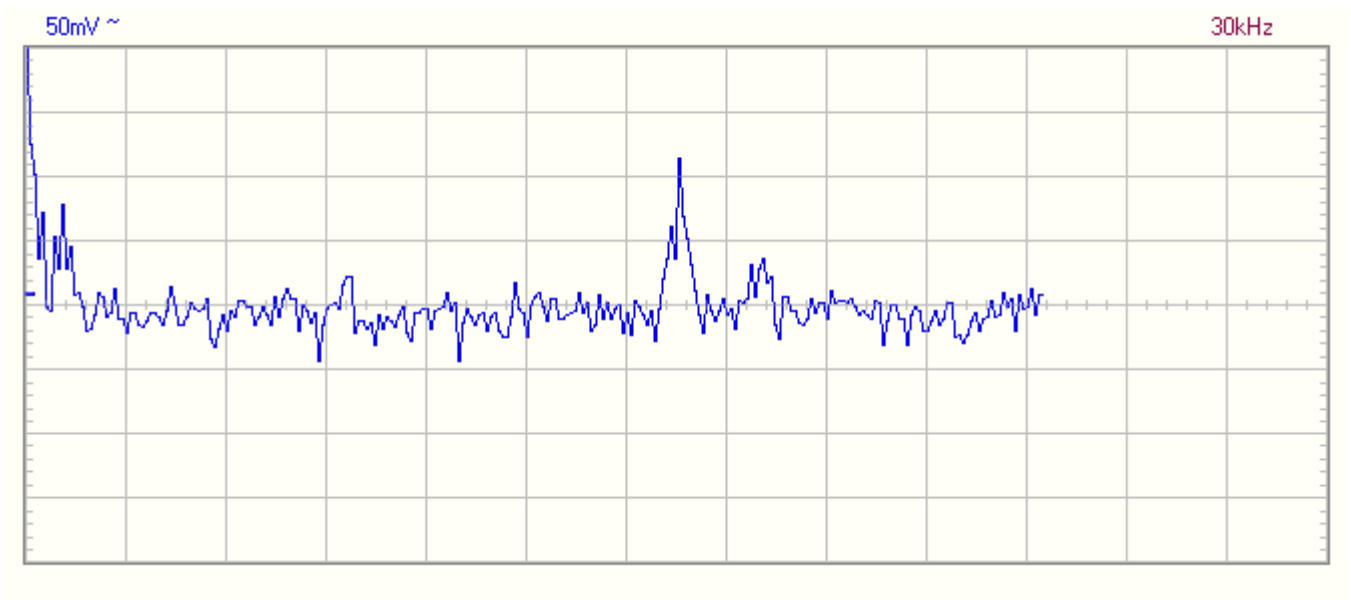
Here the 20 kHz spike is seen again, this time at 6.6 divisions from the left on a tracing with a 0-30 kHz range:

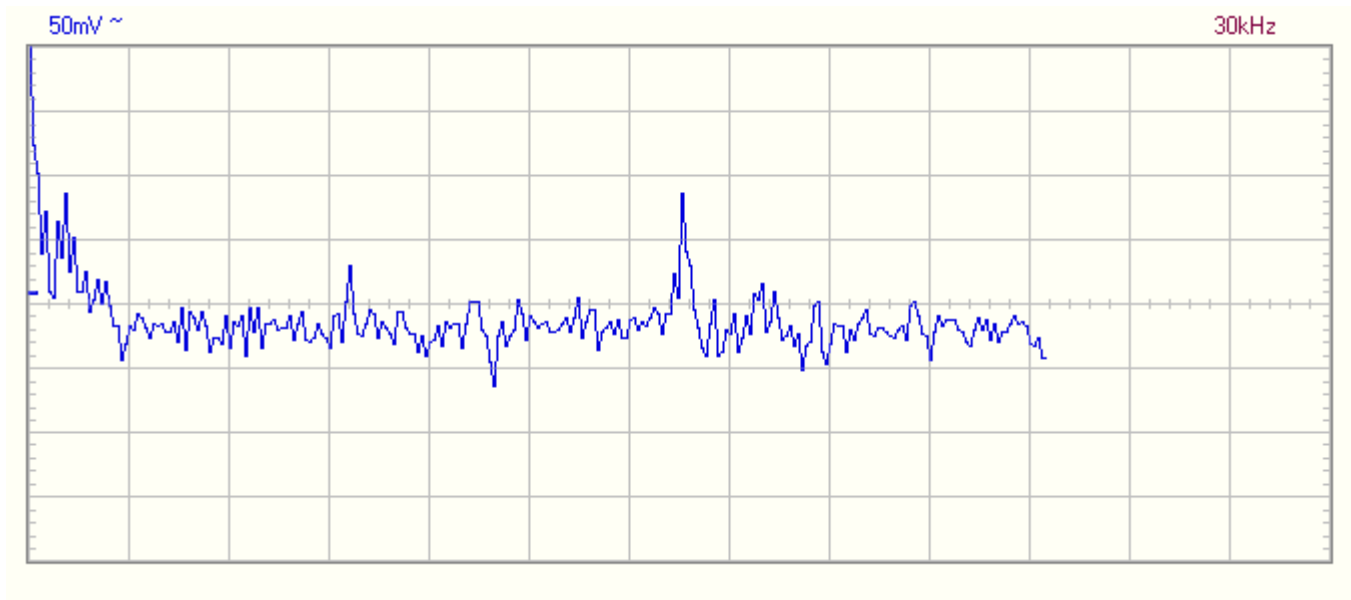
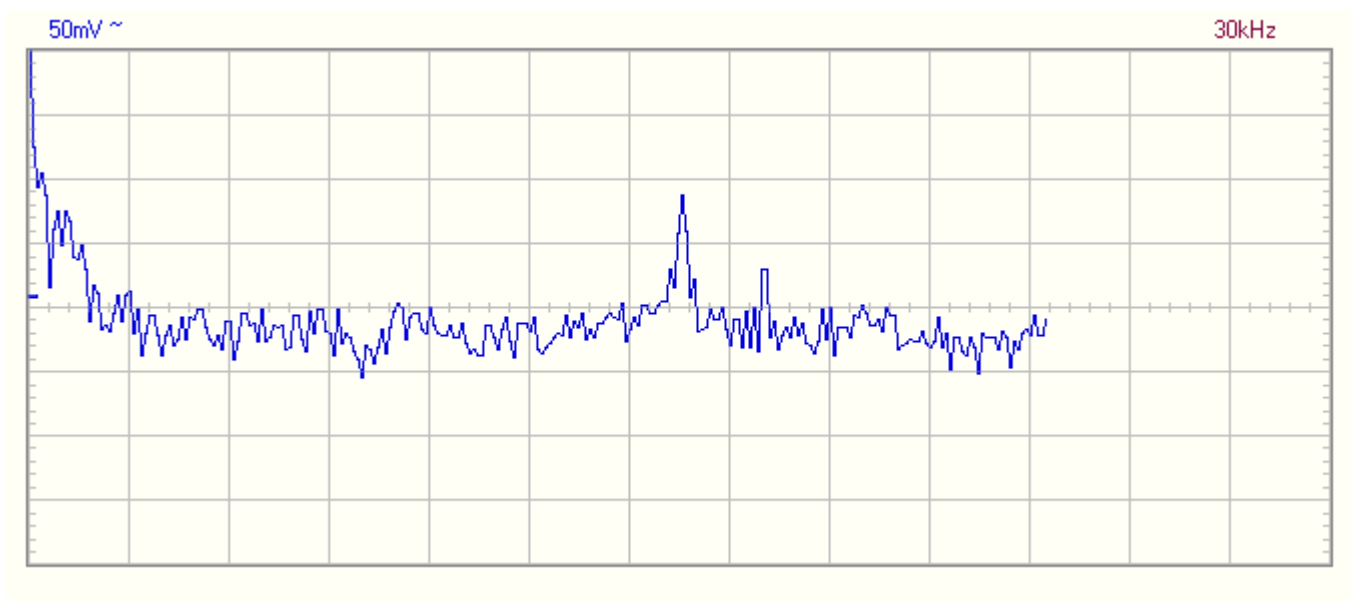
The first photo below shows a Greenwave filter in use. Below that an RxDNA device is in use. In both cases, spikes are 100 mV (2 divisions) high, not 125 mV (2.5 divisions) high, representing a 20% reduction:
